**Upper Penitencia Creek Improvement Project  
Year 4 (2016) Monitoring Report**

**Project 3518-03**

**Santa Clara Valley Transportation Authority**

February 2017

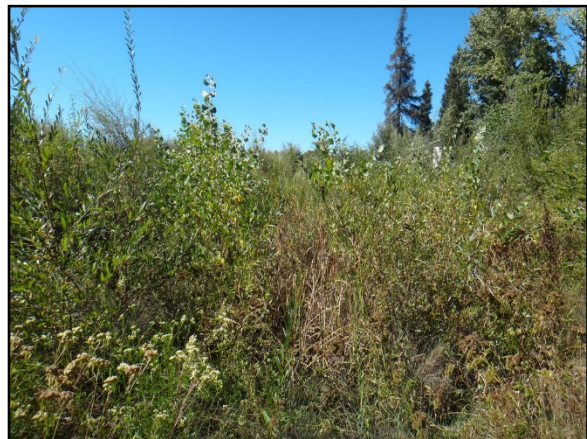
**Floodplain Wetland 1.** Floodplain Wetland 1 is located east of the main stream channel (Figure 2). It is approximately 175 feet long and 25 feet wide with a surface area of approximately 4,400 square feet. The wetland has expanded northwest toward the storm drain outfall since Year 3, increasing the area of the wetland by approximately 1,340 square feet. Photo 1 shows a representative depiction of the state of the wetland in August 2016. Approximately 6 inches of standing water was present at the southern end. Hundreds of mosquito larvae were observed. The remainder of the wetland was dry but had small areas of saturated soil and dried algal mats. The plant community was stratified into distinct concentric rings of vegetation spanning a gradient from perennial, emergent wetlands at the lower elevations to seasonal wetland vegetation and riparian trees and shrubs along the upper slope. The lowest vegetation consisted of emergent cattails (*Typha* sp.) that are increasing in cover through lateral vegetative expansion. Wetland vegetation located upslope from the cattails included

**Photo 1. View of Floodplain Wetland 1, looking northwest from the south bank**

rabbitsfoot grass (*Polygomon monspeliensis*), tall flatsedge (*Cyperus eragrostis*), curly dock (*Rumex crispus*), knotweed (*Persicaria* sp.), planted irisleaf rush (*Juncus xiphioides*) and common bog rush (*Juncus effusus*), naturally recruited and planted marsh baccharis, and planted willow. The vigorous growth of willow and cottonwood indicated that they were likely rooted into groundwater. In the upper banks of the wetland, mulefat (*Baccharis salicifolia*) and Fremont cottonwood plantings showed new growth and good health.

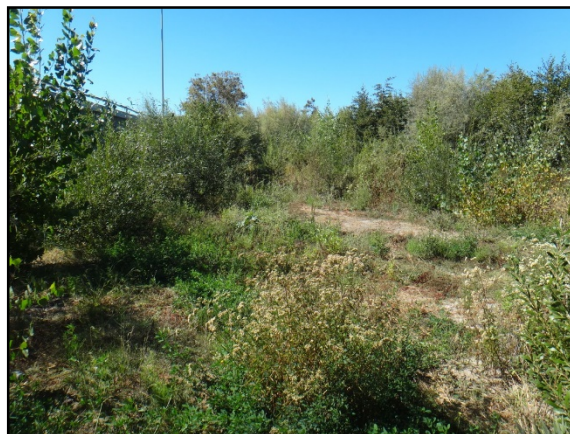
**Floodplain Wetland 2.** Floodplain Wetland 2 is located east of the new roadway bridge crossing (Figure 2). It is approximately 100 feet long and 55 feet wide with a surface area of approximately 5,500 square feet. The wetland has expanded 4,870 square feet since Year 3. Photo 2 shows a representative depiction of the state of the wetland in August 2016. No standing water or saturated soil was present; however, soil cracks were observed in the deepest portion of the wetland. The plant community was composed of knotweed, curly dock, marsh baccharis, common plantain (*Plantago major*), bristly ox-tongue (*Helminthotheca echioides*), rabbitsfoot grass, rough cocklebur (*Xanthium strumarium*), and one cattail. Sandbar willow, arroyo willow, white alder, and Fremont cottonwood were growing along the wetland banks. The presence of emergent cattail indicates that the depth and duration of ponding at Wetland 2 has increased since Year 3. This area was submerged under water during winter storms because woody debris jams located downstream of the site cause water to back up into the mitigation site. Several sandbar willow recruits were observed in Wetland 2, indicating that high quality wetland habitat is developing on the floodplain.

**Photo 2. View of Floodplain Wetland 2, looking northeast**

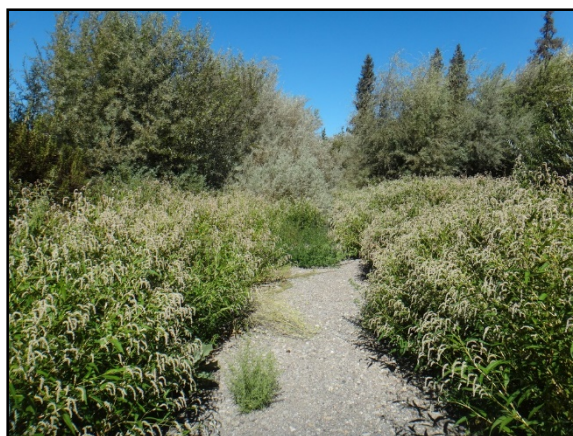
**In-Channel Wetland 1.** In-Channel Wetland 1 is located upstream of the new roadway bridge crossing (Figure 2). It is approximately 215 feet long and 12 feet wide with a surface area of approximately 2,600 square feet. Photo 3 shows a representative depiction of the state of the wetland in August 2016. No standing water was present; however, soils in the low-flow channel were damp. The plant community was composed of knotweed along the channel bed and banks and willows along the top of the banks. This portion of the site was inundated during winter storms.

**Photo 3. View of In-Channel Wetland 1, looking northeast from the New Roadway Bridge Crossing**

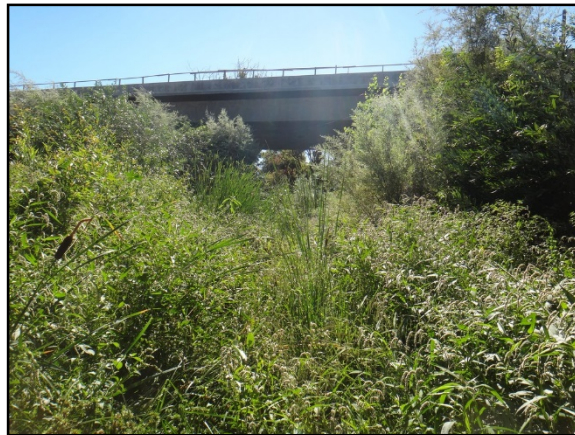
**In-Channel Wetland 2.** In-Channel Wetland 2 is located downstream of the new roadway bridge crossing (Figure 2). It is approximately 160 feet long and 24 feet wide with a surface area of approximately 3,900 square feet. Photo 4 shows a representative depiction of the state of the wetland in August 2016. Standing water (approximately 3 inches in depth) was present at the downstream end of the wetland. Soils were dry at the upstream end of the wetland. The plant community was stratified into distinct concentric rings of vegetation spanning a moisture gradient from perennial, emergent wetlands at the lower elevations to seasonal wetland vegetation and riparian trees and shrubs along the upper slope. The lowest vegetation consisted of emergent cattails. Wetland vegetation upslope of the cattails included knotweed, alkali bulrush (*Bolboschoenus maritimus*), and tall flatsedge. Willows lined the tops of banks along the northwest and southwest sides of the channel. In-Channel Wetland 2 was submerged under water during winter storms because woody debris jams located downstream of the mitigation site caused water to back up into the wetland.

**Photo 4. View of In-Channel Wetland 2, looking southwest from the New Roadway Bridge Crossing**

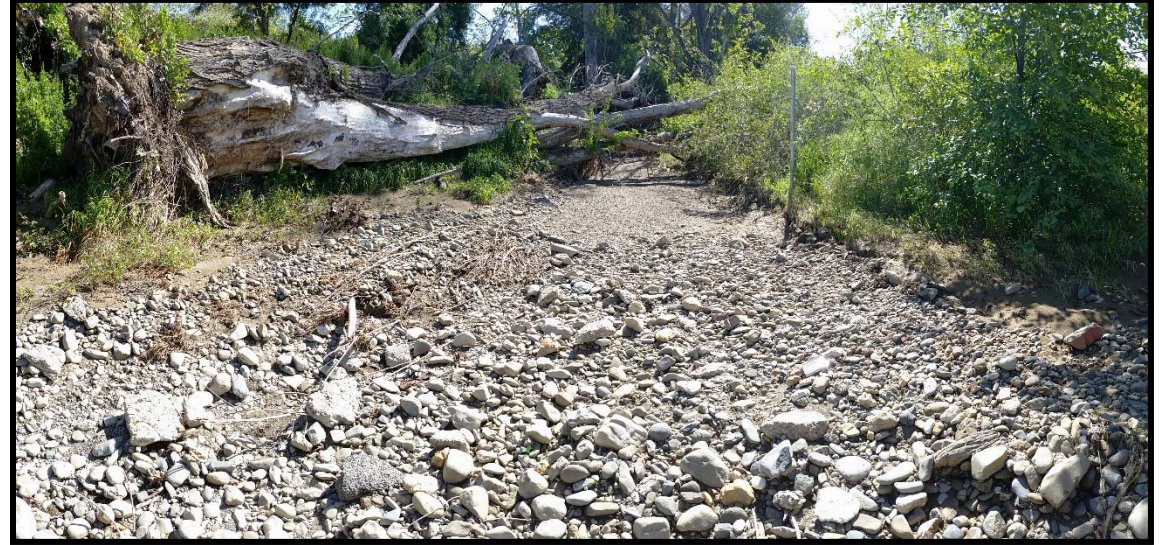
Photo Point #2: Station 10+00, March 2016, Year 4.

**Appendix B2. View upstream, entrance to project reach, Station 10+00, Upper Penitencia Creek, San Jose, California.** Riparian vegetation continues to mature and establish the banks. A large cottonwood tree fell into the channel in Year 4, creating the potential for an instream wood jam to occur in the future.

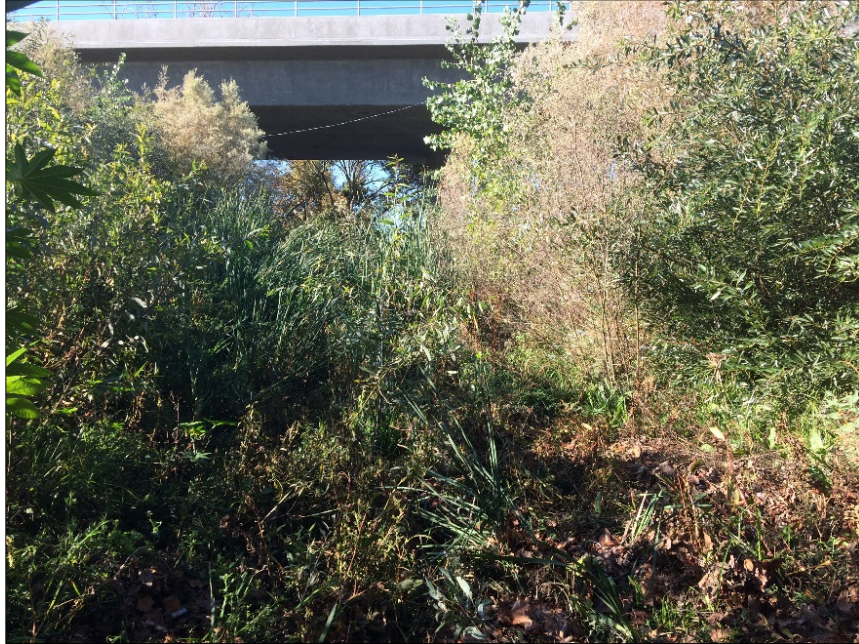
**Photo 1. Habitat unit 3, no water (damp) and heavily vegetated, looking downstream (October 2016)**

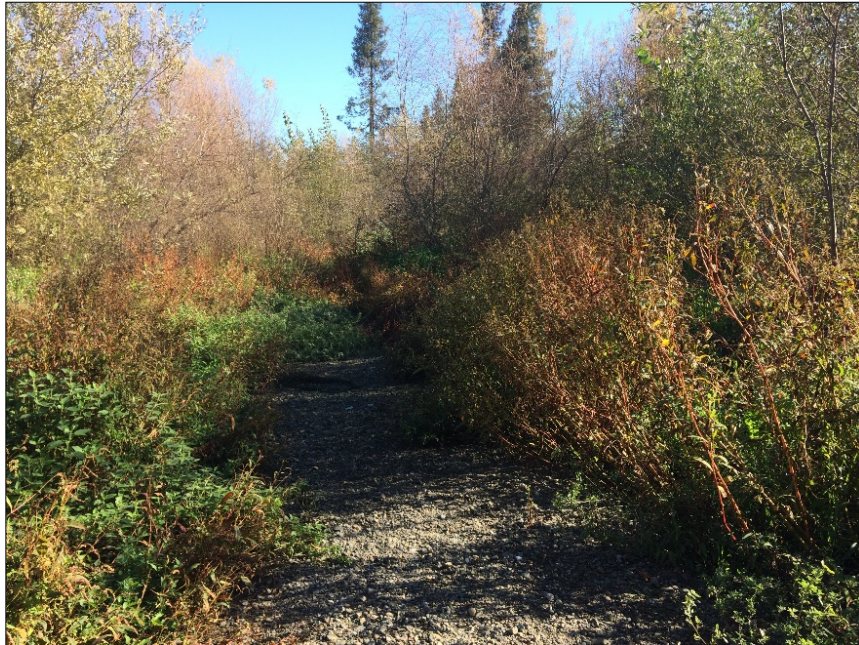
**Photo 2. Habitat unit 4, coarse gravel bars and scour channels, heavily over-grown, standing water at the lowest elevation, looking upstream (October 2016)**

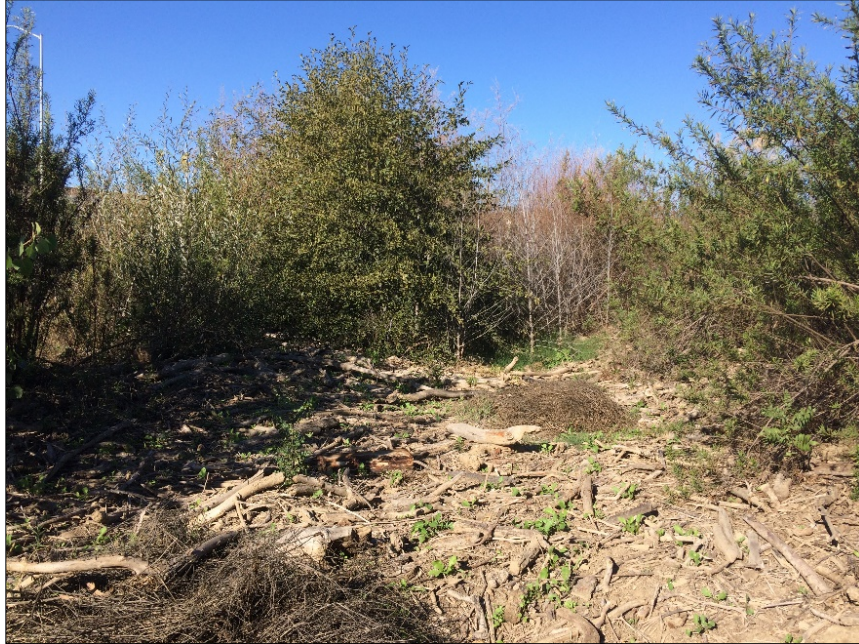
**Photo 3. Habitat unit 6, dry with woody debris (October 2016)**

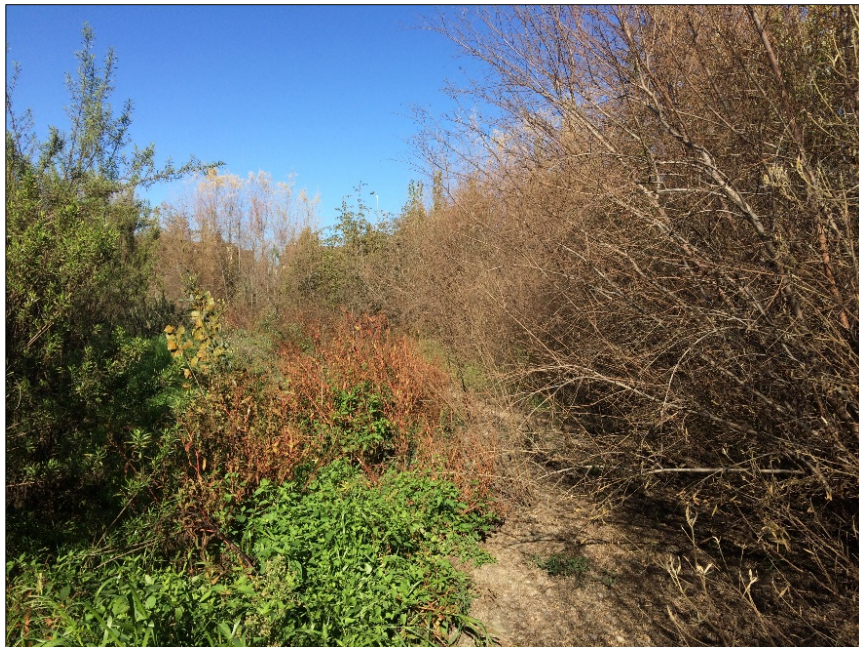
**Photo 4. Near junction of Habitat units 7 and 8, dry and heavily vegetated (October 2016)**

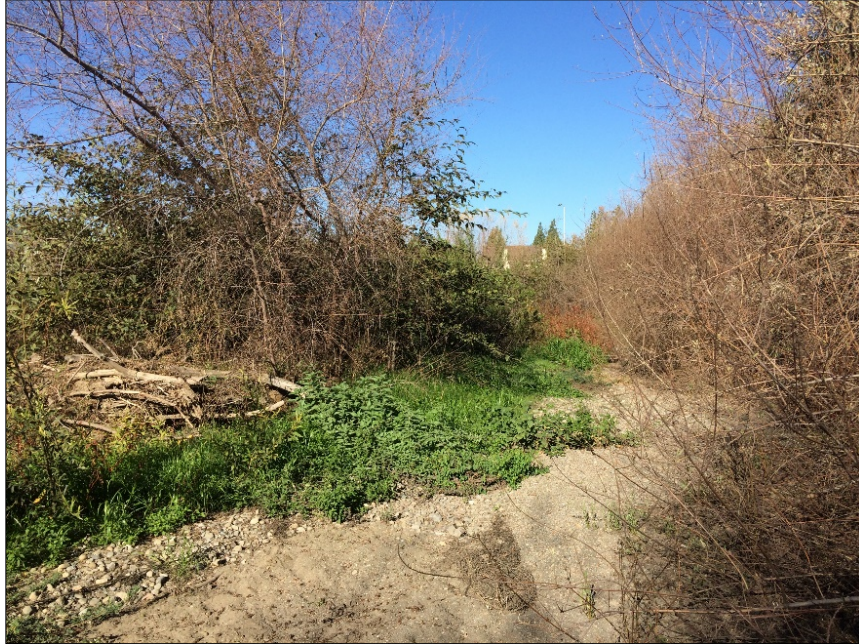
**Photo 5. Habitat unit 8, main channel of fines and large pebbles, large woody debris deposition, dry, looking downstream (October 2016)**

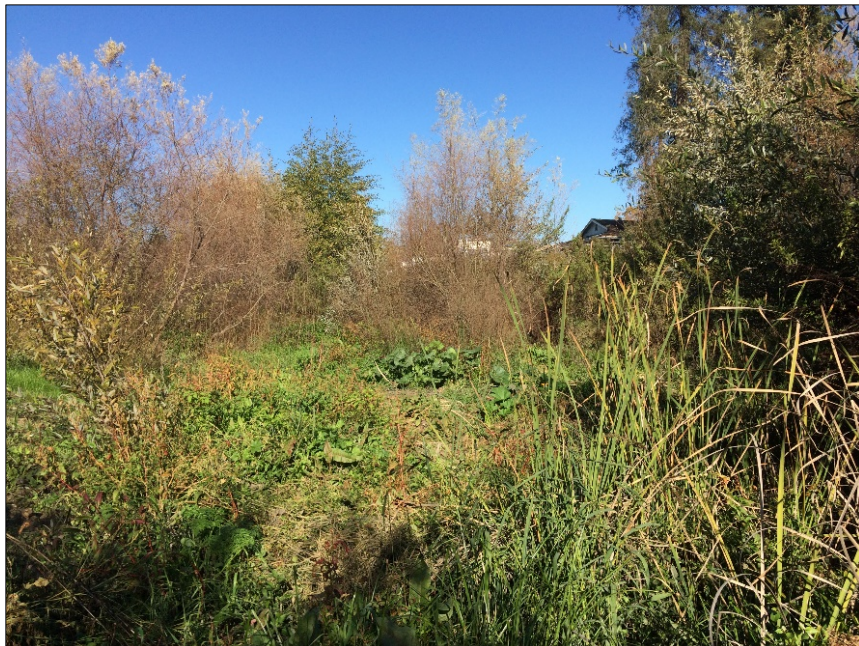
**Photo 6. Habitat unit 9, off-channel depression, damp (October 2016)**

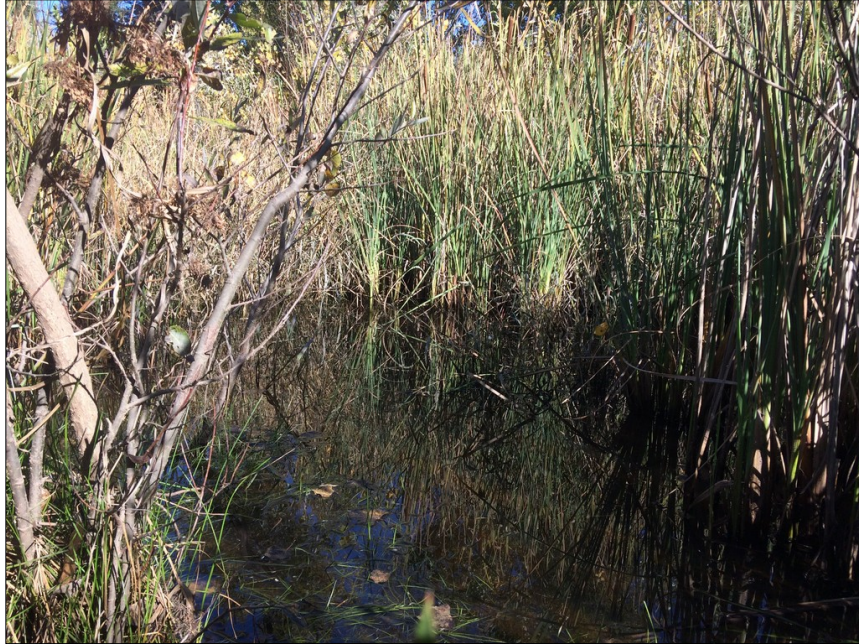
**Photo 7. Habitat unit 11, off-channel pond (October 2016)**

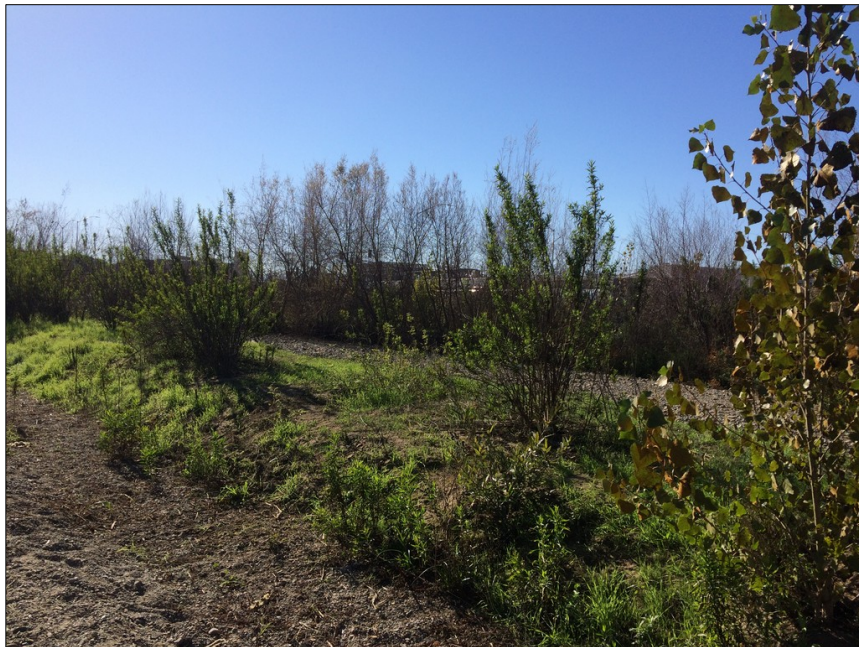
**Photo 8. Habitat unit 9, secondary and main channels, dry, coarse gravel and sand, cobble (October 2016)**

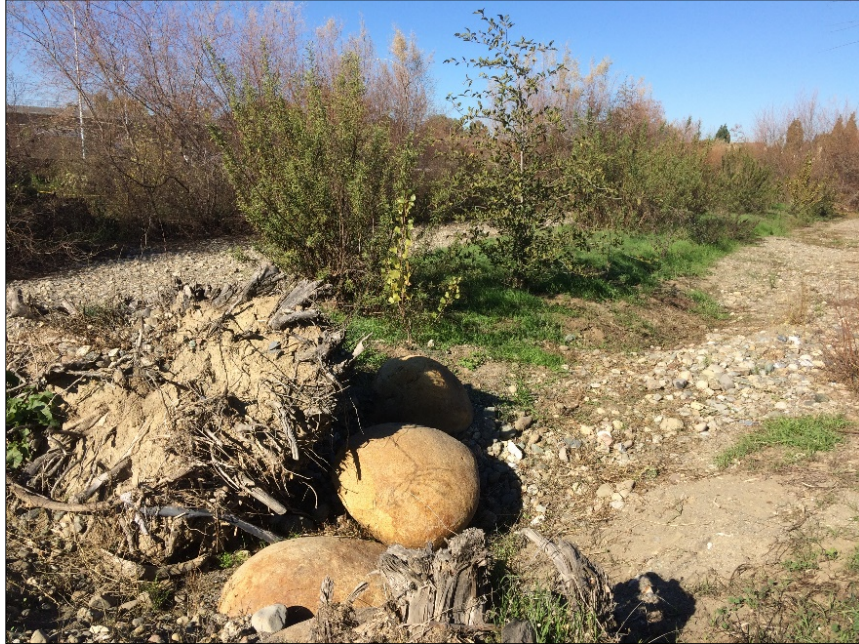
**Photo 9. Habitat unit 11, main and secondary channels, rootwad and boulders, dry, cobble and coarse sand (October 2016)**

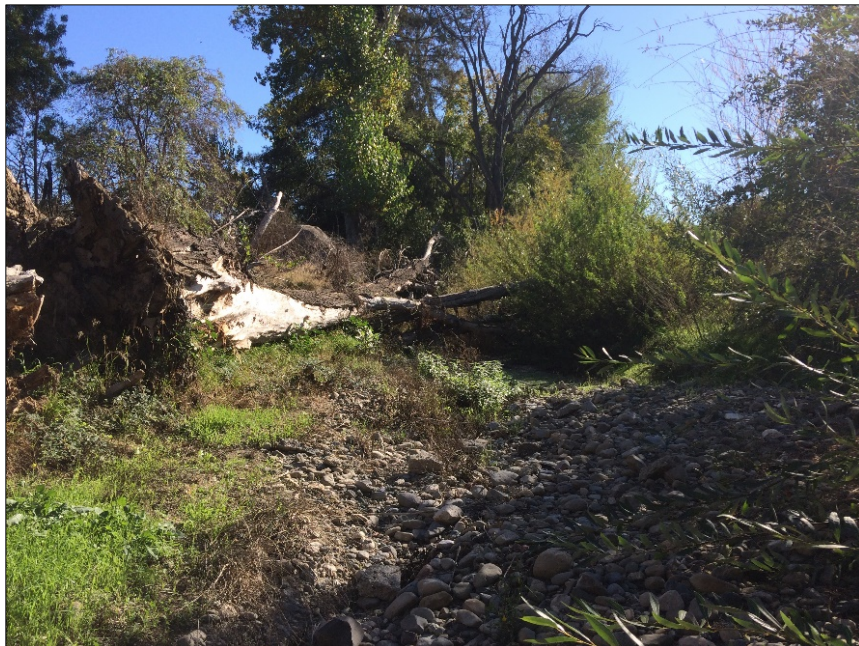
**Photo 10. Habitat unit 12, single channel narrows, lined with downed tree, small pebbles to large cobble, dry (October 2016)**
