ALUM ROCK FISH PASSAGE PROJECT MITIGATION MONITORING REPORT YEAR FOUR, 2016

Santa Clara Valley Transportation Authority
3331 North First Street, Bldg. B-2
San Jose, CA 95143-1906
Contact: Ann Calnan
408.321.5976

ICF
75 E. Santa Clara Street, Suite 300
San Jose, CA 95113
Contact: Donna Maniscalco
408.216.2802

April 2017

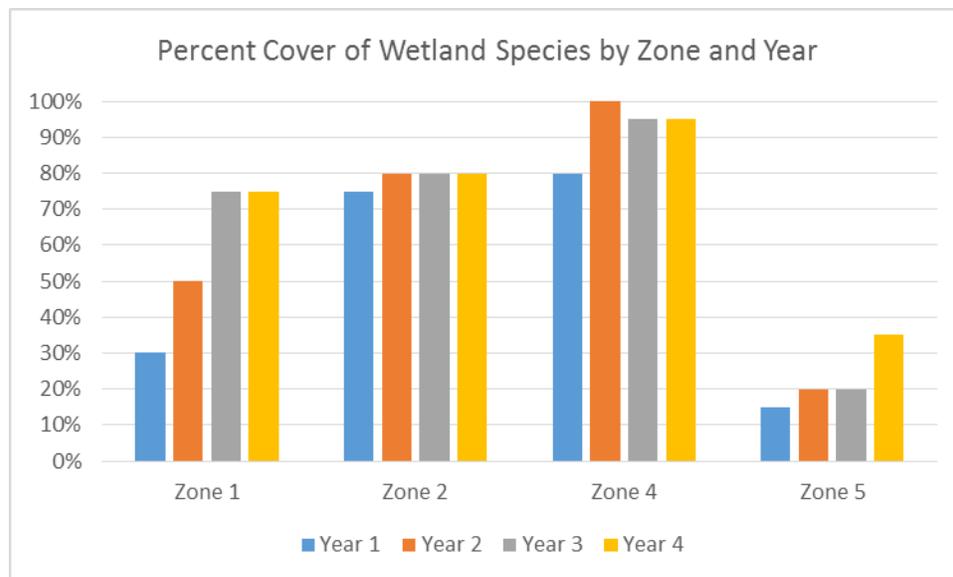
Note: For Year 4, the success criterion for Objective 1 is a minimum of 45% aerial cover of native facultative and wetter species within the re-established scrub/shrub and emergent floodplain area.

Figure 6. Percent Cover of Wetland Species by Zone and Year

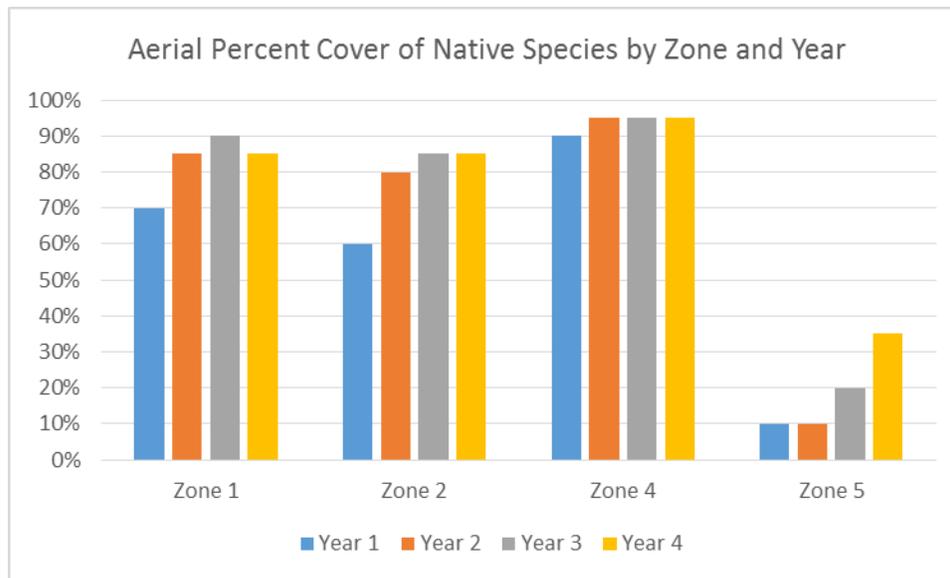
Note: For Year 4, the success criterion for Objective 2 is a minimum of 35% aerial cover of all native species within the riparian and restored upland area.

Figure 7. Percent Cover of Native Species by Zone and Year

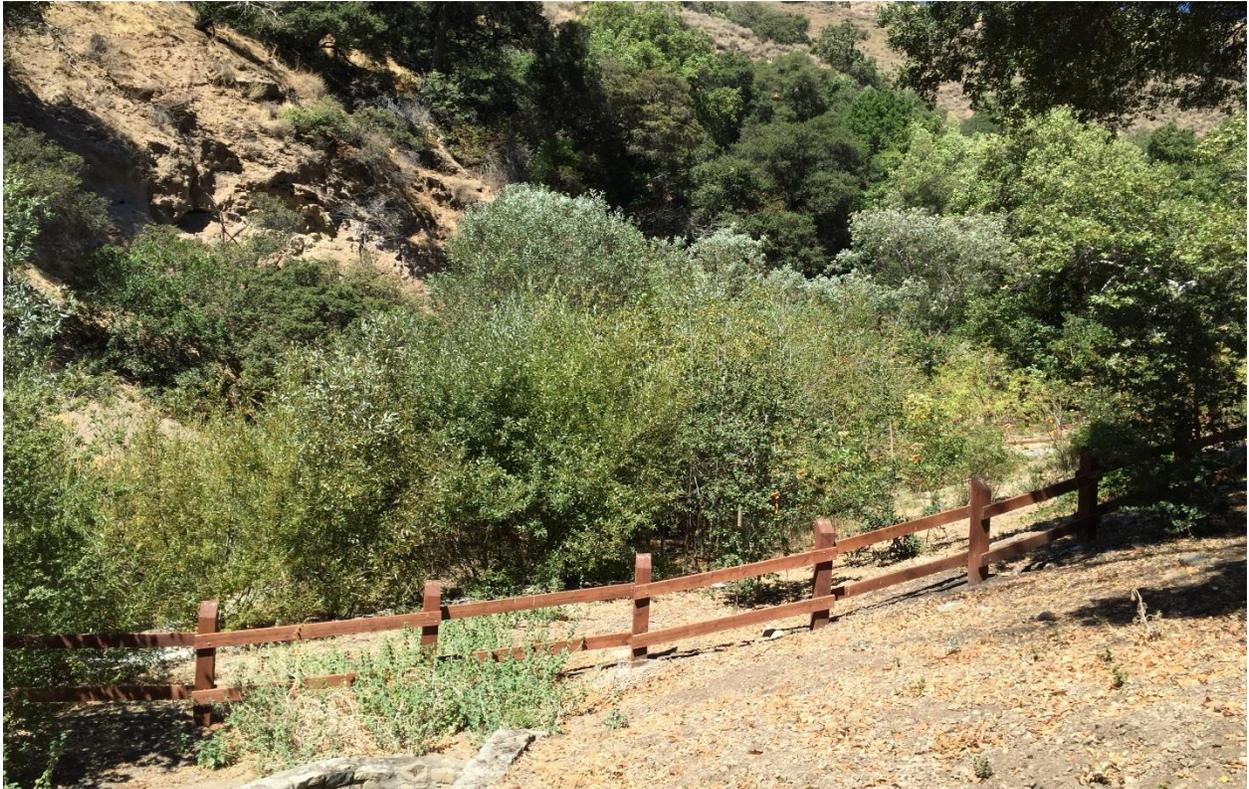
Photo 5. Looking northeast at Zones 4 and 5 from pedestrian path.

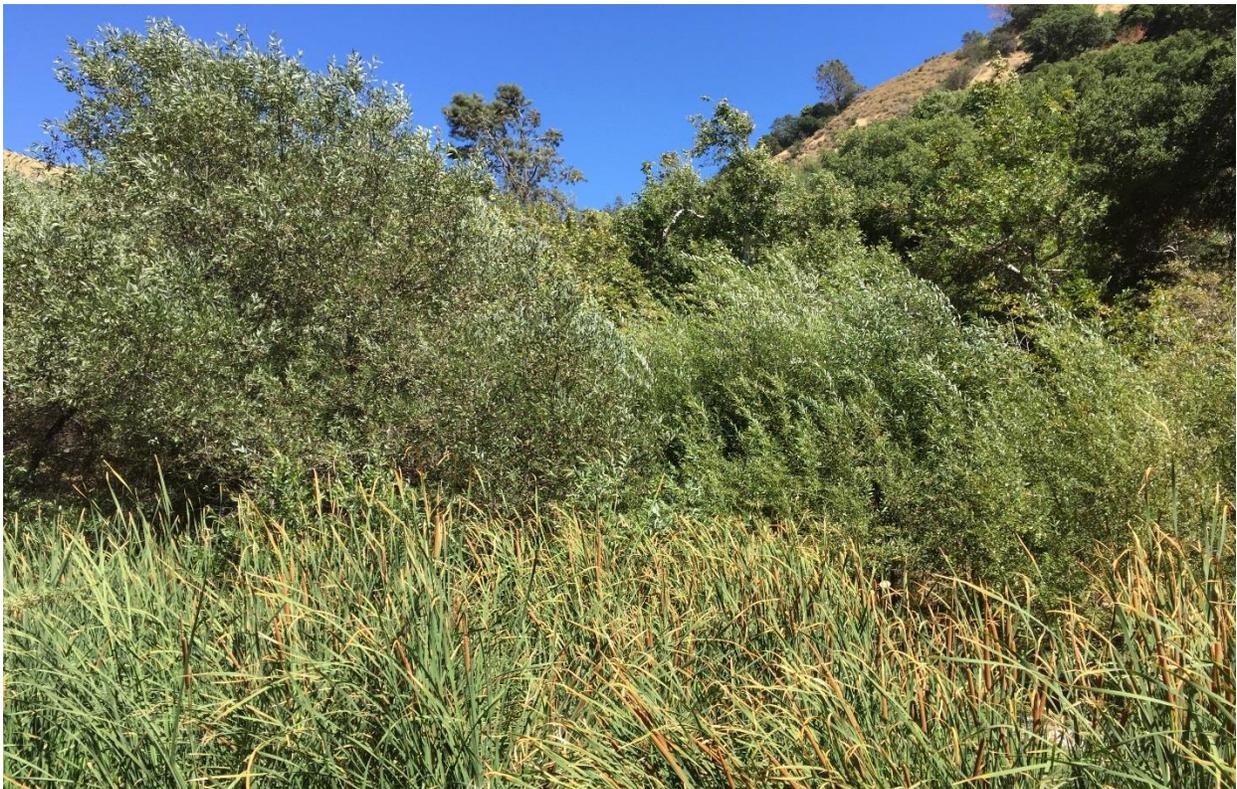
Photo 6. Looking southeast at Zone 4.

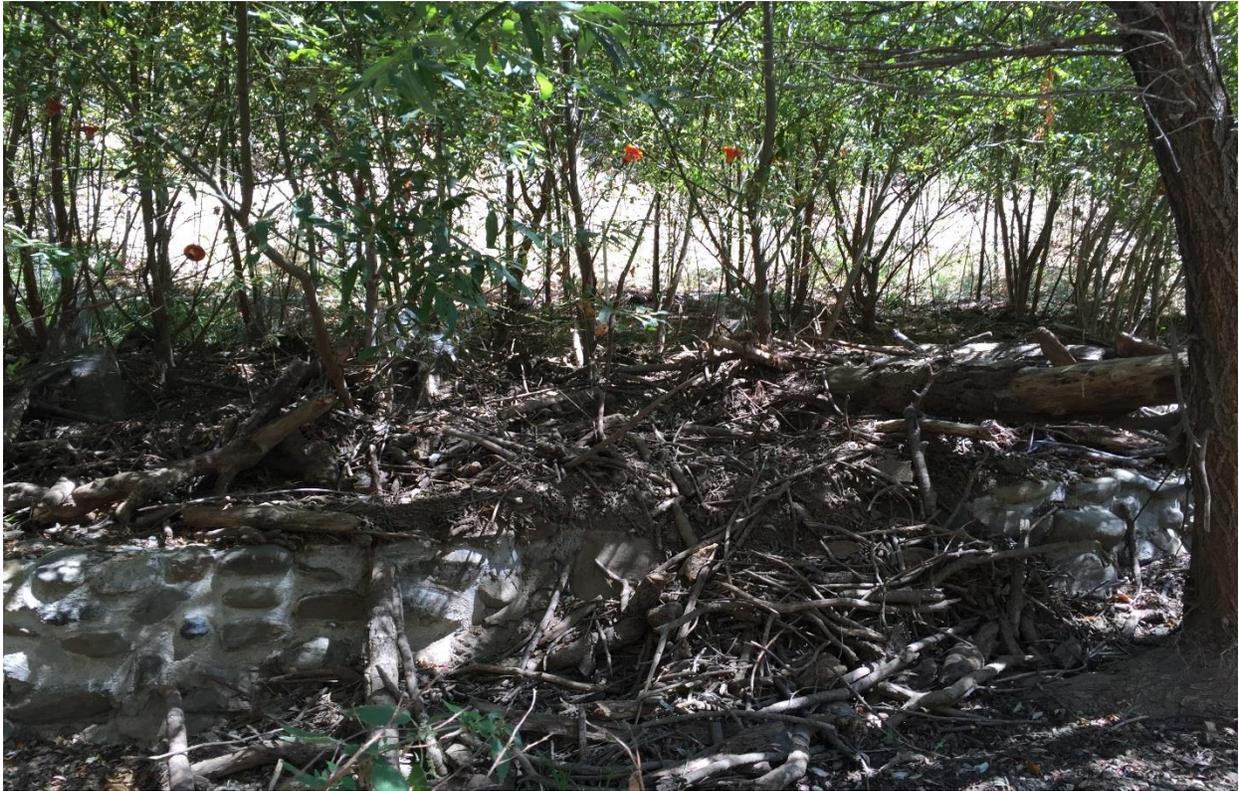
It was apparent that the floodplain (Zone 4) became inundated with surface flow during 2015/2016. Many of the cages are damaged and thick sediment and organic debris has covered most of the floodplain (see Appendix B Miscellaneous Photos, Photo 6 and Appendix C Geomorphic and Hydrologic Monitoring Annual Report). This caused a loss of herbaceous species but has not compromised the site. Planted trees (willows, alders) are thriving. We suggest that the damaged cages and rebar be removed. There are no plants in the cages and the cages and rebar may get swept downstream into the creek when the floodplain becomes inundated again.

Photo 7. Organic debris and sediment at Zone 4.

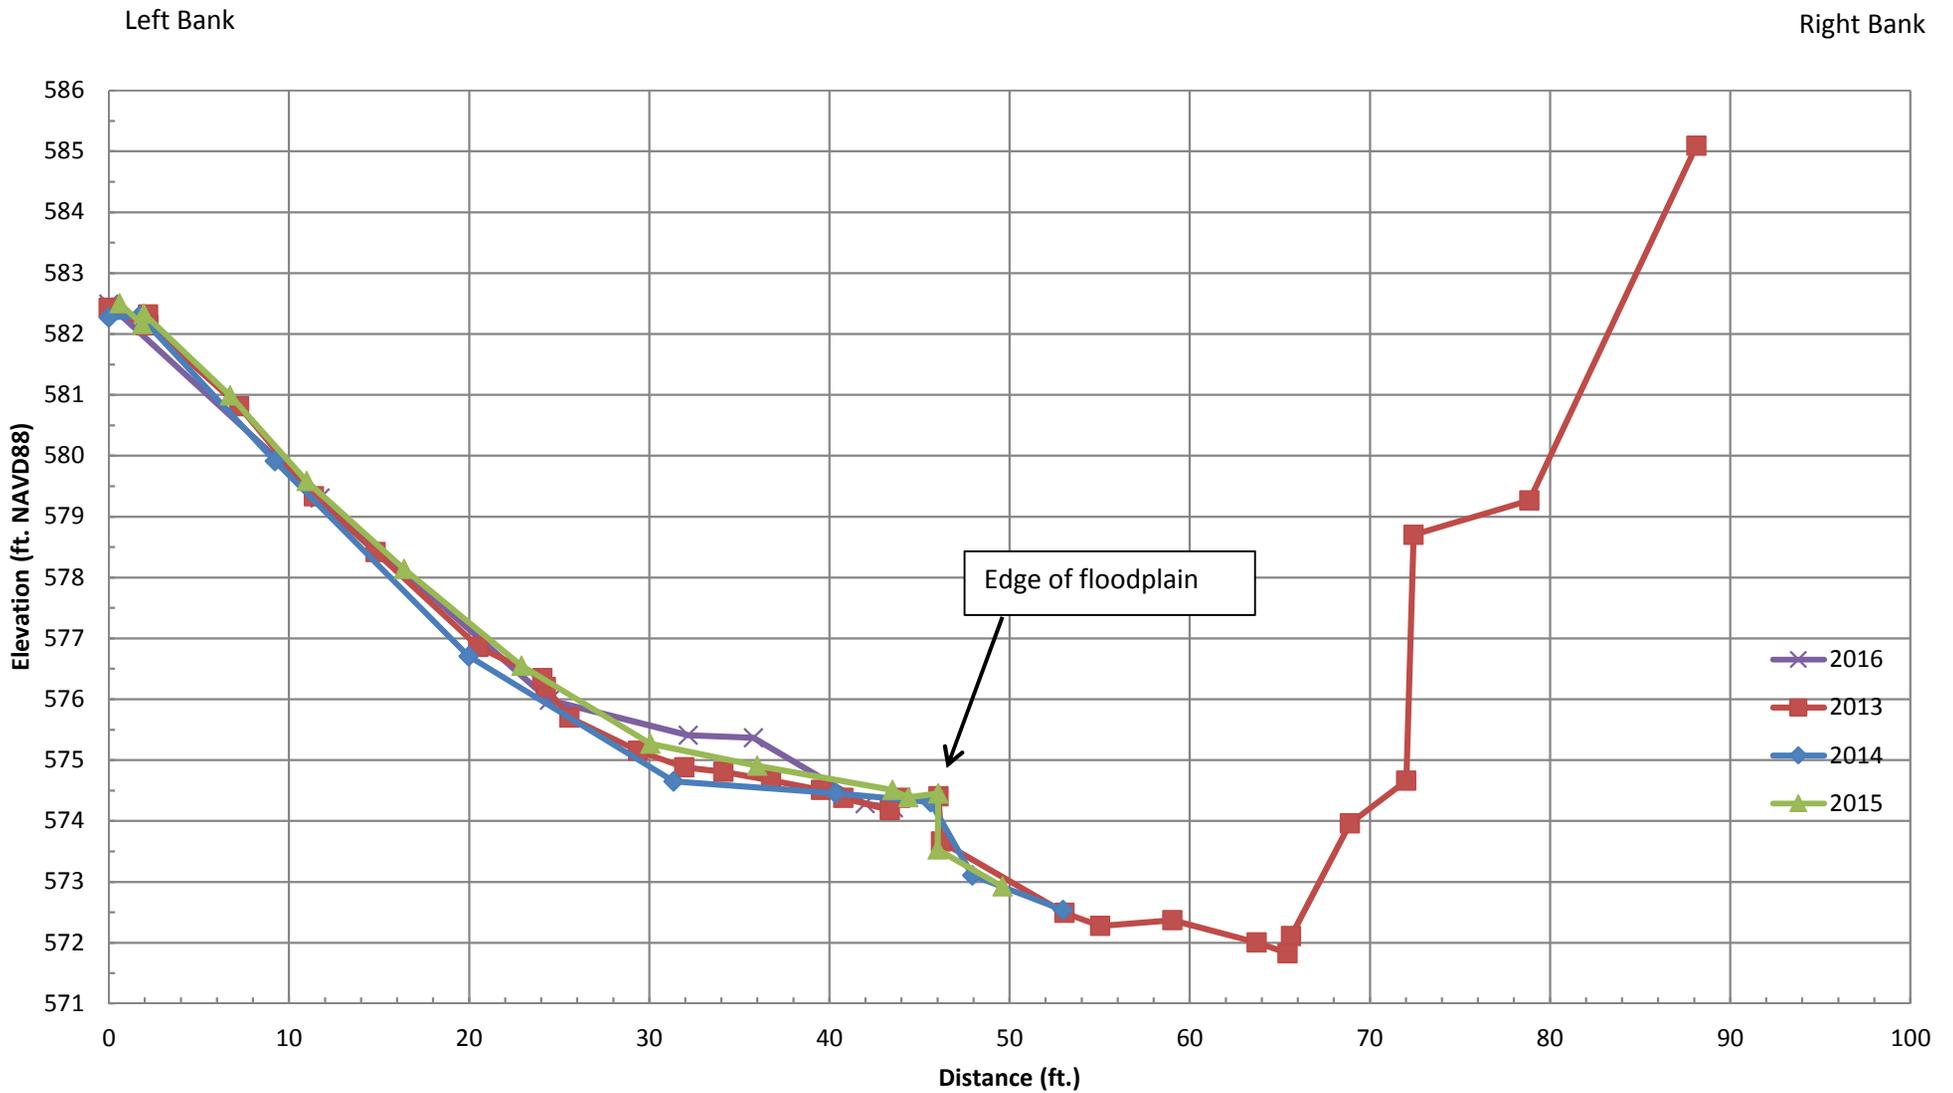
Figure 31 . Cross section 101, Alum Rock WY2016 monitoring, Santa Clara County, California.

The quantitative surveys of the floodplain (Site 10) were a challenge this year due to vigorous willow and alder growth. This proved to be a major obstacle in surveying cross section (XS) 101 – only the upstream portion of the survey could be completed in a timely manner. The ability to capture accurate survey data in a cost-effective manner is diminishing each year. As such, it is recommended that starting Year 5 (2018), monitoring relies on qualitative descriptions, sediment plate measurements, and photo points to assess the condition of the floodplain, and eliminate the total station surveys. An established solid baseline survey dataset can be re-occupied, should issues arise with the site that would require measurement along the profiles.

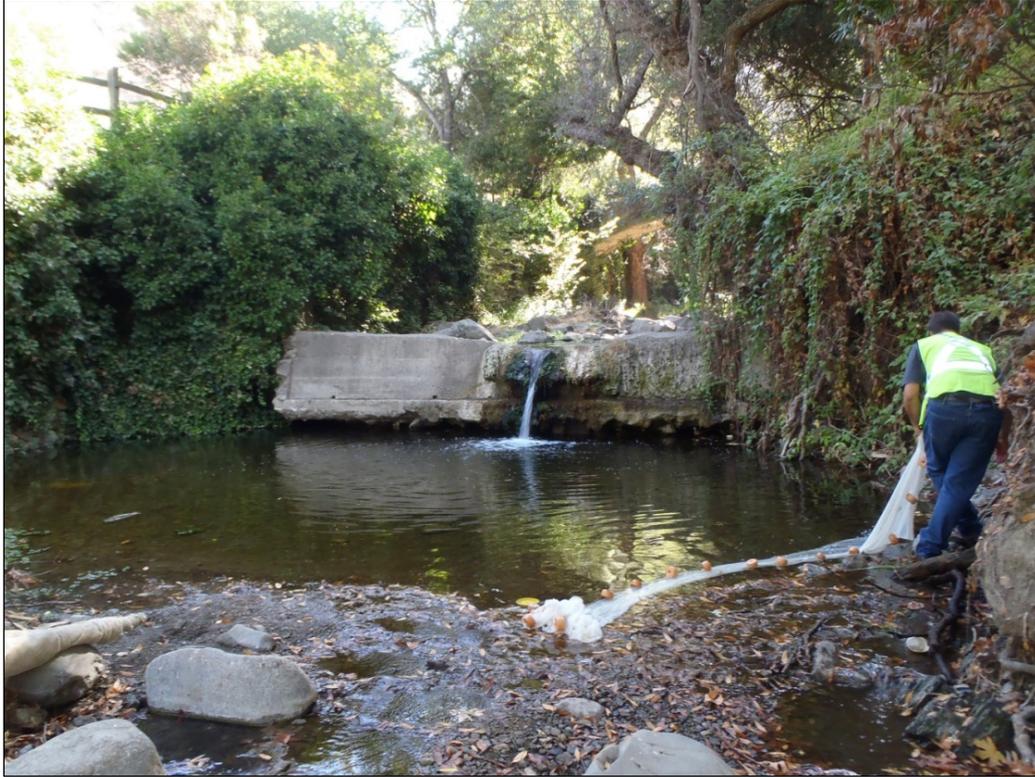
Figure 1. Concrete Weir before Modification, August 8, 2012 (Looking Upstream)

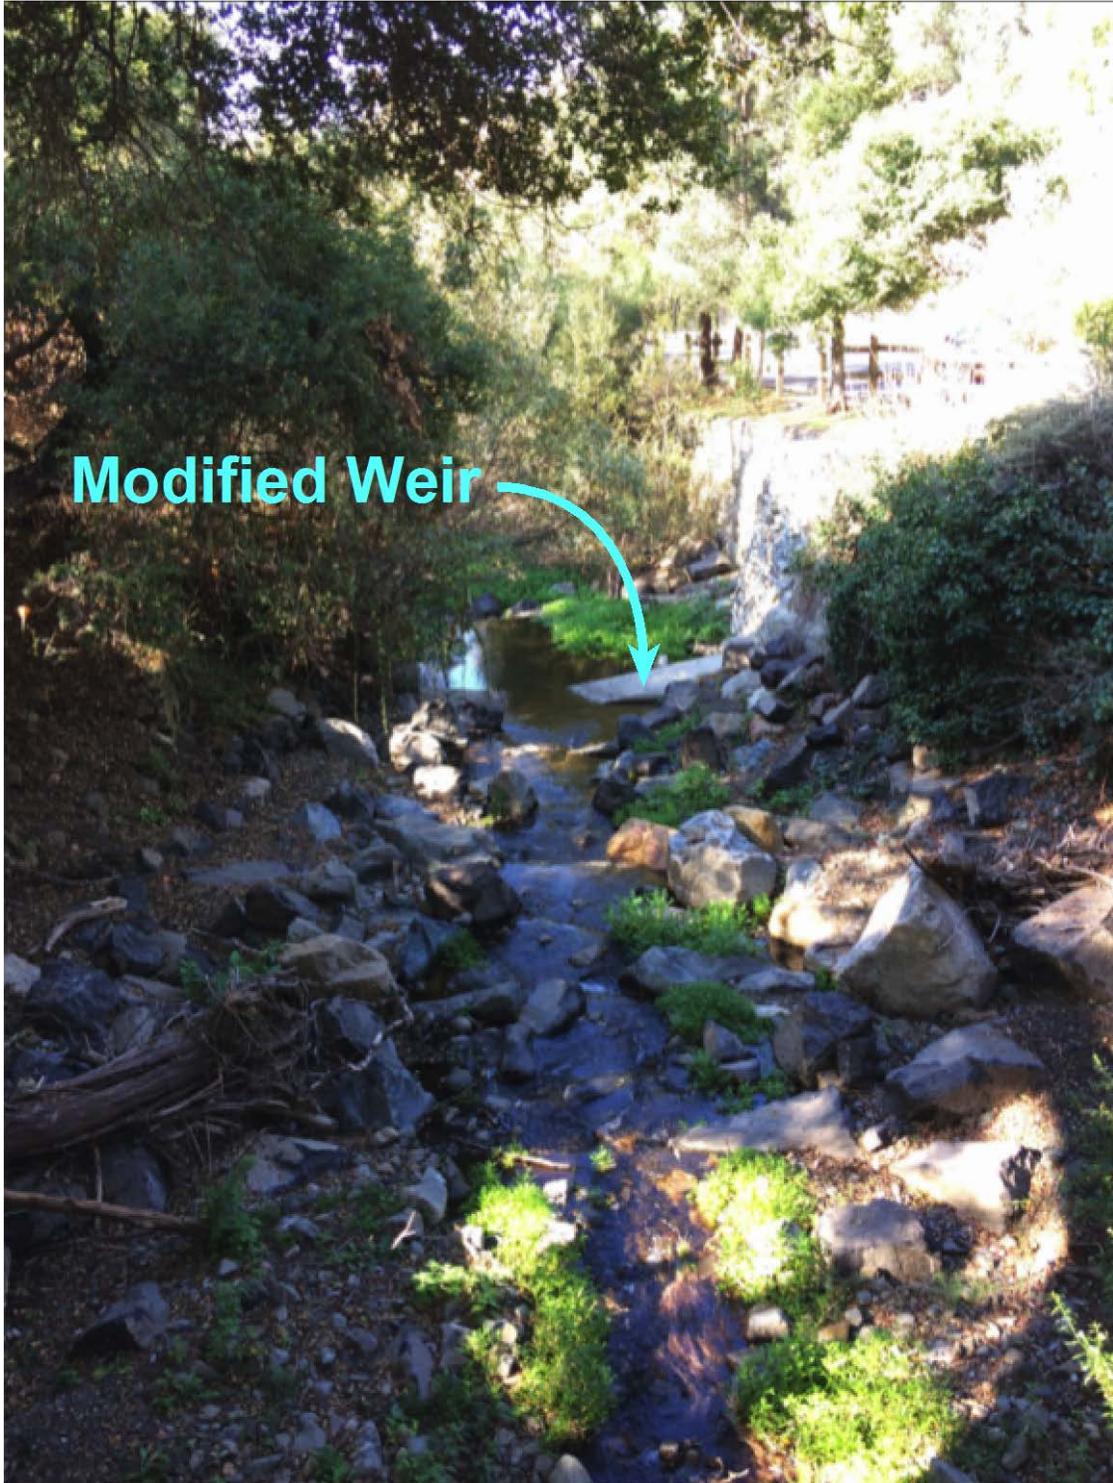
Fish passage in the Project reach was improved by modifying a 4.5-foot-high concrete weir. The crest of the weir was lowered to the level of the normal pool surface and a 225-foot-long roughened channel was constructed to improve passage for *O. mykiss* and other native fishes (Figures 1 and 2). Post-construction monitoring is required to “assess the biological performance of the fish passage improvement Project and evaluate the ability of the site to pass steelhead” (NMFS 2012). To meet this goal, a 5-year fisheries monitoring plan was developed by H. T. Harvey & Associates (H. T. Harvey), approved by the National Marine Fisheries Service (NMFS), and implemented beginning in September 2013 (H.T. Harvey 2013a, 2014). The plan involves conducting electrofishing surveys and habitat typing to document the fish species and habitat associations in the Project reach. During monitoring, fish ecologists document all the fish species encountered while focusing on CCC steelhead. Both CCC steelhead and resident rainbow trout have been documented in Upper Penitencia Creek, including upstream of the Project reach (Leidy et al. 2005, Leicester 2011, Leicester and Smith 2012, Leicester and Smith 2013a, Leicester and Smith 2013b, Leicester and Smith 2014, Leicester and Smith 2015, HTH 2013b). Because *O. mykiss* may adopt anadromous or resident life history strategies, all anadromous steelhead and resident rainbow trout observed during surveys are referred to as *O. mykiss* in this report. Other Project monitoring components performed by other firms and not summarized in this report include vegetation monitoring and streambed hydrological monitoring, all of which, when combined, will improve understanding of the evolving habitat conditions and species use in the restored channel.

Figure 2. Modified Concrete Weir, November 9, 2016 (Looking Downstream)

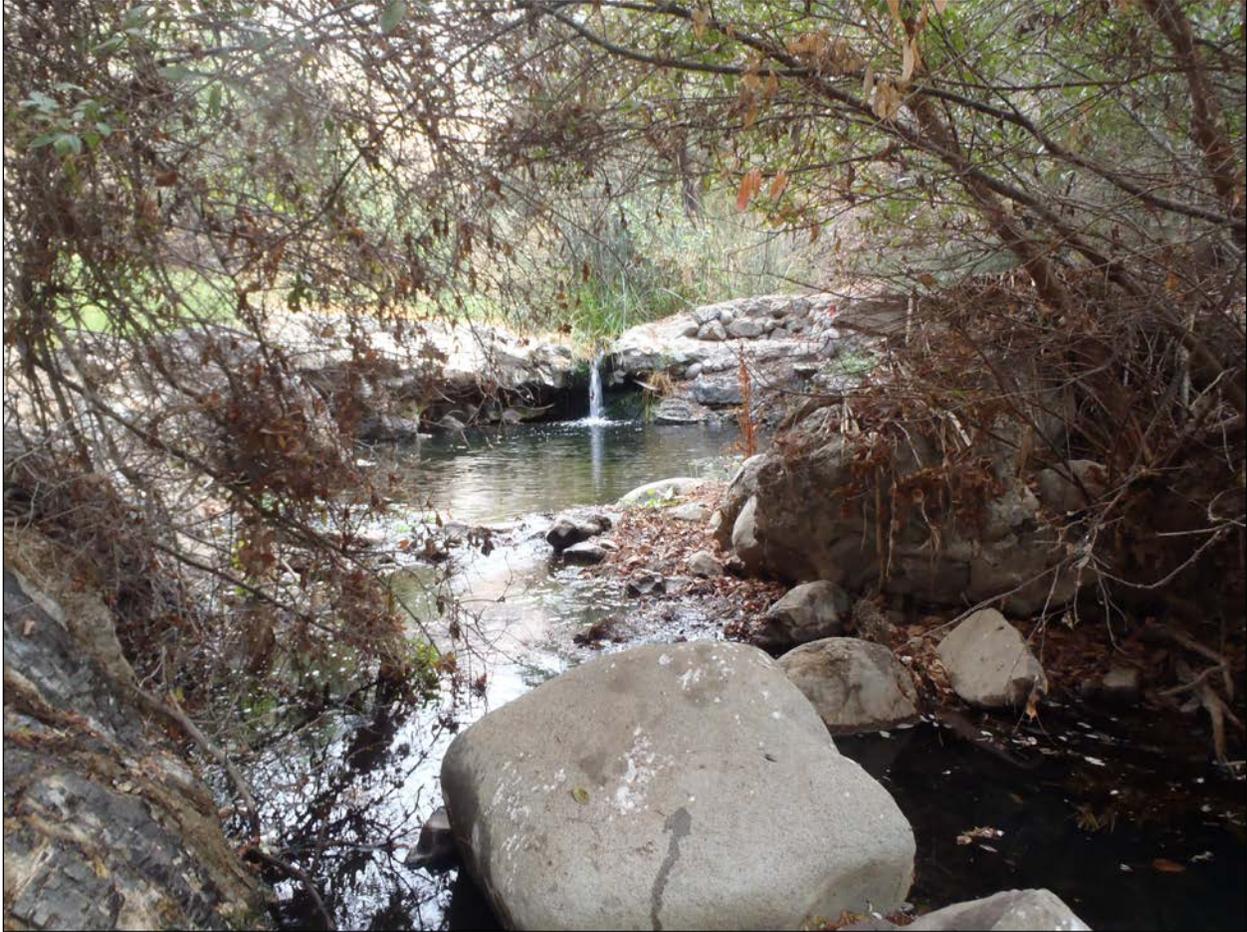
Figure 12. Concrete Barrier in Upstream Reach (ca. November, 2015)
