Appendix C: Walk Audit Summary

TASMAN DRIVE COMPLETE STREETS CORRIDOR STUDY WALK AUDIT SUMMARY

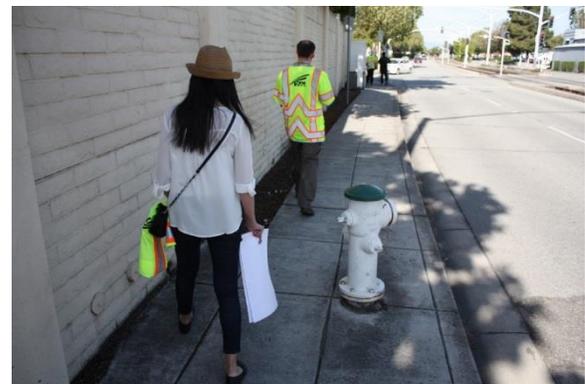
Photo 2: Obstacles such as fire hydrants block the sidewalk on Tasman Drive, east of the Lawrence Expressway.

- Gaps in the sidewalk, especially between Fair Oaks Avenue and Vienna Drive, occur in a constrained right-of-way situation where the corridor contains median-running light rail, two lanes of vehicular traffic, mature trees, and a sound barrier wall.
- Some sidewalk sections have barriers to people walking, such as utility poles and fire hydrants, particularly from Reamwood Station to Lawrence Expressway.

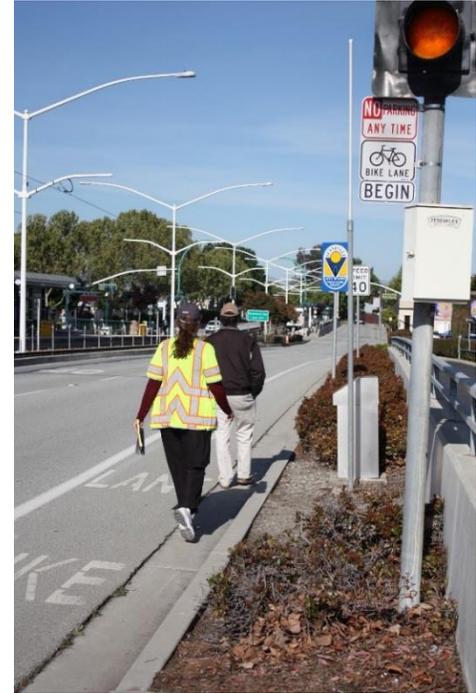
- Large segments of sidewalk are missing along Tasman Drive, including:
 - On the south side of Tasman Drive:
 - East of Fair Oaks Avenue to Vienna Drive
 - On the north side of Tasman Drive:
 - East of Fair Oaks to Lawrence Expressway
 - East of Lawrence Expressway to west of Reamwood Avenue
 - Reamwood Avenue to the Calabazas Creek Trail

Photo 3: Missing sidewalk along Tasman Drive, west of Calabazas Creek Bridge

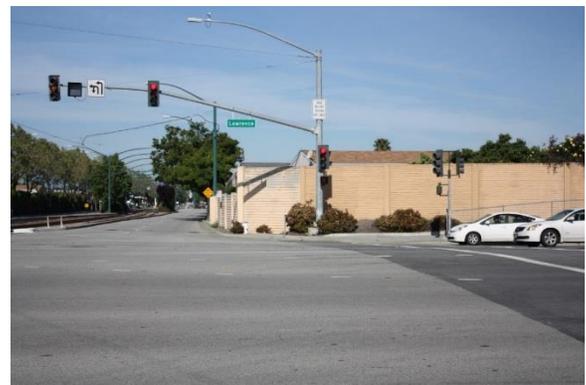
Photo 4: Wide intersections and lack of bicyclist infrastructure were noted at Lawrence Expressway and Tasman Drive.

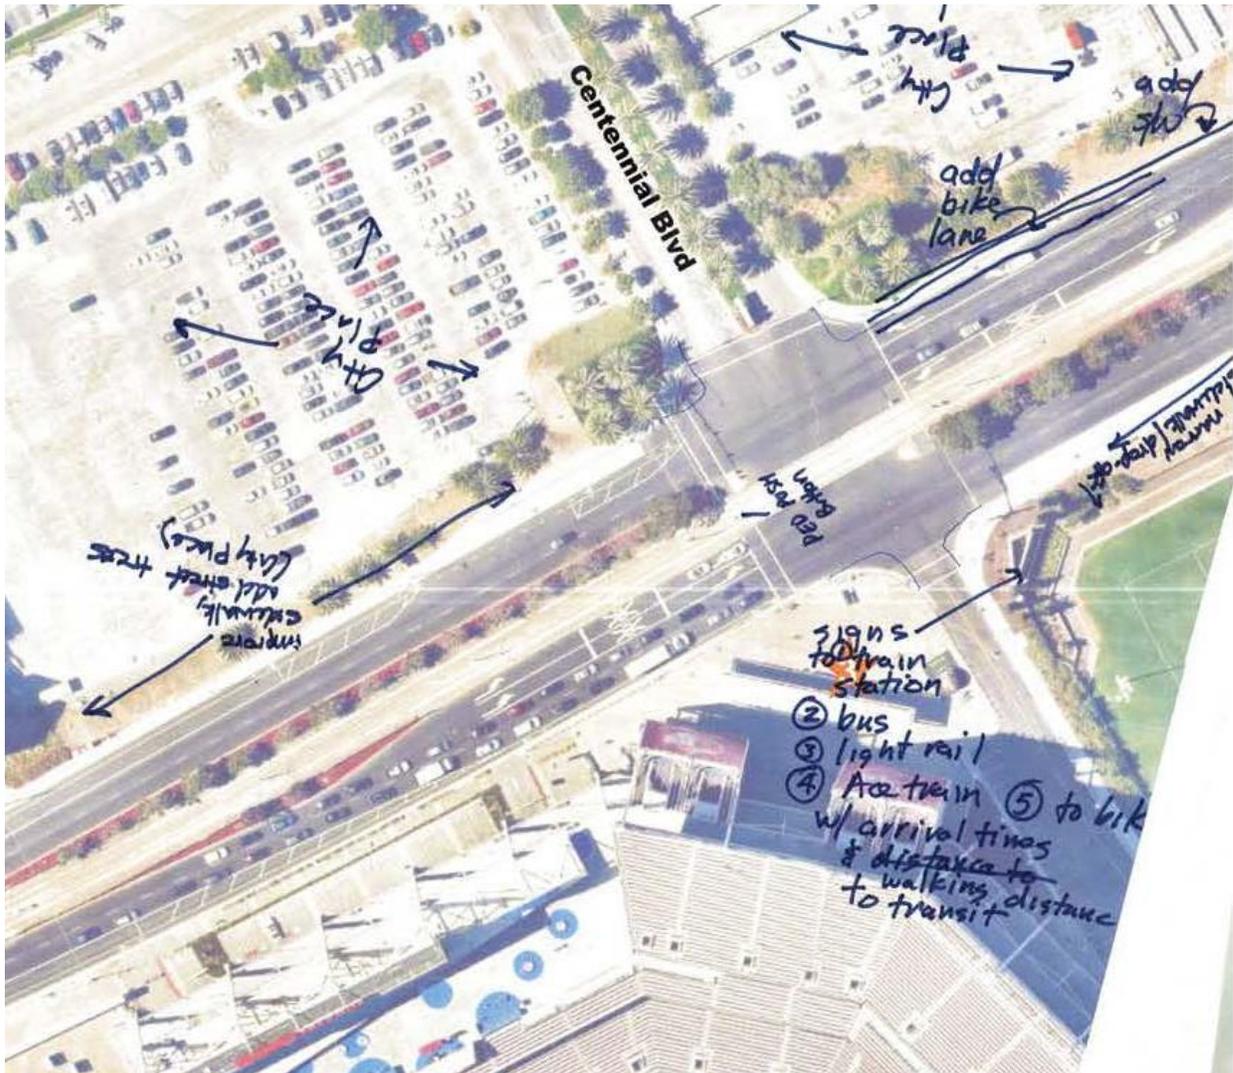
Figure 2: Hand-written comments from the Walk Audit Maps at Station #3 Centennial Boulevard in Santa Clara.

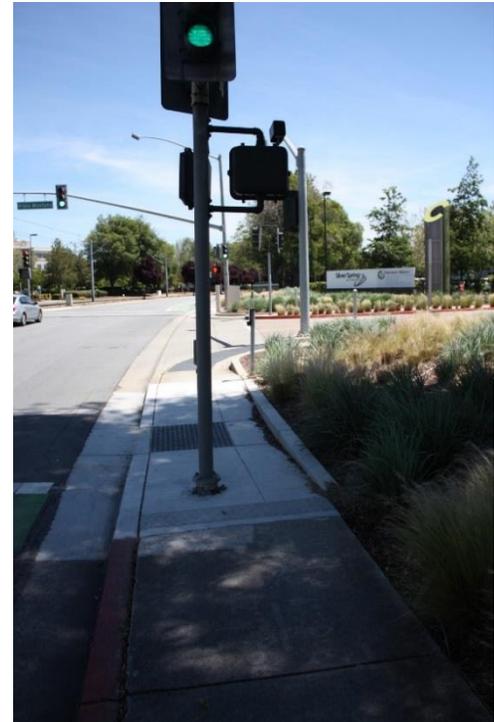
- The sidewalk is in good condition in this part of the corridor. A few barriers such as traffic signal poles and utility boxes reduce the amount of clear space for wheelchair access and pedestrians.
- City staff noted the City of San Jose right-of-way extends beyond the sidewalk, which could provide an opportunity to widen the sidewalk or expand the width of the bike lane. A wider sidewalk particularly near the office buildings will create a more pleasant pedestrian environment because this will increase the distance between the cars and the pedestrians.

Photo 8: Traffic signal blocking the sidewalk on at Vista Montana

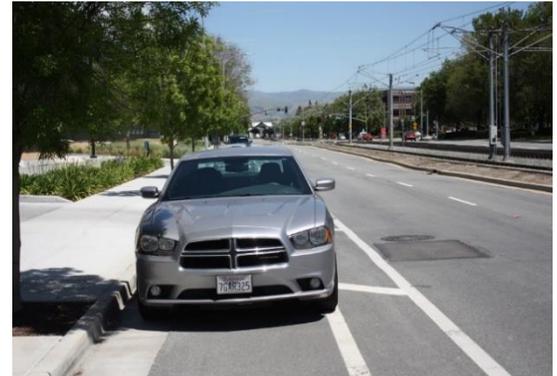
- San Jose has some of the highest quality bicycle facilities along the Tasman corridor. The bike lanes are striped with a buffer and green paint marking conflict zones on the approach to intersections along the corridor.
- Challenges such as high speed traffic and conflict areas still exist, and the City of San Jose would like to implement Class IV protected bike lanes as a low stress facility, whenever possible.
- At North 1st Street and Tasman Drive (on the north side), vehicles were parked in the bike lane in front of the Samsung building. Vehicles were also observed blocking the VTA bus stop.

Photo 10: Cars parked in the bike lane at Tasman Drive and N. First Street

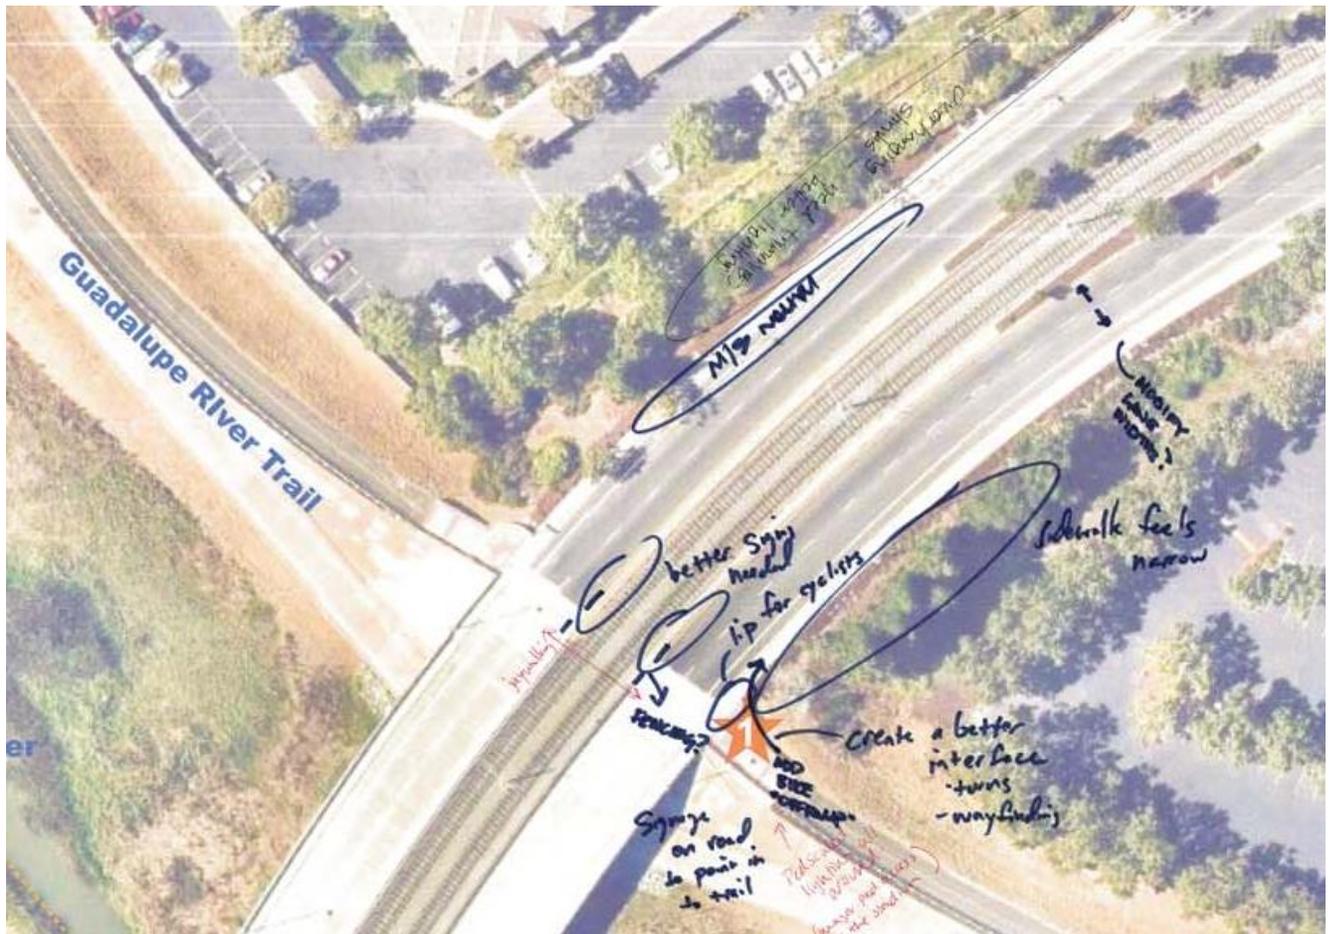
Figure 3: Hand-written comments from the Walk Audit Maps at Station #1 Guadalupe River Trailhead in San Jose.

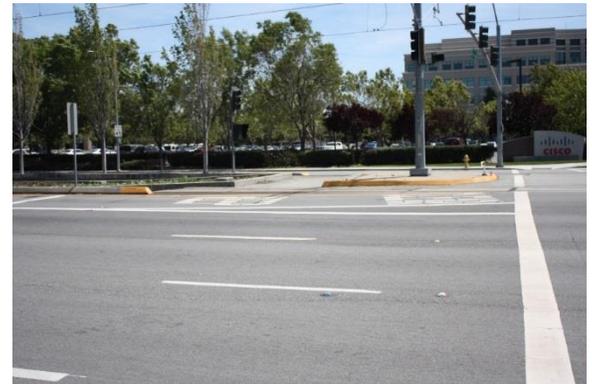
- Participants noted challenges with pedestrians exiting the train at the Champion Station and crossing east of the station rather than crossing at the signalized intersection at Champion Court. People who are going to the office buildings, such as Cisco Systems Building 8, were seen illegally crossing at the back of the platform and making an unprotected crossing of two travel lanes into the driveway of the buildings. VTA is examining additional railings or directing the train drivers to pull closer the intersection to discourage this behavior.

Photo 21: The pedestrian refuge from the Cisco Way Station does not connect to the marked crosswalk

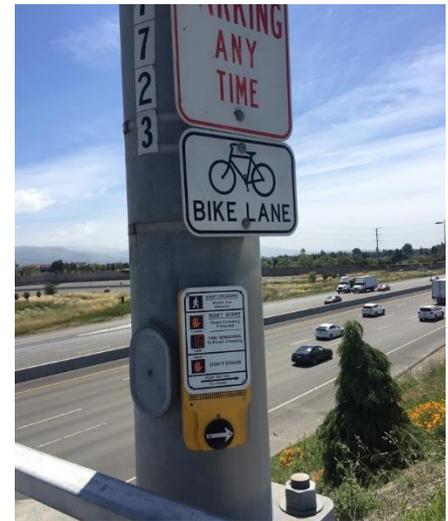
Photo 12: Pedestrian crossing button behind barrier

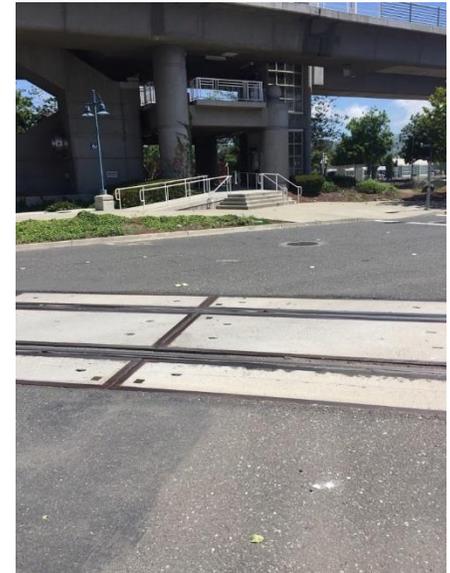
- At the intersection of Tasman Drive and South Main Street, the skewed roadway geometry and current placement of marked crosswalks results in long walking distances to access the light rail station. As a result, people were observed crossing mid-block. Restriping and expanding the crosswalks to meet desire lines will greatly help to facilitate access in and out of the station and to communicate to drivers that pedestrians are present. Wayfinding, public art, and other plaza elements will also contribute as gateway features and station-identifiers.

Photo 13: Mid-block pedestrian desire lines at the light rail tracks

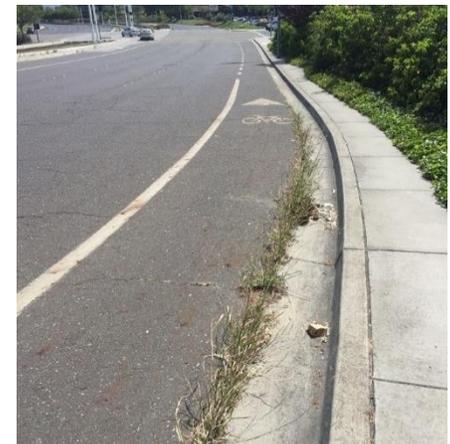
- The on-street bike lanes are located adjacent to traffic, and bicyclists may not feel comfortable riding in these bike lanes.
- In some locations, debris and weeds obstruct the bike lanes.

Photo 14: Weeds and debris in bike lane

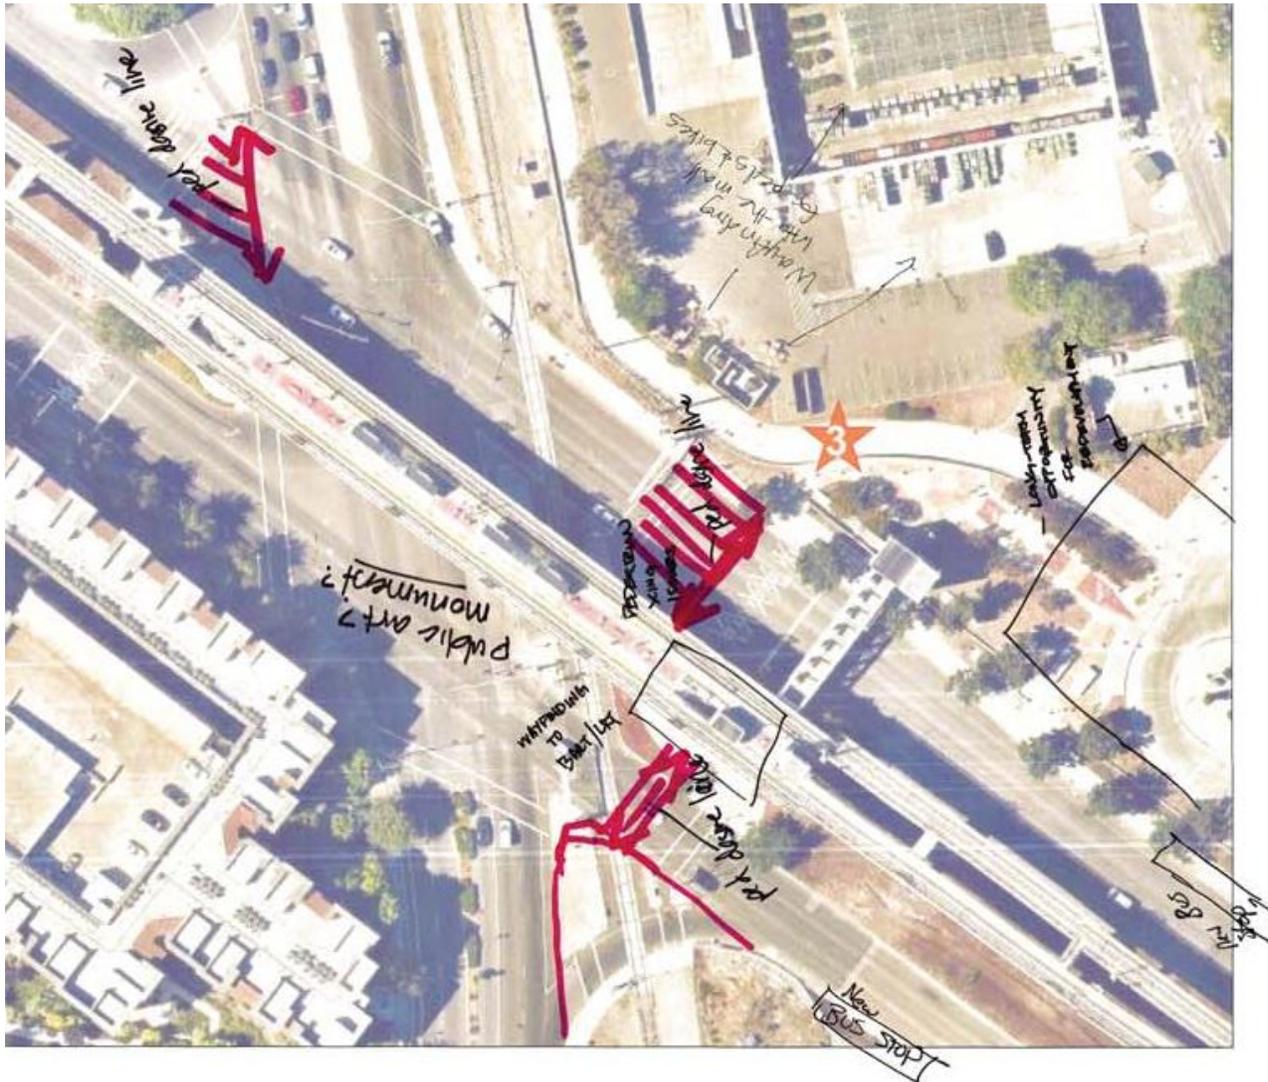
Figure 4: Hand-written comments from the Walk Audit Maps at Station #3 South Main Street in Milpitas.
