H. T. HARVEY & ASSOCIATES
ECOLOGICAL CONSULTANTS

**TASMAN CORRIDOR WETLAND MITIGATION SITE
YEAR-1 MONITORING**

24 May, 2010

Project No. 2506-10

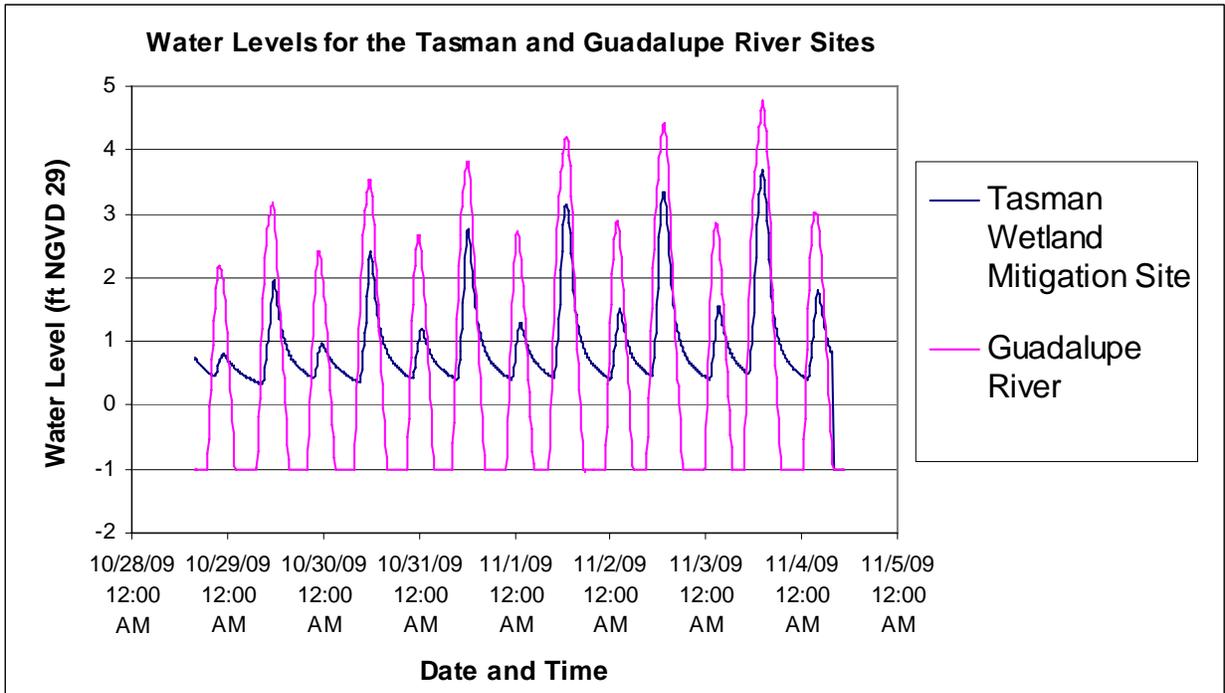
The mitigation and monitoring performance criterion state that the tides within the mitigation site should be only slightly muted compared to the tides in the Guadalupe River marsh plain; the reduced tidal elevations should not deviate from those within the Guadalupe River by more than 0.5 ft (H. T. Harvey & Associates 1997). The site is not yet meeting this criterion for tidal function. However, the scouring of the slough channels and predicted sedimentation for the site will likely help the site eventually reach the target criteria over the longer term. In addition, the criterion states that the tidal elevations should not vary by more than 0.5 ft. In 2009, the tidal elevations did vary by more than this amount.

Figure 5. Continuous Water Level Measurements (NGVD 29) - Comparison of Tasman Wetland Mitigation Site to the Guadalupe River Site.

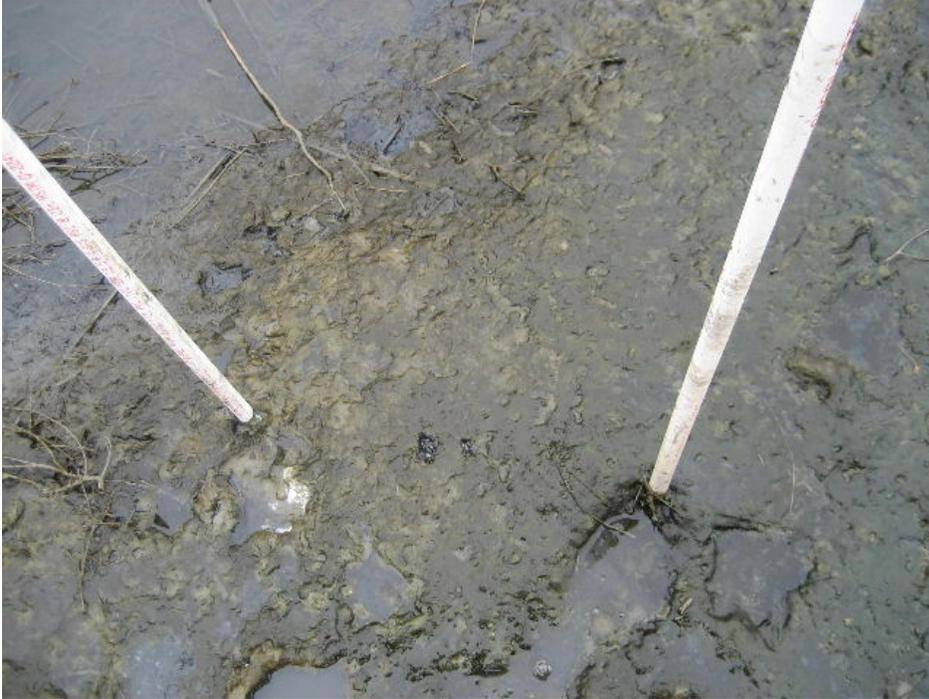
Photo B-5. Feldspar sedimentation plot; white feldspar is buried beneath a layer of new sediment.

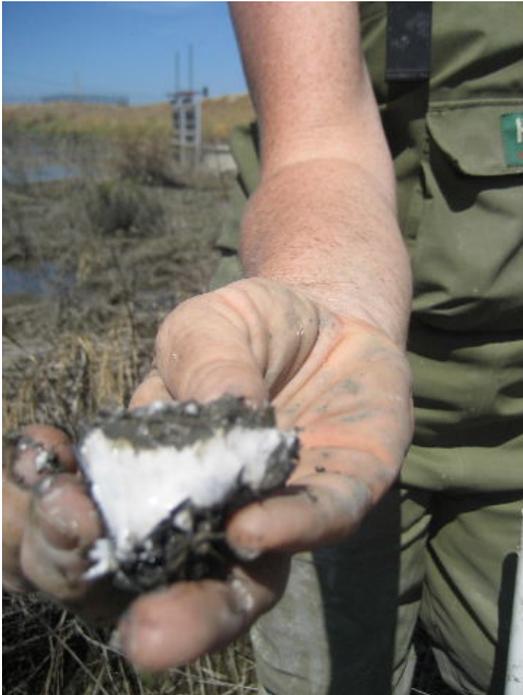
Photo B-6. Feldspar sample cut from sedimentation plot showing a layer of sediment above the white feldspar marker horizon.

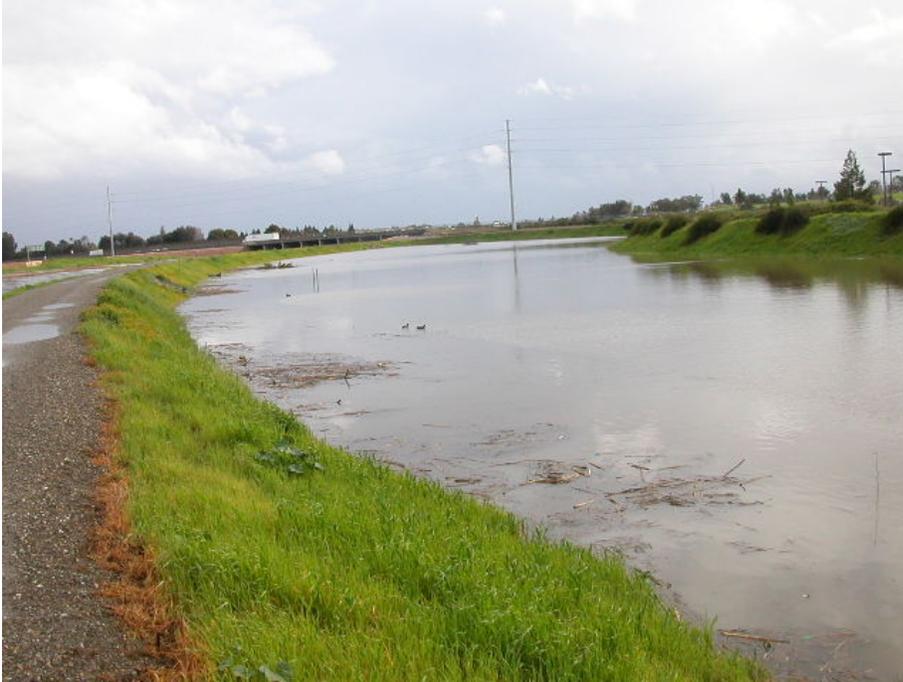
The water level results indicated that the wetland mitigation site (Station 1) is experiencing tidal flushing (with two high and two low tides occurring each day) during spring tides, similar to the Guadalupe River site (Station 2) (Figure 5). However, the tidal amplitude within the mitigation site is muted in comparison to the Guadalupe River site, particularly during the lower high tide event each day. The truncated lower tide water levels at the Guadalupe site indicate that the Guadalupe site is fully drained to the bottom of the channels during water level monitoring, while the wetland mitigation site did not fully drain the site during water level monitoring. The extent of tidal flooding during a combined high tide and storm event was also photographed during a high tide and is shown in Appendix B (Photos B-7 and B-8).

Photo B-7. Tasman Wetland Mitigation Site during a combined high tide and heavy rainfall event (Photo taken 20 January 2010).

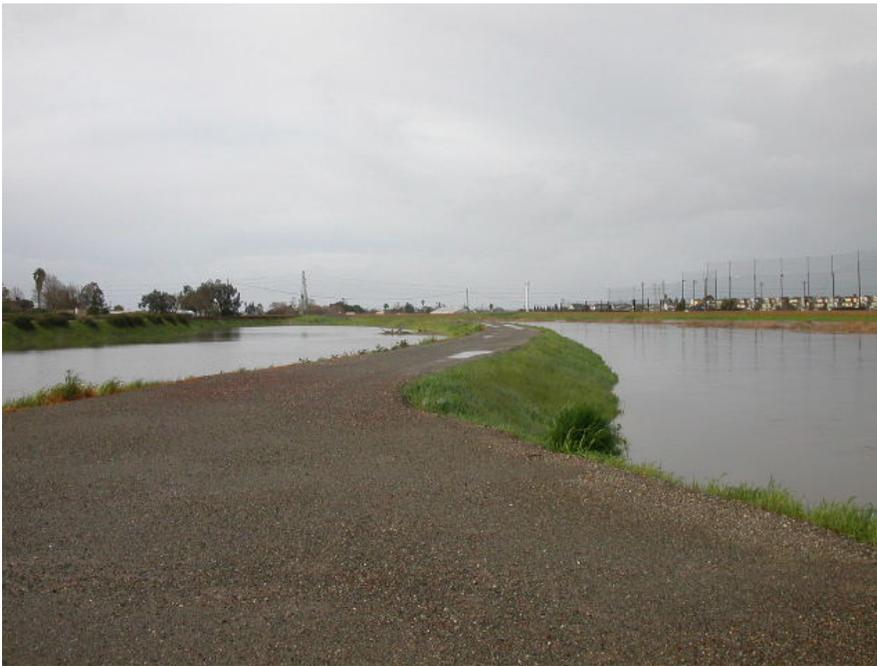
Photo B-8. Tasman Wetland Mitigation Site (left) and Guadalupe River (right) during a high tide and heavy rainfall event (Photo taken 20 January 2010).

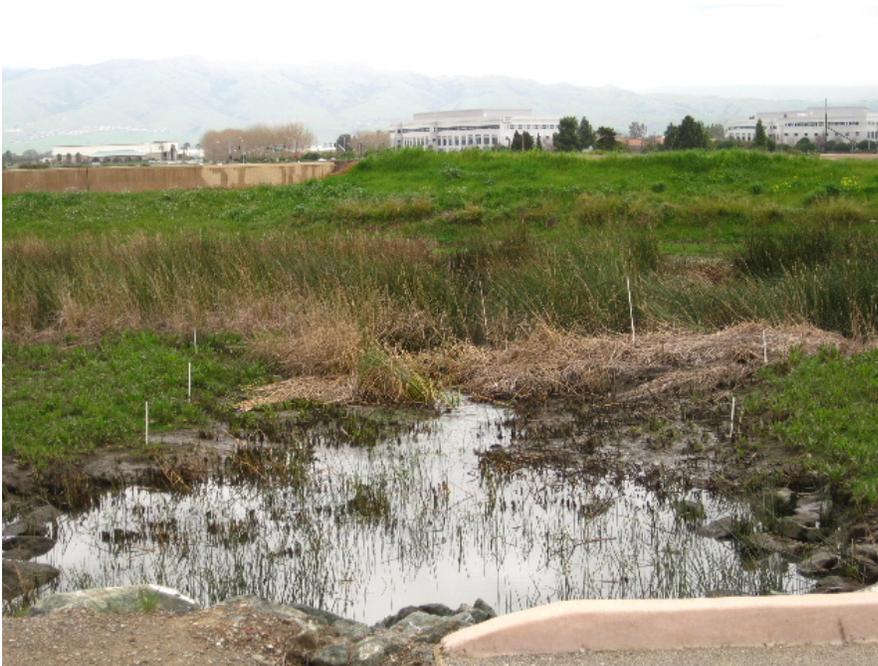
Photo B-20. Photopoint 4 showing outboard pilot channel on 8 February 2010

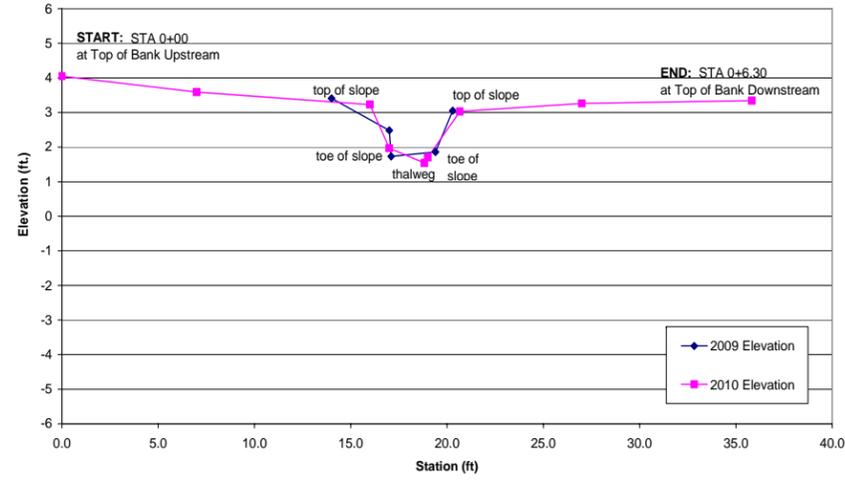
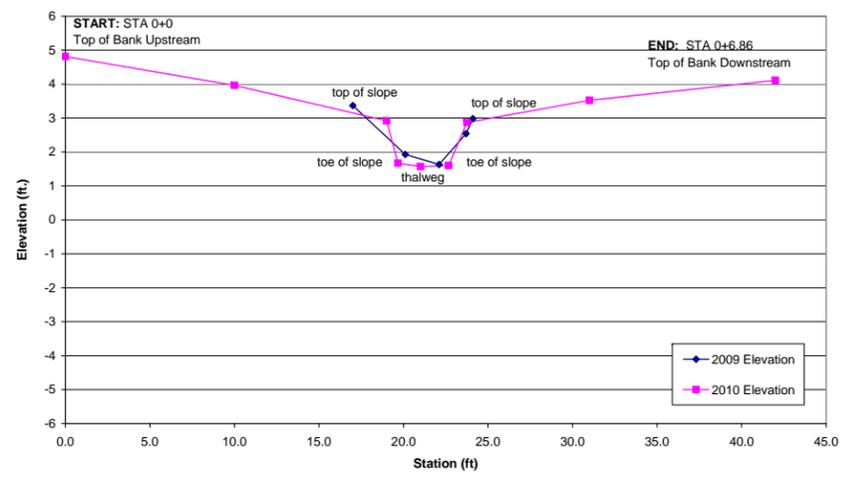
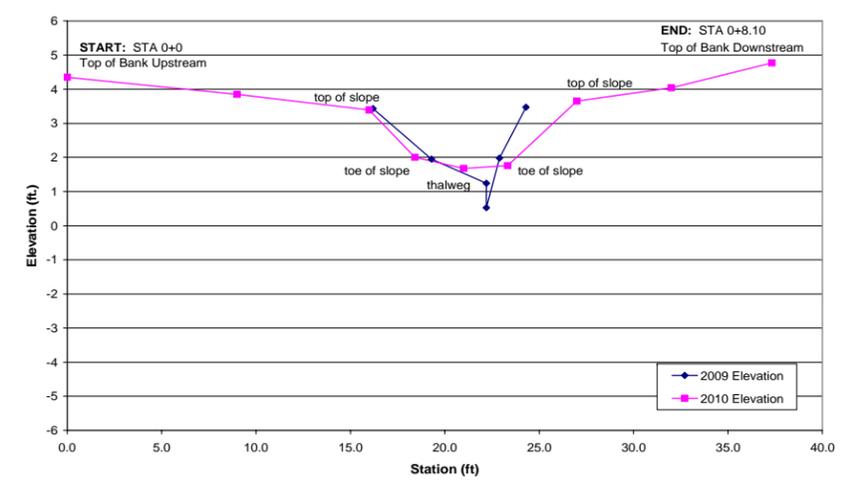
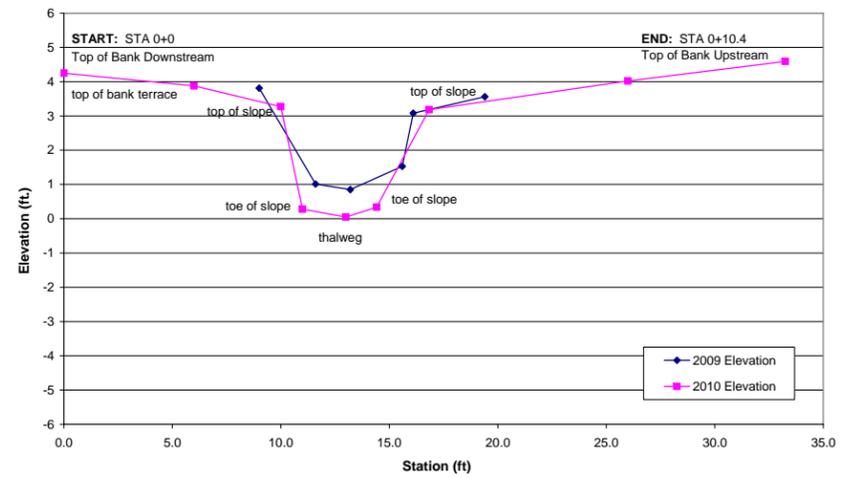
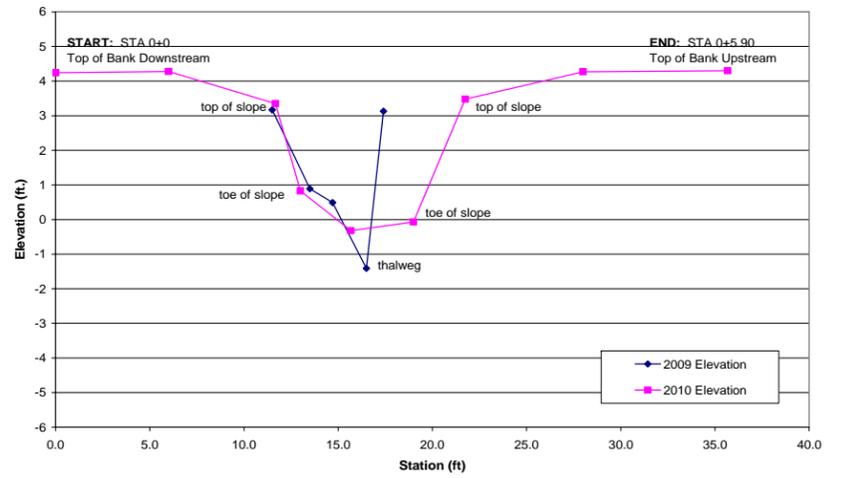
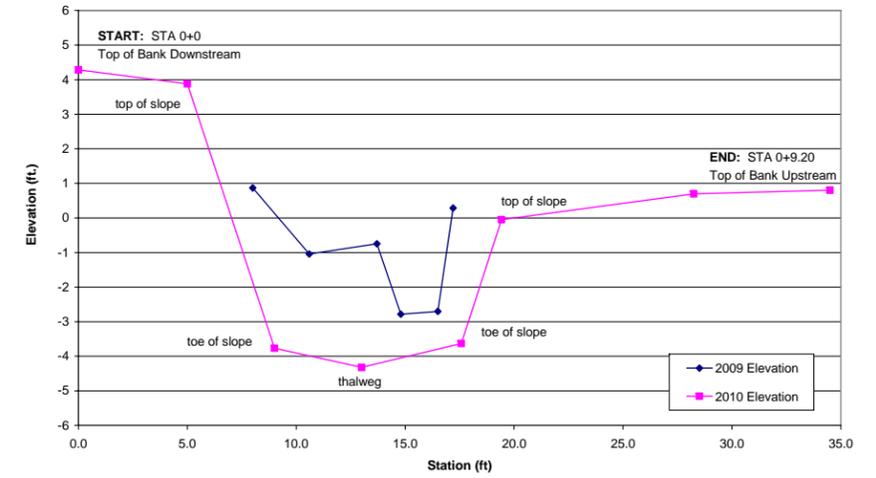
The mitigation site and the inlet channels were inspected for erosion and/or slumping. No significant erosion or slumping was observed at the mitigation site. However, the inlet channels experienced some slumping and channel reshaping after the opening of the tide gates and after vegetation removal by the SCVWD during the summer of 2009. Scour also indicates that substantial draining of the mitigation site occurs during tidal cycles and results in some reworking of the inlet channels to a more natural shape. The reshaping of the inlet channels is reflected in the topographic survey data in Appendix C; Figures C7 – C12.
