**Upper Penitencia Creek Improvement Project
Year 3 (2015) Monitoring Report**

Project #3518-03

May 2016

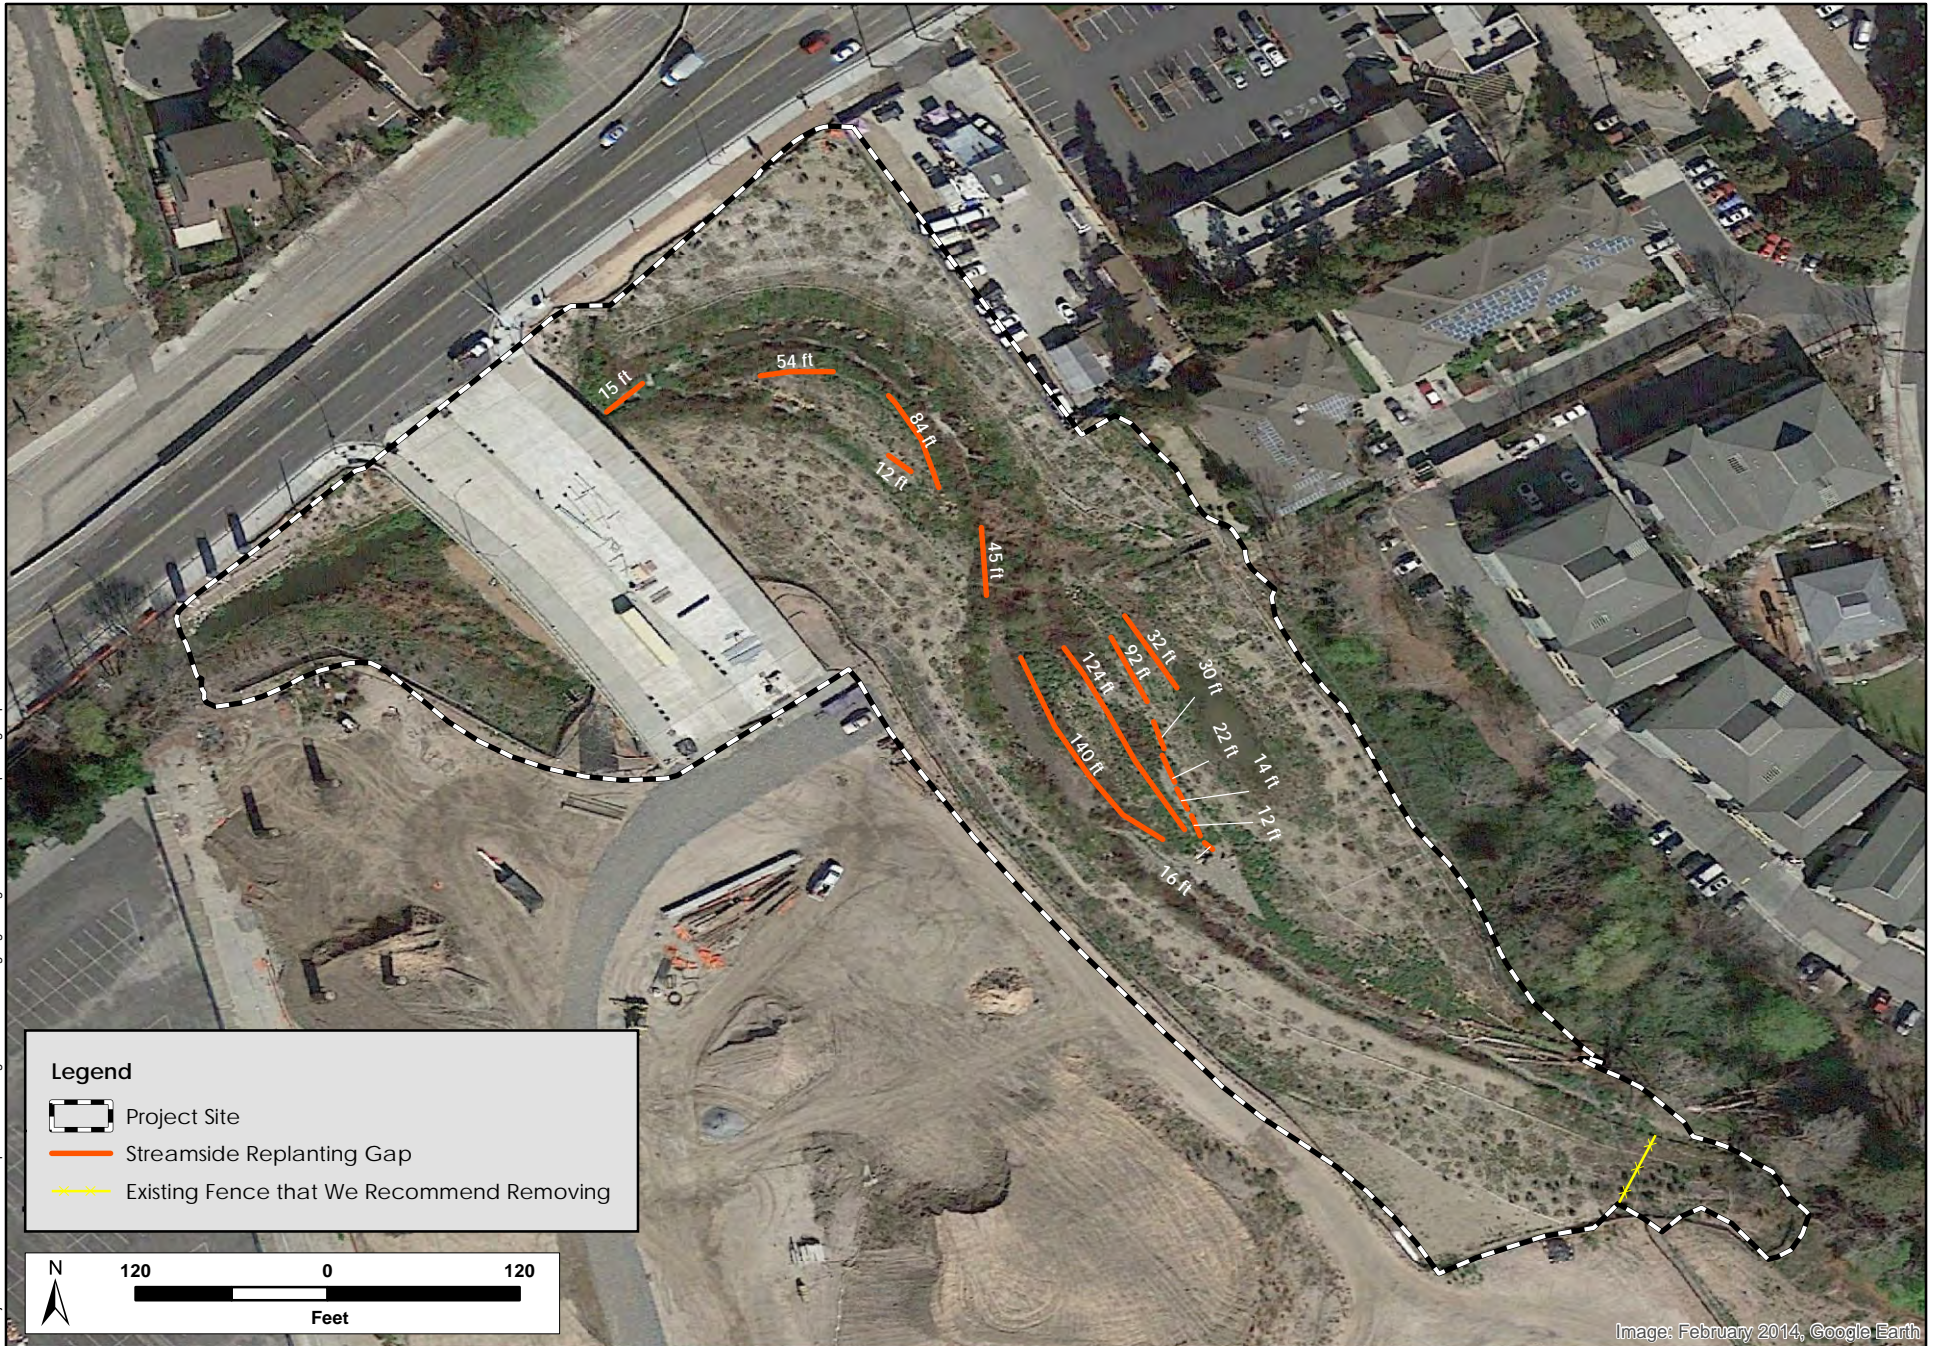
Streamside Area. In March 2015, VTA installed 110 willow cuttings on 6-foot centers in the Streamside Area (Ecological Concerns 2015), which is five more plants than the 105 cuttings recommended in the Year 2 monitoring report (HTH 2015). Cuttings installed in Year 2 were successful in forming a canopy throughout most of the Streamside Area; however, several canopy gaps of substantial length were still present in this area in Year 3. The total length of Streamside Area canopy gaps totaled 692 feet, resulting in a recommended total of 87 cuttings to be installed on 8-foot centers in winter 2015–2016. Figure 10 shows the locations of the canopy gaps in the Streamside Area, and Table 7 presents recommended replanting quantities for these gaps.

Table 7. Streamside Area Canopy Gaps -Replanting Recommendations

Scientific Name	Common Name	Recommended Replanting Quantity
<i>Populus fremontii</i>	Fremont cottonwood	12
<i>Salix laevigata</i>	Red willow	50
<i>Salix lasiolepis</i>	Arroyo willow	25
	Total	87

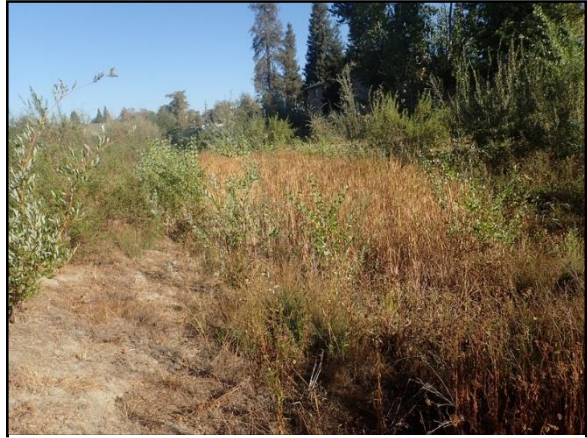
Wetland 1. Wetland 1 was approximately 102 feet long and 30 feet wide with a surface area of approximately 3,060 square feet. Photo 1 shows a representative depiction of the state of the wetland in September 2015. The wetland was dry but showed evidence of recent inundation in the form of shallow surface soil cracks. The plant community was stratified into distinct concentric rings of vegetation spanning a gradient from perennial, emergent wetlands at the lower elevations to seasonal wetland vegetation and riparian trees and shrubs along the upper slope. The lowest vegetation consisted of emergent cattails (*Typha* sp.) that are increasing in cover through lateral expansion. Wetland vegetation located upslope from the cattails included rabbitsfoot grass (*Polygomon monspeliensis*), tall flatsedge (*Cyperus eragrostis*), planted irisleaf rush (*Juncus xiphioides*), naturally recruited and planted marsh baccharis, and planted willow. The vigorous growth of willow and cottonwood indicated that they were likely rooted into groundwater. In the upper banks of the wetland, mulefat (*Baccharis salicifolia*) and Fremont cottonwood plantings showed new growth and good health.

Photo 1. View of Wetland 1, looking north from the south bank

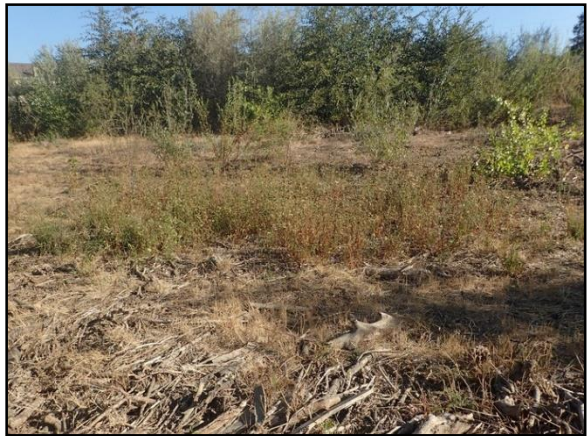
Wetland 2. Wetland 2 was approximately 30 feet long and 21 feet wide with a surface area of approximately 630 square feet. Photo 2 shows a representative depiction of the state of the wetland in September 2015. The wetland was dry and composed of marsh baccharis and rush (*Juncus* sp.). Sandbar willow was growing along the wetland banks. The absence of emergent cattails at Wetland 2 indicates that the depth and duration of ponding at Wetland 2 is likely less than in Wetland 1.

Photo 2. View of Wetland 2, looking northeast

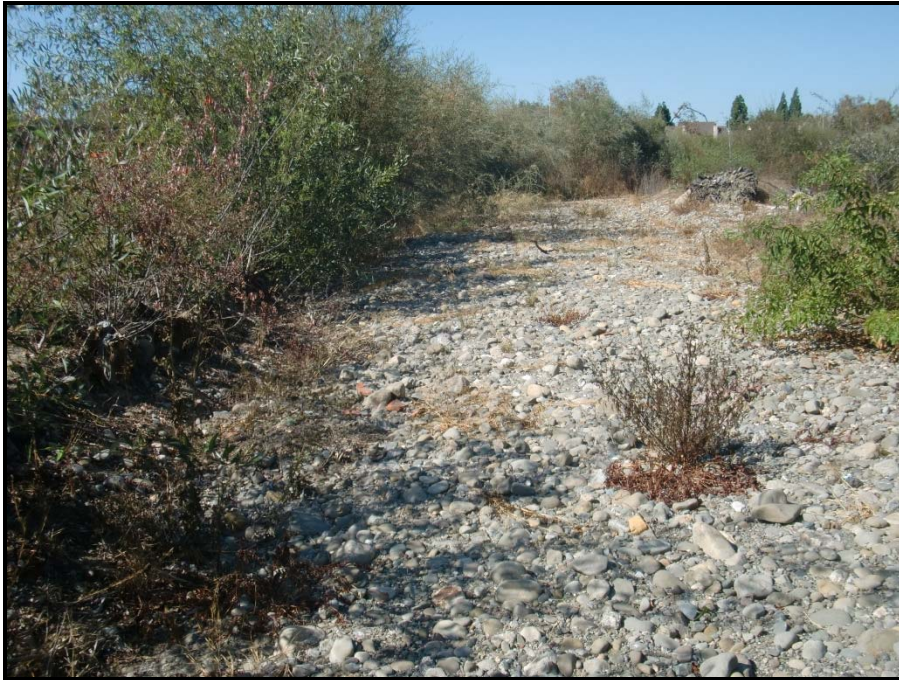
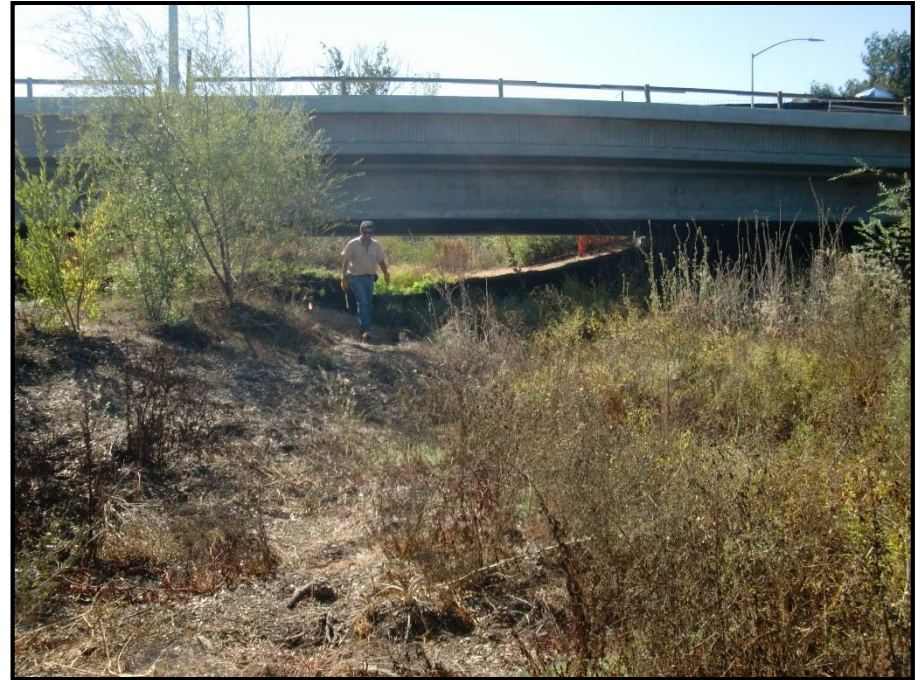
Figure 7. Photographs showing general conditions and absence of flow in Year 3

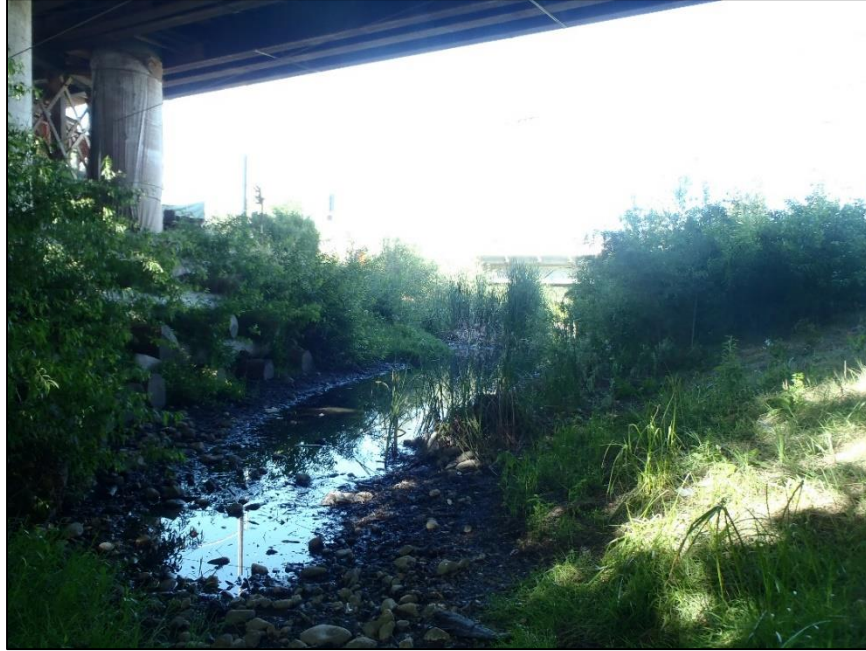
Photo 1. Shallow habitat unit with no surface flow in Habitat Unit 1, looking upstream (spring 2015)

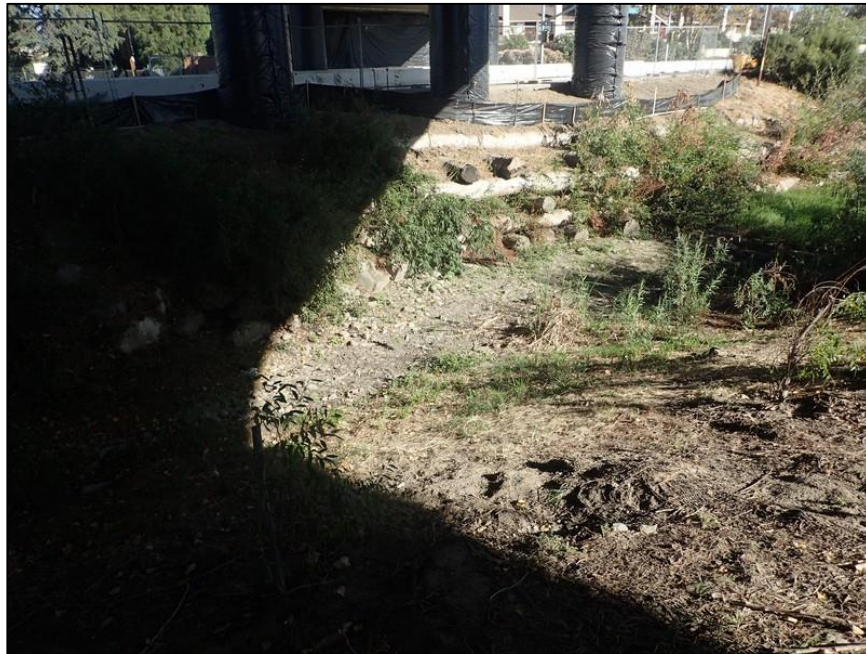
Photo 2. Dry habitat in Habitat Unit 1 (fall 2015)

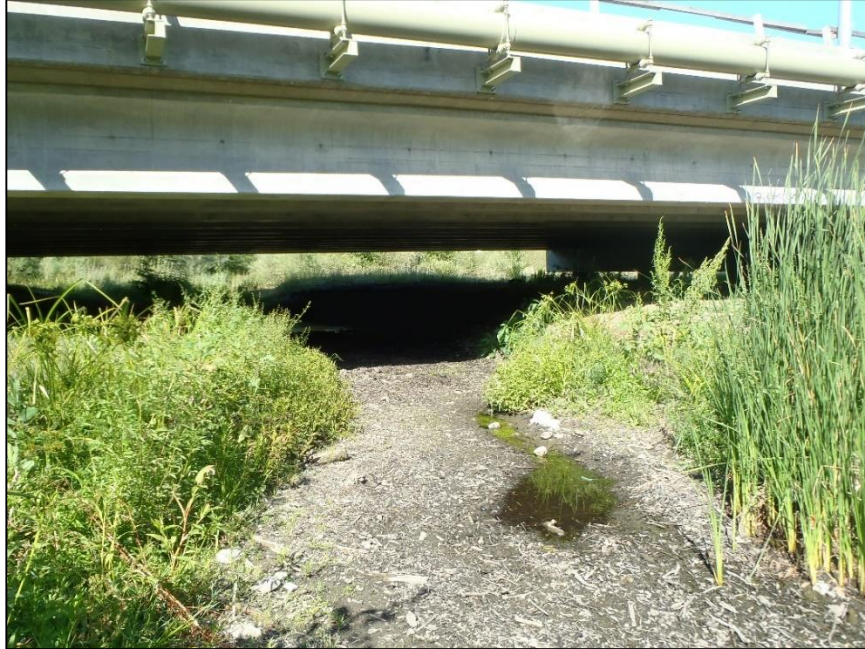
Photo 3. Damp channel and standing water in Habitat Unit 4, looking upstream (fall 2015)

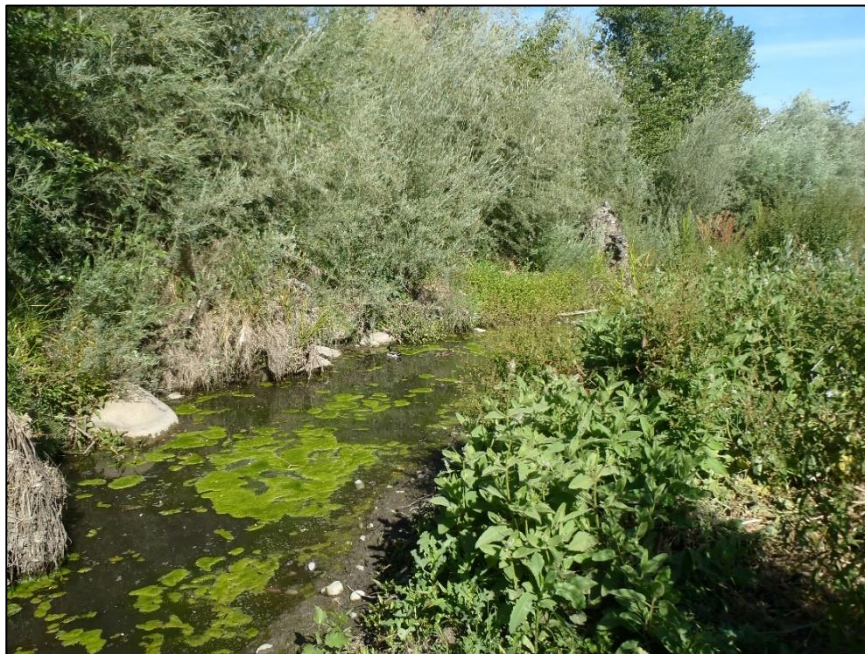
Photo 4. Stagnant pools near rootwad restoration features in Habitat Unit 7 (spring 2015)

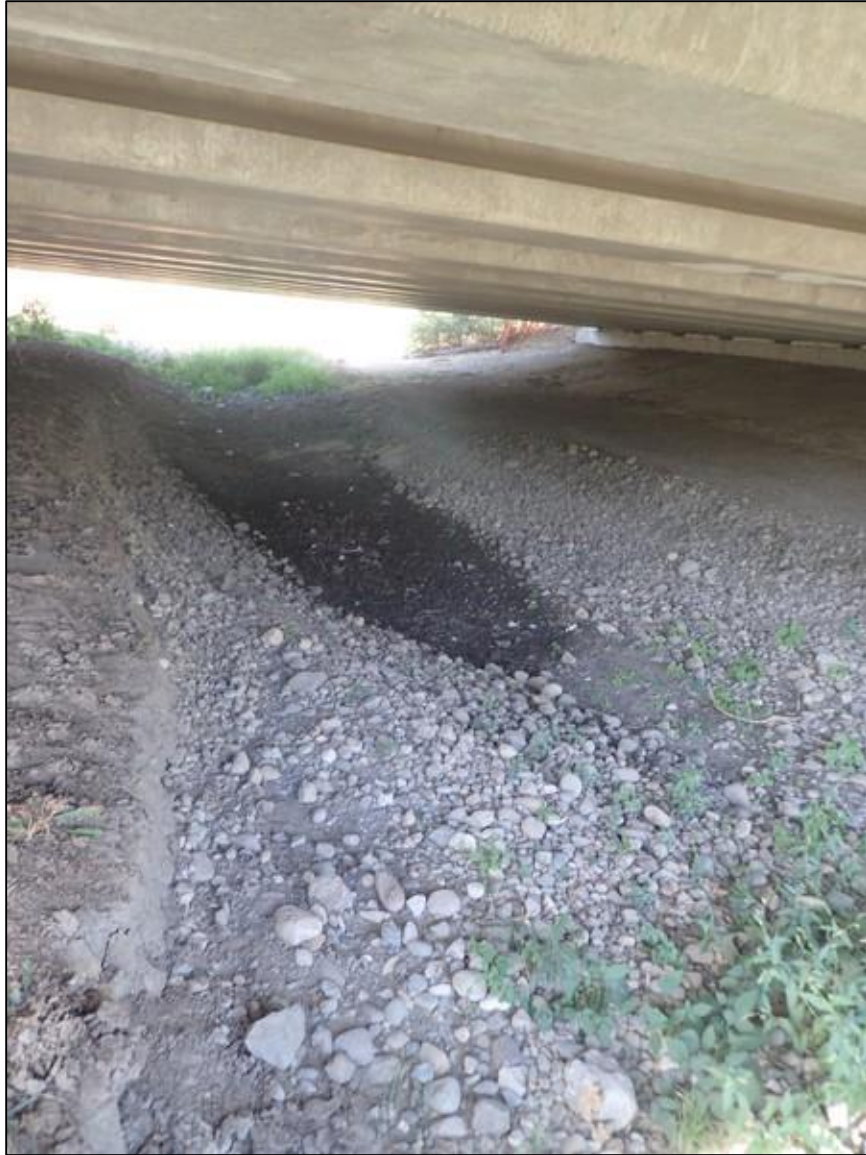
Photo 5. Damp channel in Habitat Unit 4 (fall 2015)
