ALUM ROCK FISH PASSAGE PROJECT MITIGATION MONITORING REPORT YEAR TWO, 2014

Santa Clara Valley Transportation Authority
3331 North First Street Bldg. B-2
San Jose, CA 95143-1906
Contact: Ann Calnan
408.321.5976

ICF International
75 E. Santa Clara Street, Suite 300
San Jose, CA 95113
Contact: Donna Maniscalco
408.216.2802

March 2015

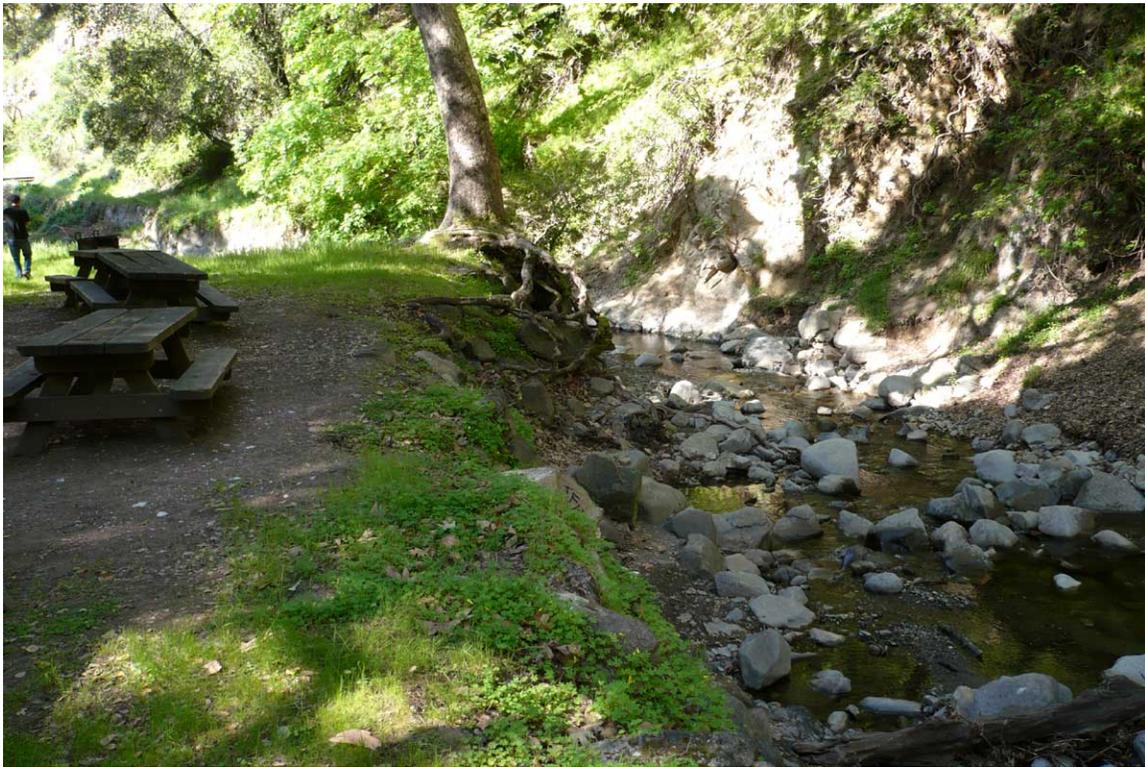
Project 11: Degraded Bank Near Mature Sycamore Tree

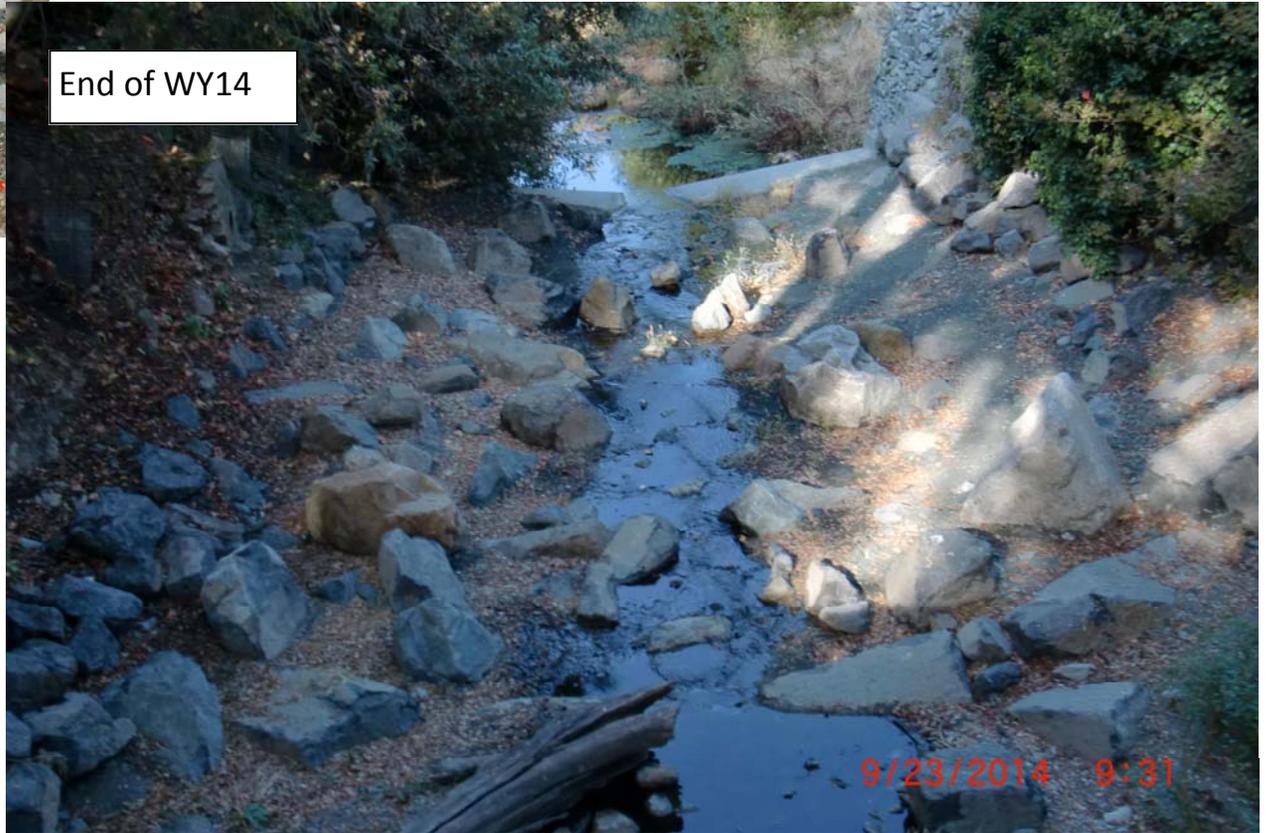
Figure 7.

Visual inspections and photo point comparisons of Project Site 13 show that the fish passage seems to be functioning as intended. Little to no erosion of the bed or construction elements was observed, and the structure was in good condition. Many fingerling fish were observed in pools throughout the reach. Bed substrates were of gravel to cobble size, with finer silts observed downstream. Some gravel appears to have been transported in the downstream sections of the fish passage. The thalweg at Cross Section 7 has developed a narrow gravel bar. Near Cross Section 6, a narrow channel with a gravel bar on the river left side has evolved, with a low floodway developing on the right bank. Gravel bars, along with increased riparian vegetation, are signs that habitat complexity is increasing within the pools and chutes of the structure.

Photo point 1 photographs taken from pedestrian bridge, looking downstream at the first rock band structure and chute of the fish passage project. WY13 photo taken November 2013. WY14 photo taken September 2014. Refer to Figure 1 of this report for photo point locations. Upper Penitencia Creek, Alum Rock Park, Santa Clara County, California.

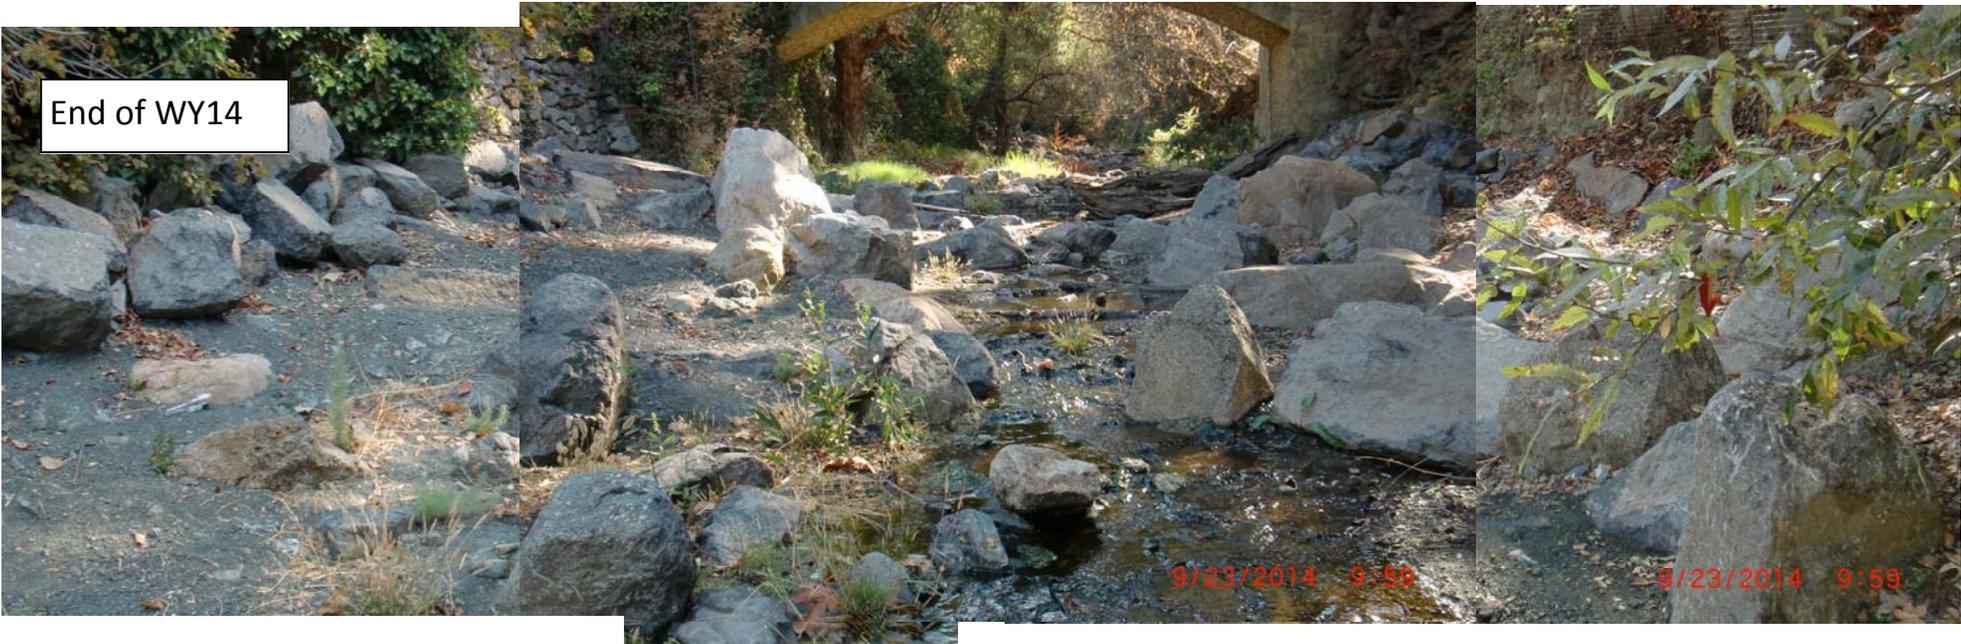
Figure 8.

Photo point 2 photographs looking upstream to bridge below first rock band structure and chute of the fish passage project. WY13 photo taken November 2013. WY14 photo taken September 2014. Refer to Figure 1 of this report for photo point locations. Upper Penitencia Creek, Alum Rock Park, Santa Clara County, California.

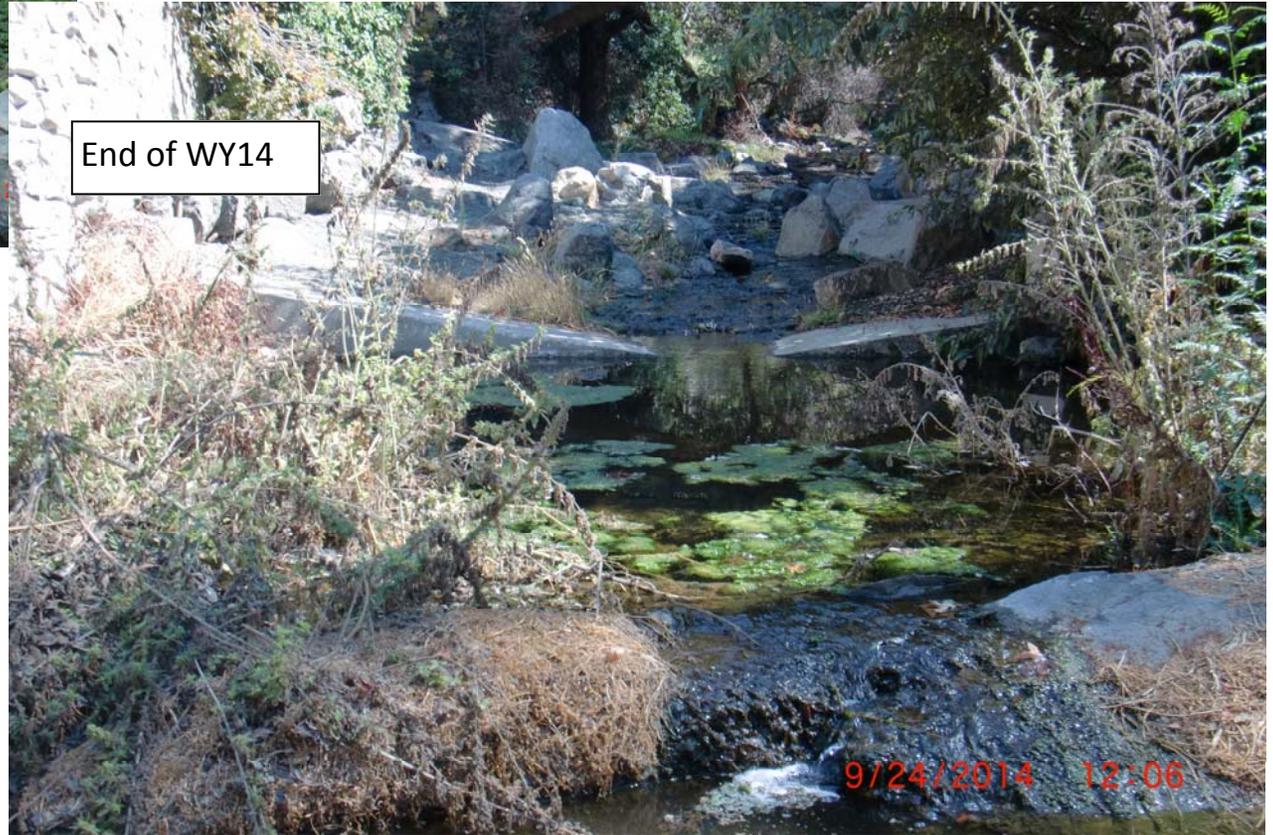
Figure 9.

Photo point 3 photographs looking upstream across pool 1 at the modified concrete grade control structure and pedestrian bridge in the fish passage project. WY13 photo taken November 2013. WY14 photo taken September 2014. Refer to Figure 1 of this report for photo point locations. Upper Penitencia Creek, Alum Rock Park, Santa Clara County, California.

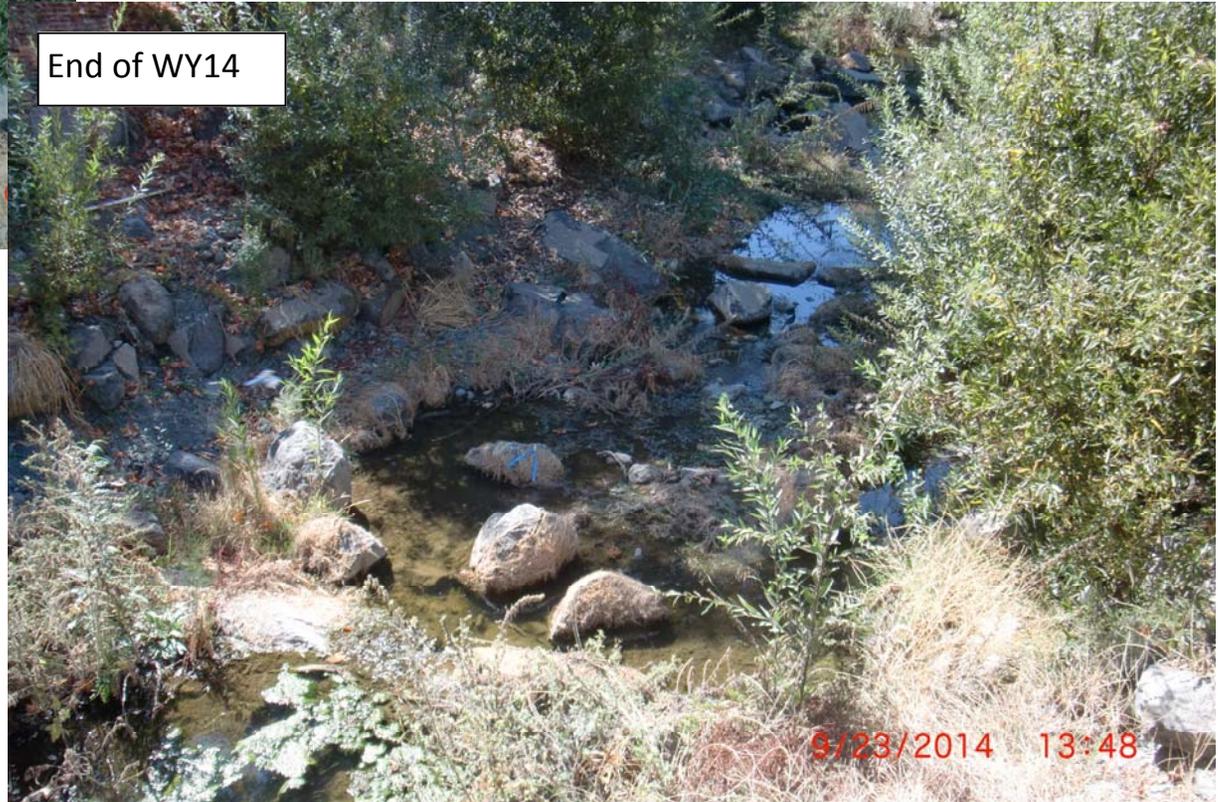
Figure 10.

Photo point 4 photographs taken on right bank from top of the modified concrete grade control structure wall looking downstream across chute 2 along the fish passage project. WY13 photo taken November 2013. WY14 photo taken September 2014. Refer to Figure 1 of this report for photo point locations. Upper Penitencia Creek, Alum Rock Park, Santa Clara County, California.

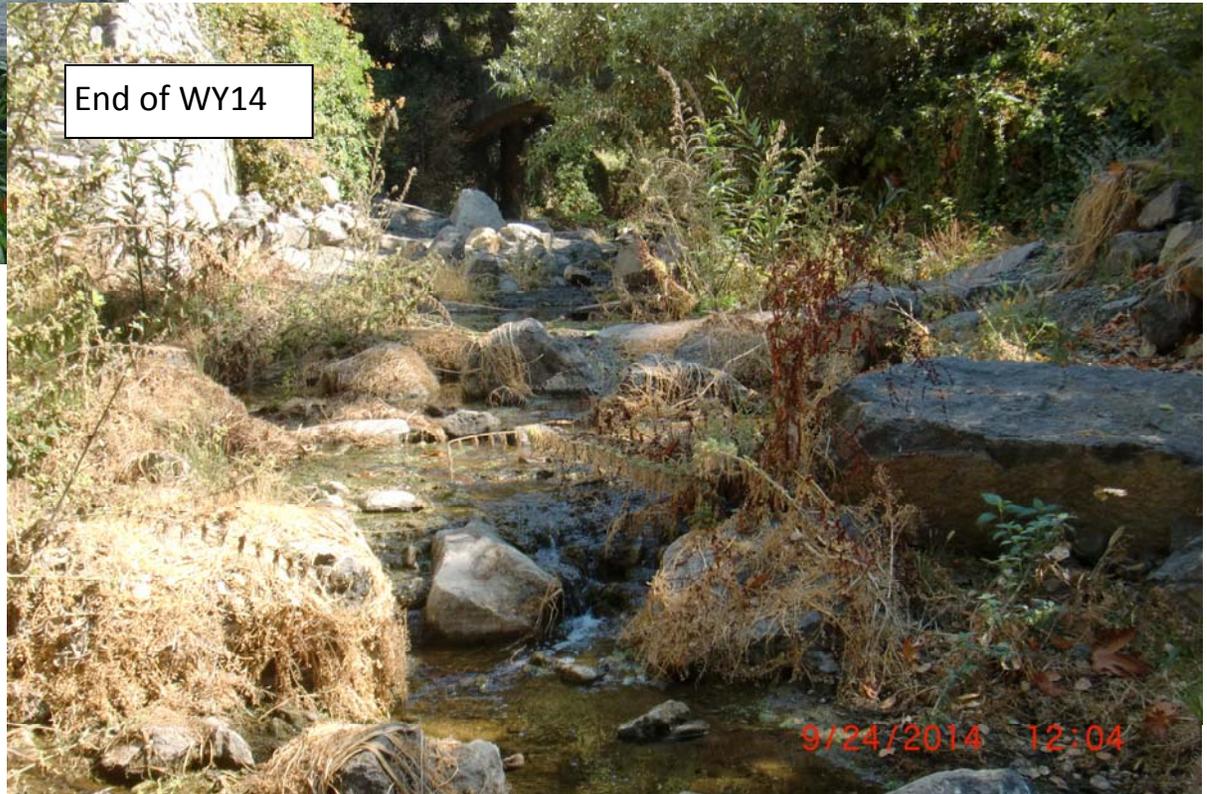
Figure 11.

Photo point 5 photographs looking upstream across chute 2 to modified concrete grade control structure and bridge in the fish passage project. WY13 photo taken November 2013. WY14 photo taken September 2014. Refer to Figure 1 of this report for photo point locations. Upper Penitencia Creek, Alum Rock Park, Santa Clara County, California.

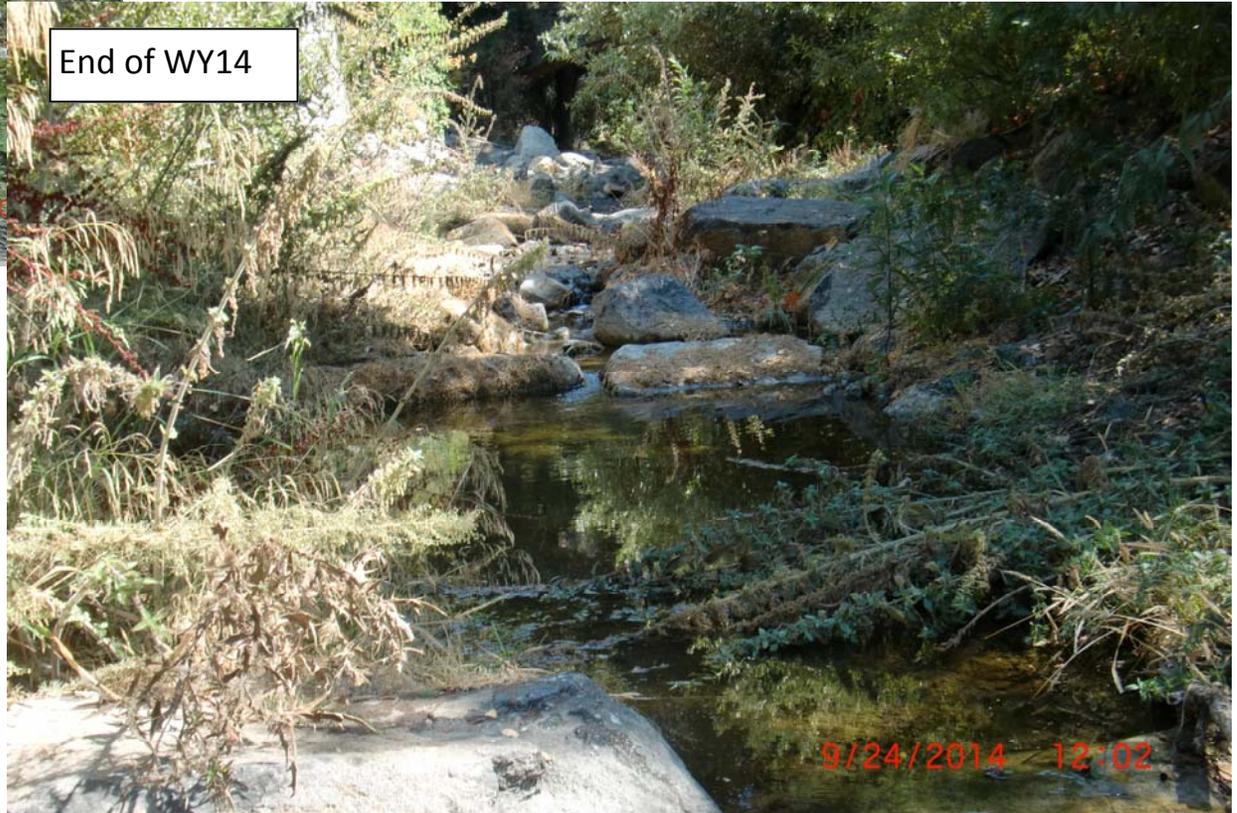
Figure 12.

Photo point 6 photographs looking upstream across pool 2 and chute 2 in the fish passage project. WY13 photo taken November 2013. WY14 photo taken September 2014. Refer to Figure 1 of this report for photo point locations. Upper Penitencia Creek, Alum Rock Park, Santa Clara County, California.

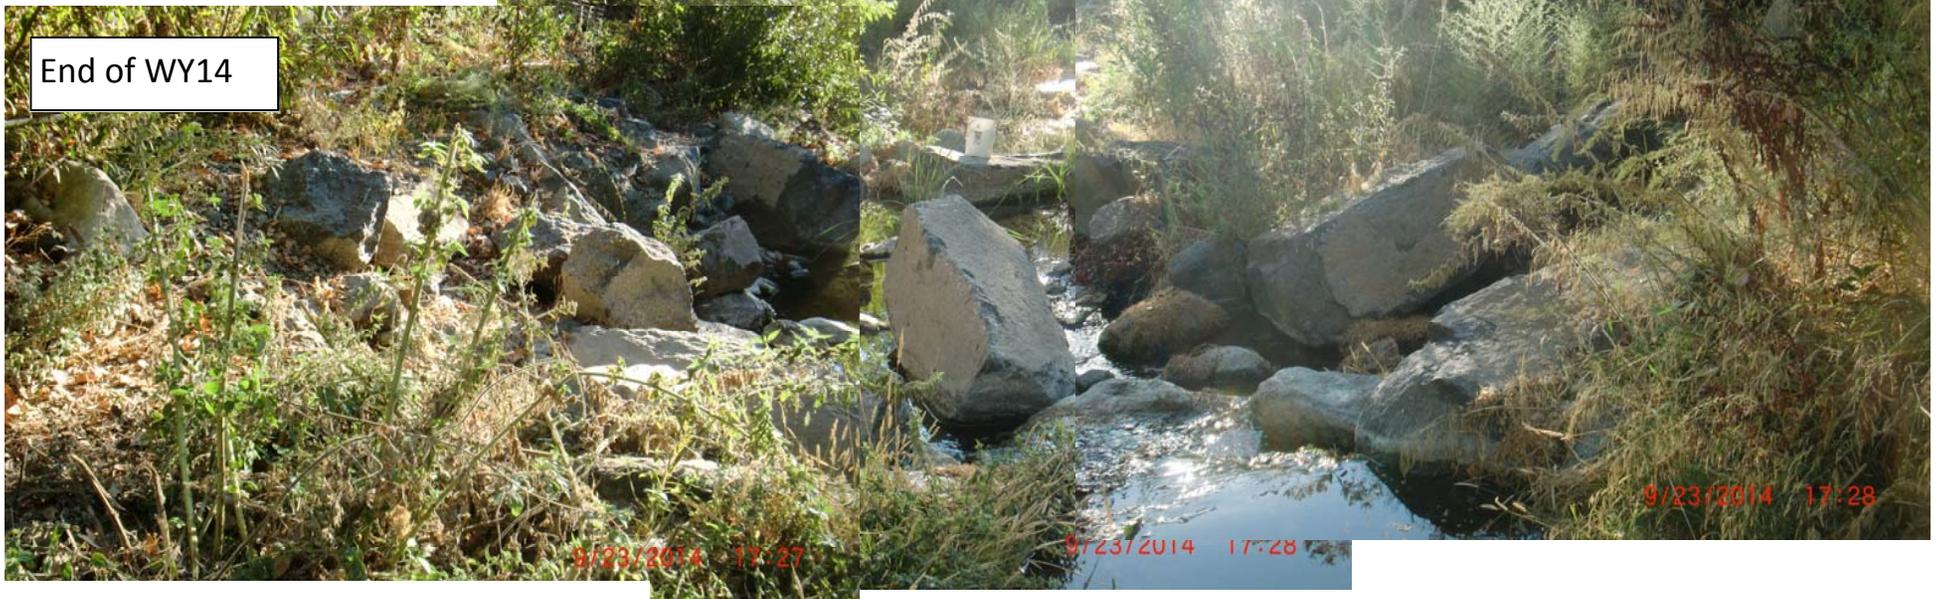
Figure 13.

Photo point 7 panoramic photographs looking downstream at rock band structure and chute 3 in the fish passage project. WY13 photo taken November 2013. WY14 photo taken September 2014. Note forming erosion line on right bank downstream of rock band. Refer to Figure 1 of this report for photo point locations. Upper Penitencia Creek, Alum Rock Park, Santa Clara County, California.

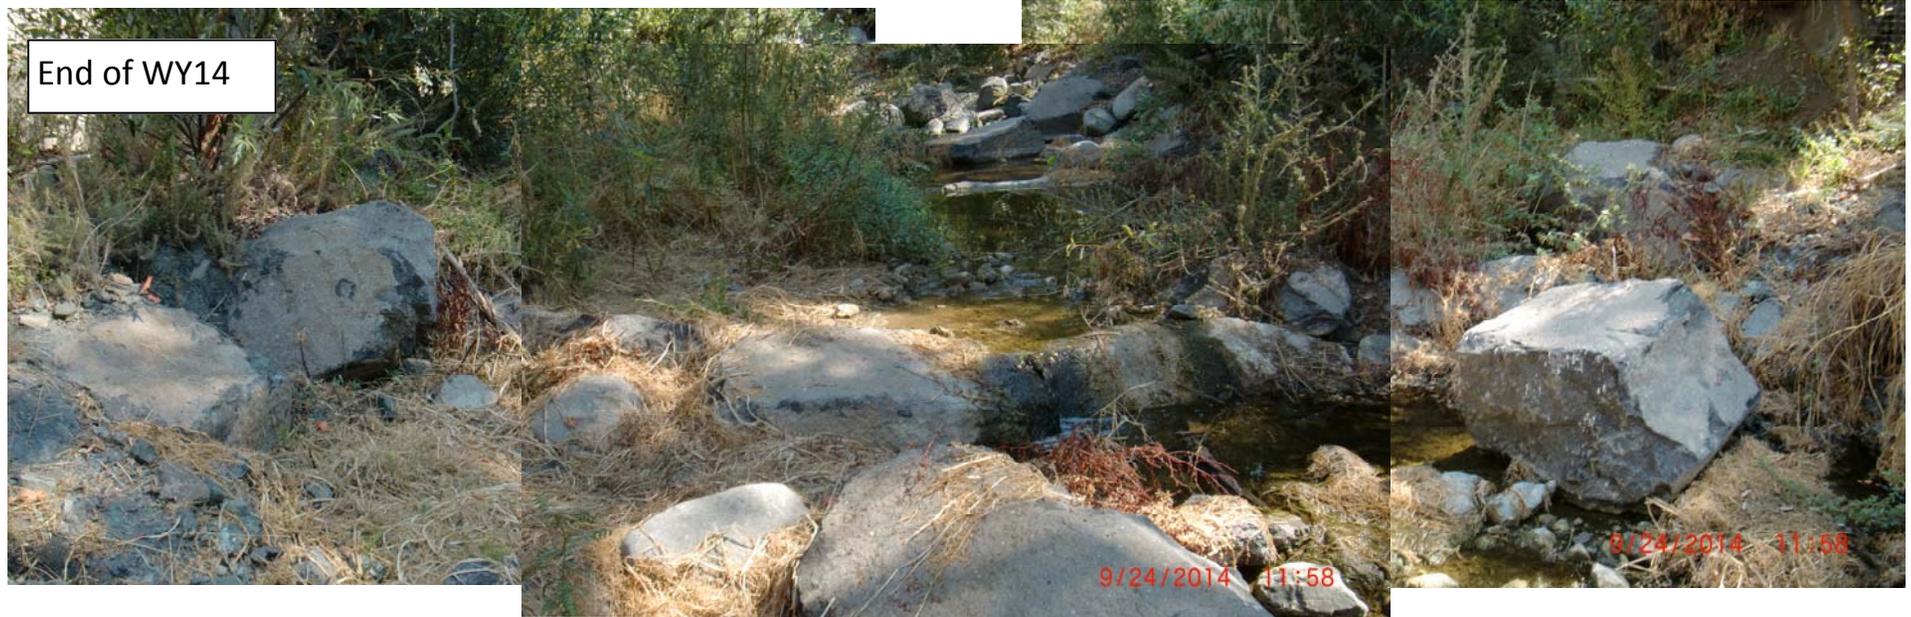
Figure 14.

Photo point 8 photographs looking upstream across rock band structure and pool 3 in the fish passage project. WY13 photo taken November 2013. WY14 photo taken September 2014. Refer to Figure 1 of this report for photo point locations. Upper Penitencia Creek, Alum Rock Park, Santa Clara County, California.

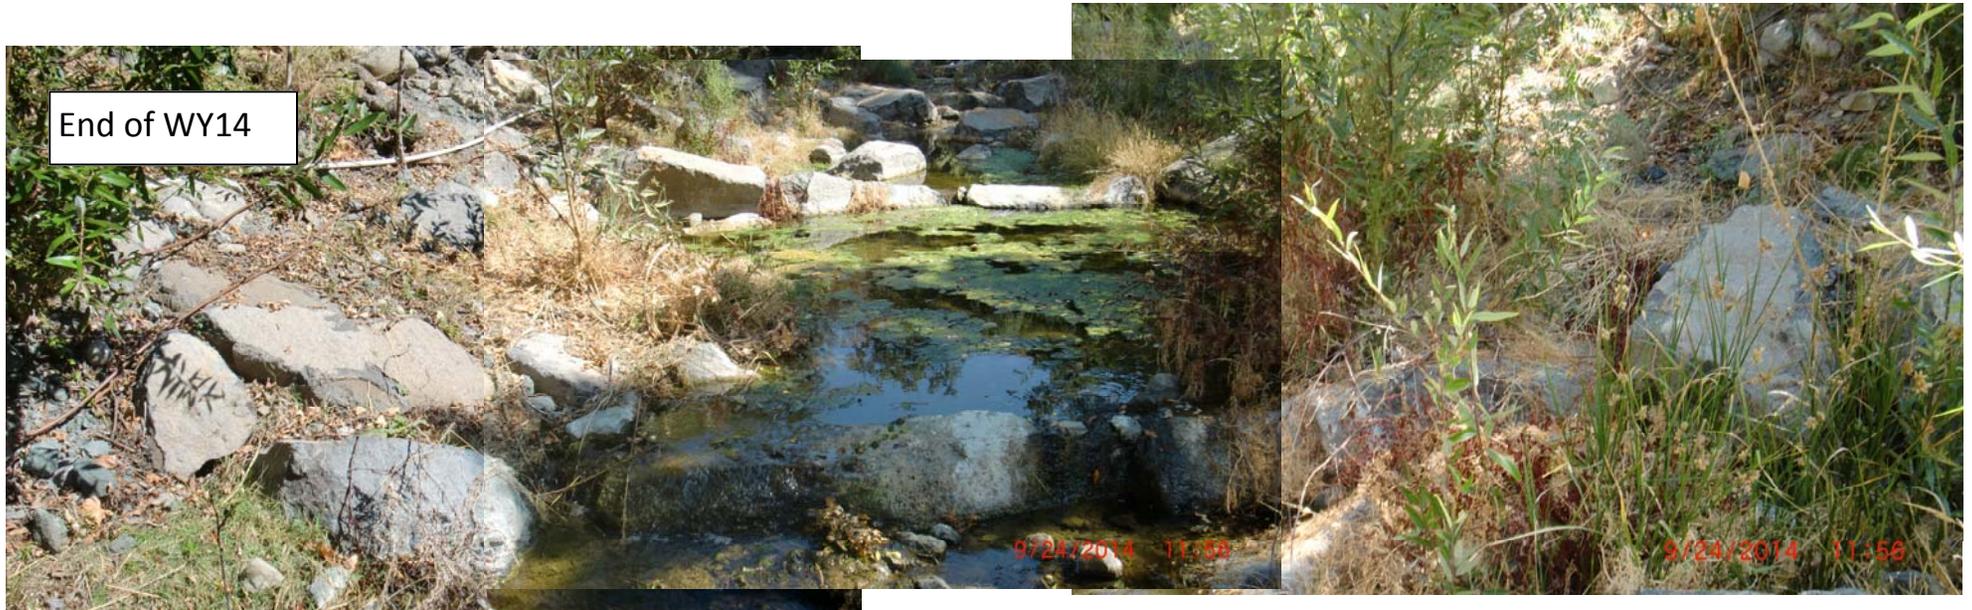
Figure 15.

Photo point 9 photographs looking upstream across rock band structure and pool 4 in the fish passage project. WY13 photo taken November 2013. WY14 photo taken September 2014. Refer to Figure 1 of this report for photo point locations. Upper Penitencia Creek, Alum Rock Park, Santa Clara County, California.

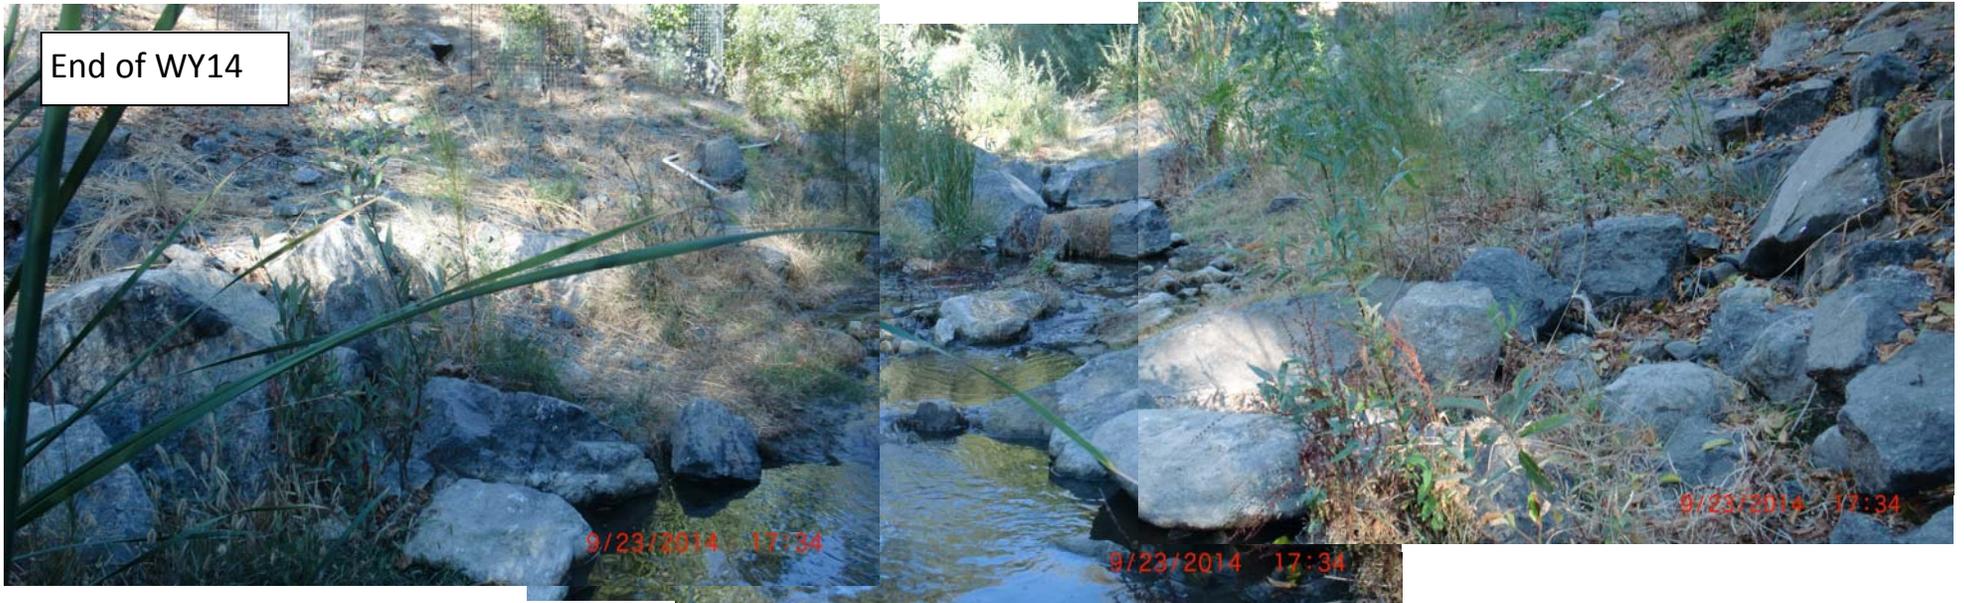
Figure 16.

Photo point 10 looking upstream from bottom of fish passage project. WY13 photo taken November 2013. WY14 photo taken September 2014. Refer to Figure 1 of this report for photo point locations. Upper Penitencia Creek, Alum Rock Park, Santa Clara County, California.

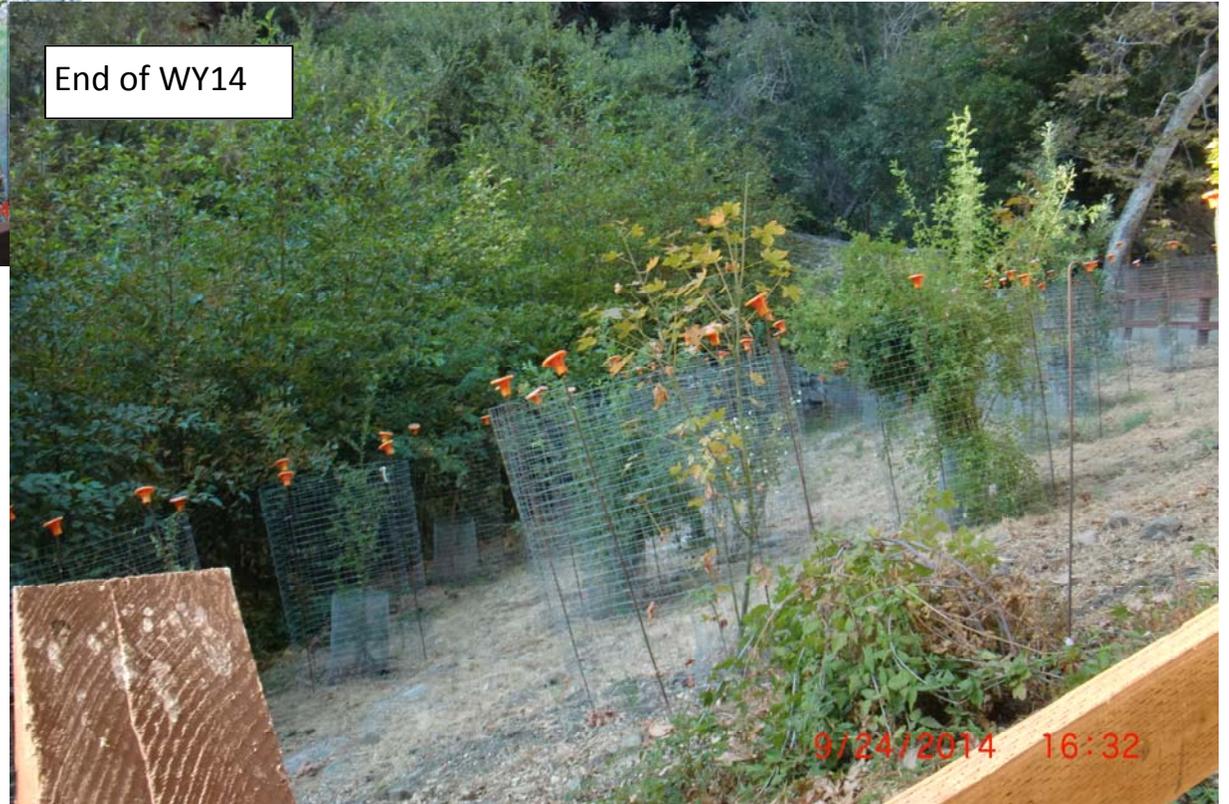
Figure 30.

Photo point 16 looking from upslope to the footbridge at Site 10 floodplain. WY13 photo taken November 2013. WY14 photo taken September 2014. Refer to Figure 2 of this report for photo point locations. Upper Penitencia Creek, Alum Rock Park, Santa Clara County, California.
