ALUM ROCK FISH PASSAGE PROJECT MITIGATION MONITORING REPORT YEAR THREE, 2015

Santa Clara Valley Transportation Authority
3331 North First Street, Bldg. B-2
San Jose, CA 95143-1906
Contact: Ann Calnan
408.321.5976

ICF International
75 E. Santa Clara Street, Suite 300
San Jose, CA 95113
Contact: Donna Maniscalco
408.216.2802

April 2016

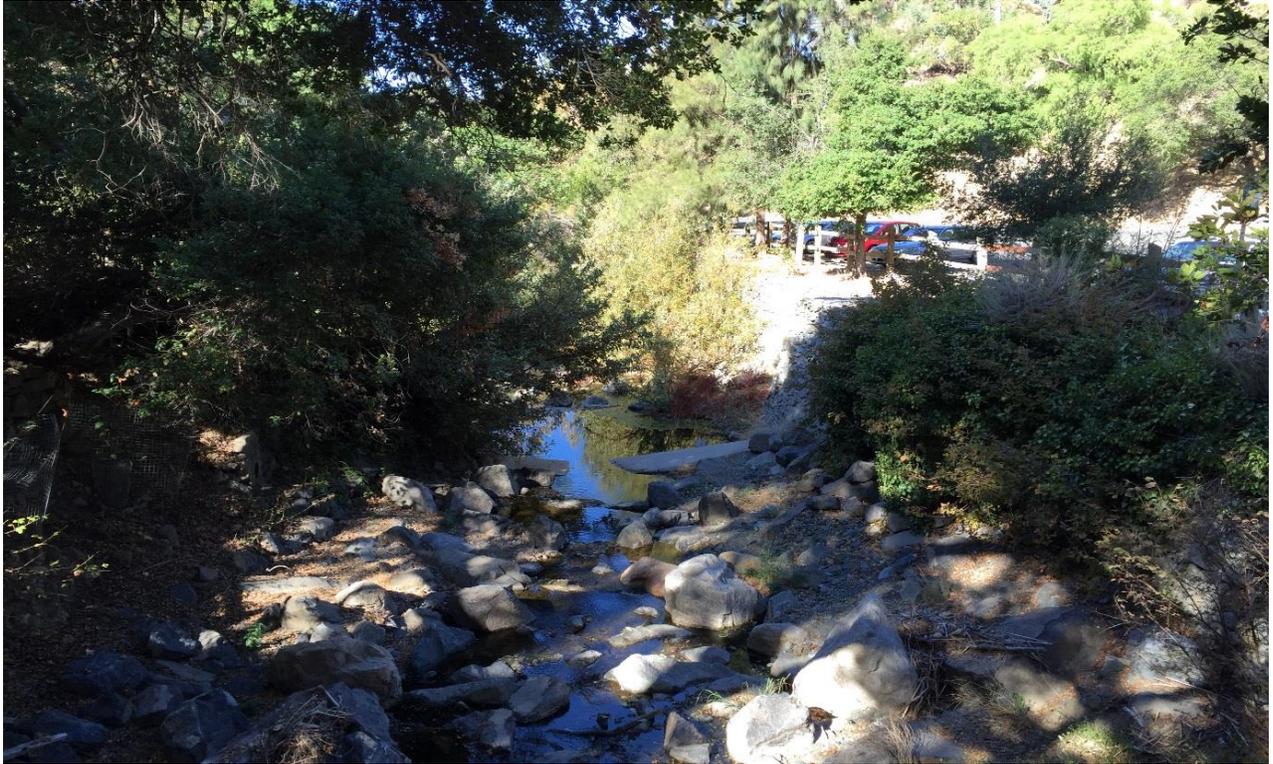
Photo 1. Looking west from YSI Bridge (Zones 1 and 2)

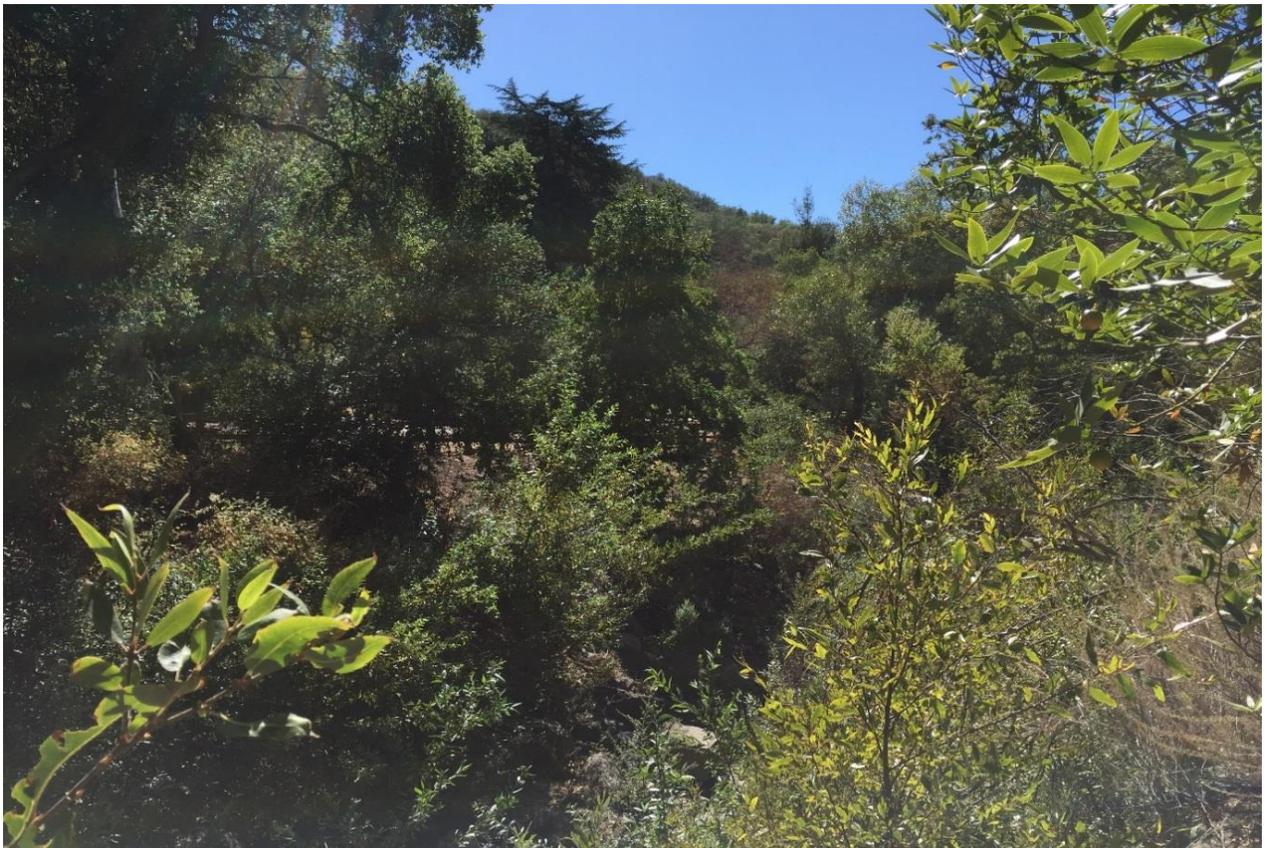
Photo 2. Looking southwest from north bank (Zones 1 and 2)

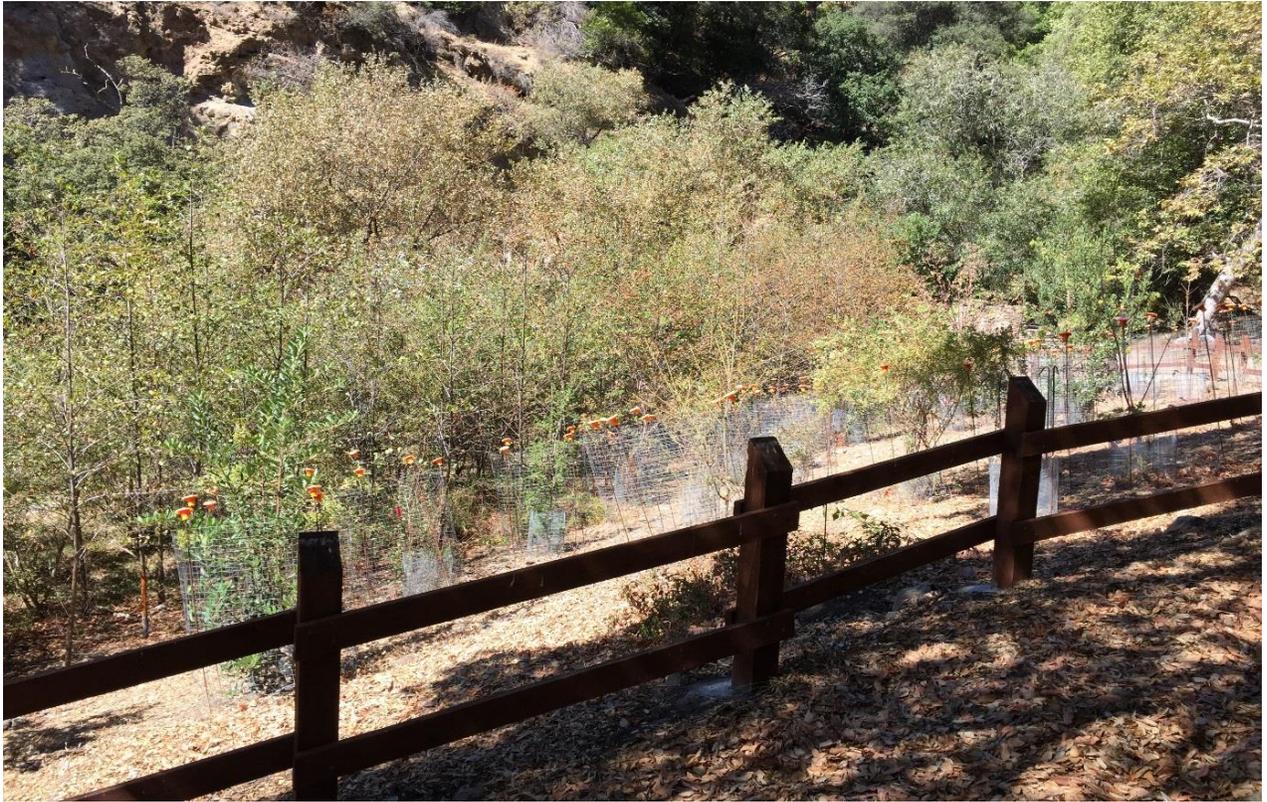
Photo 3. Looking northeast to floodplain from pedestrian path (Zones 4 and 5).

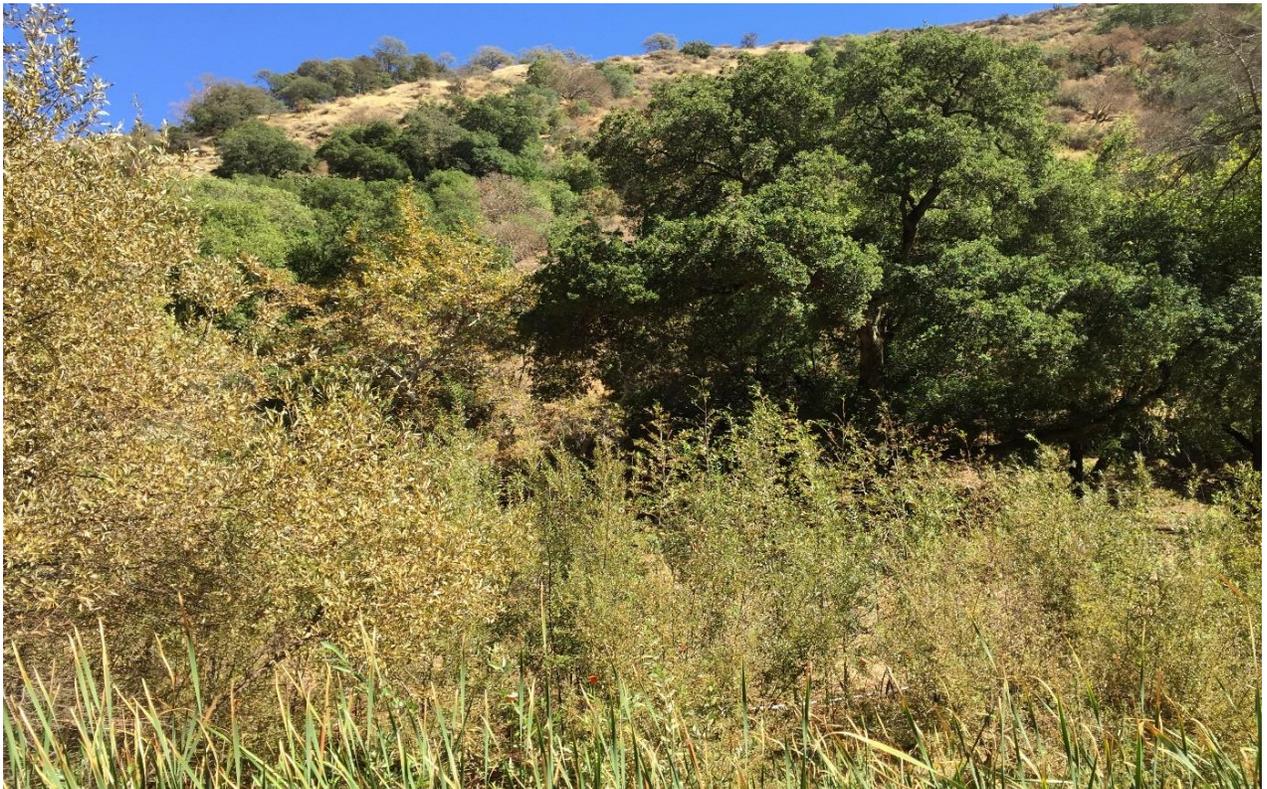
Photo 4. Looking south at Zone 4 from north bank of creek.

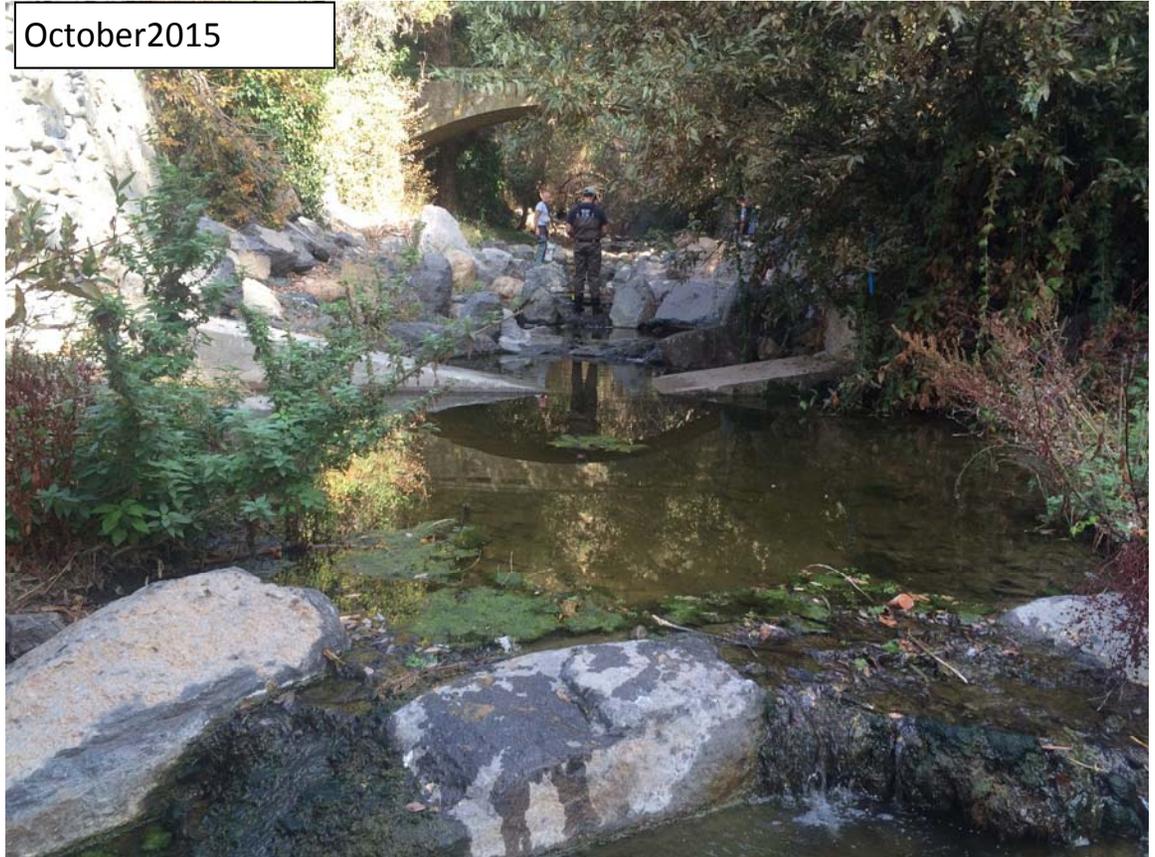
Figure 9.

Photo point 3, Site 13, Years 0-2. Alum Rock Monitoring, Upper Penitencia Creek, Santa Clara County, California . Photo point 3 photographs looking upstream across pool 1 at the modified concrete grade control structure and pedestrian bridge in the fish passage project. Refer to Figure 1 of this report for photo point locations.

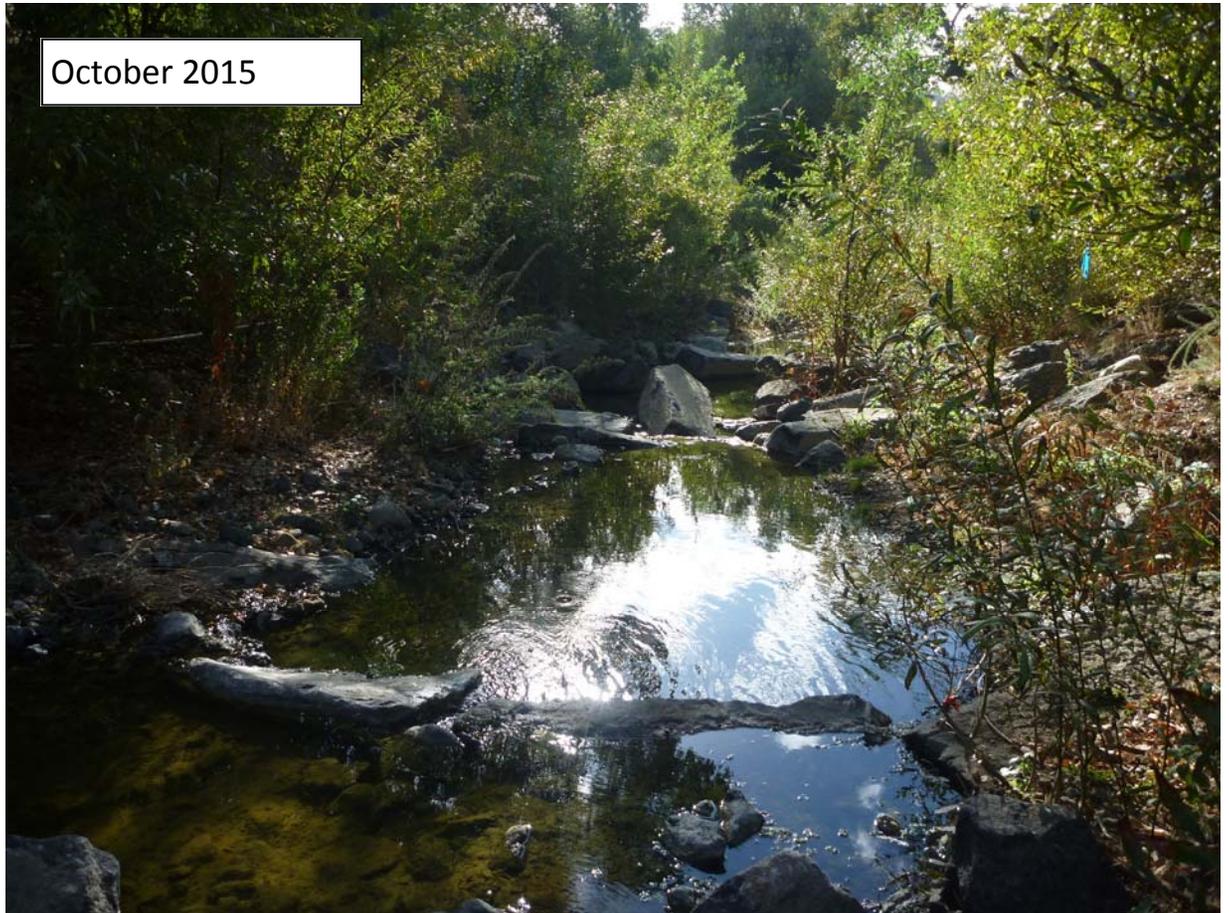
Figure 10. Photo point 4, Site 13, Years 0-2. Alum Rock Monitoring, Upper Penitencia Creek, Santa Clara County, California . Photo point 4 photographs taken on right bank from top of the modified concrete grade control structure wall looking downstream across chute 2 along the fish passage project. Refer to Figure 1 of this report for photo point locations.

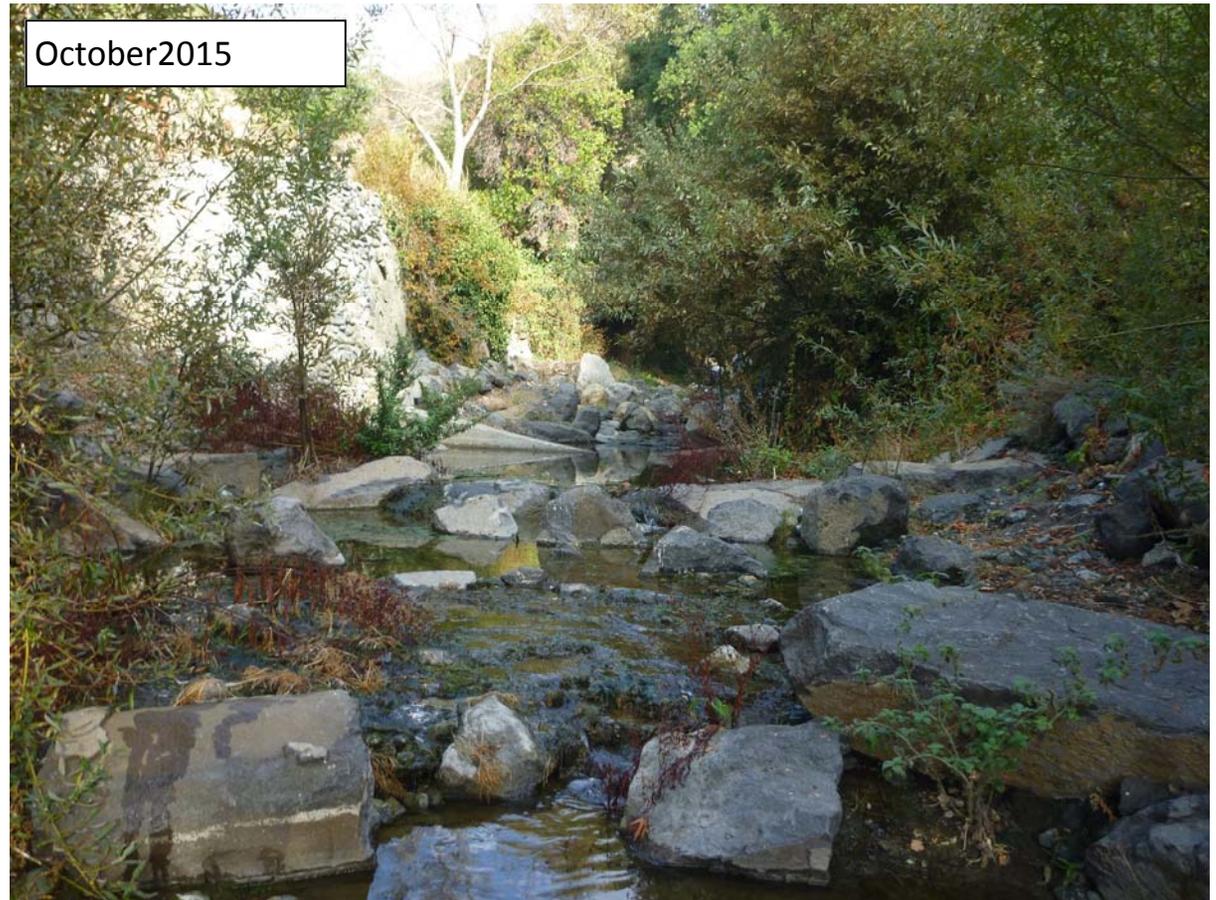
Figure 11. Photo point 5, Site 13, Years 0-2. Alum Rock Monitoring, Upper Penitencia Creek, Santa Clara County, California . Photo point 5 photographs looking upstream across chute 2 to modified concrete grade control structure and bridge in the fish passage project. Note the scour of vegetation and algal mats. Refer to Figure 1 of this report for photo point locations.

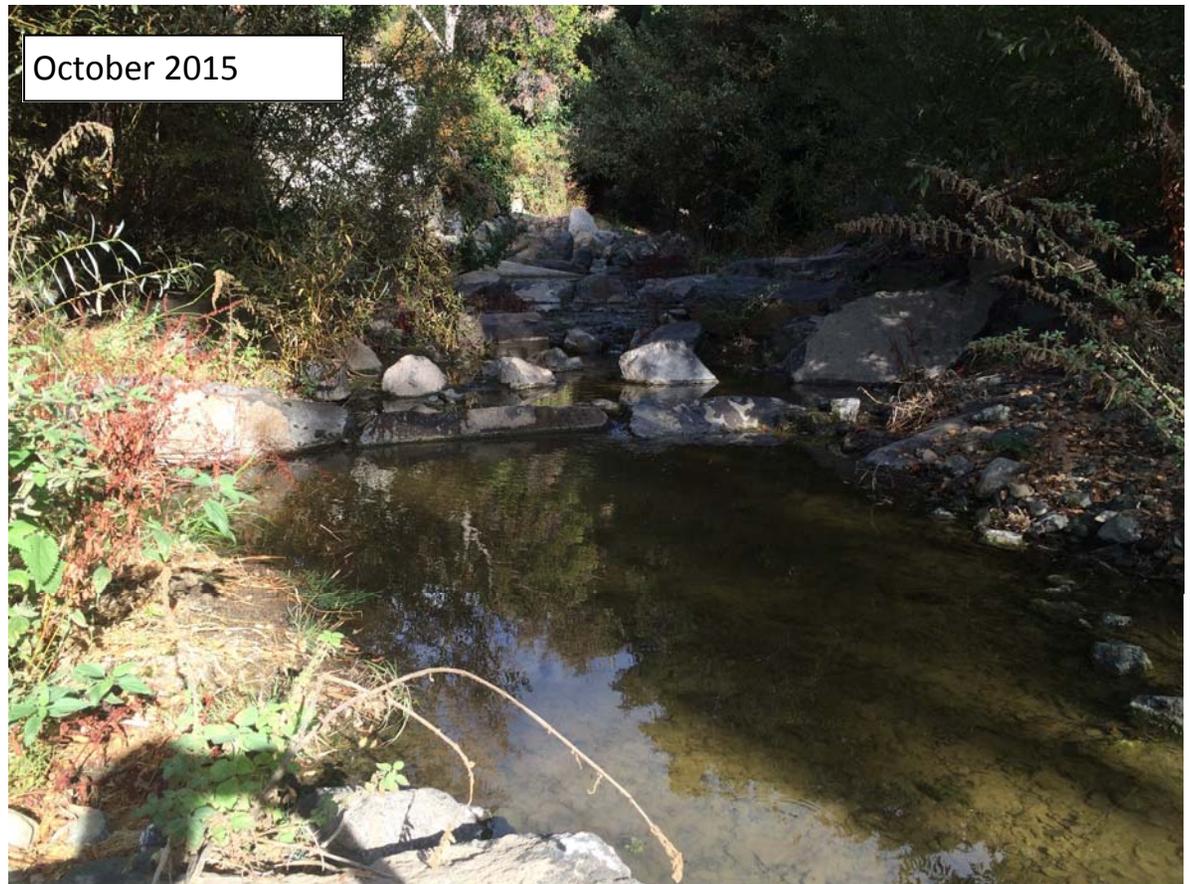
Figure 12. Photo point 6, Site 13, Years 0-2. Alum Rock Monitoring, Upper Penitencia Creek, Santa Clara County, California . Photo point 6 photographs looking upstream across pool 2 and chute 2 in the fish passage project. Refer to Figure 1 of this report for photo point locations.

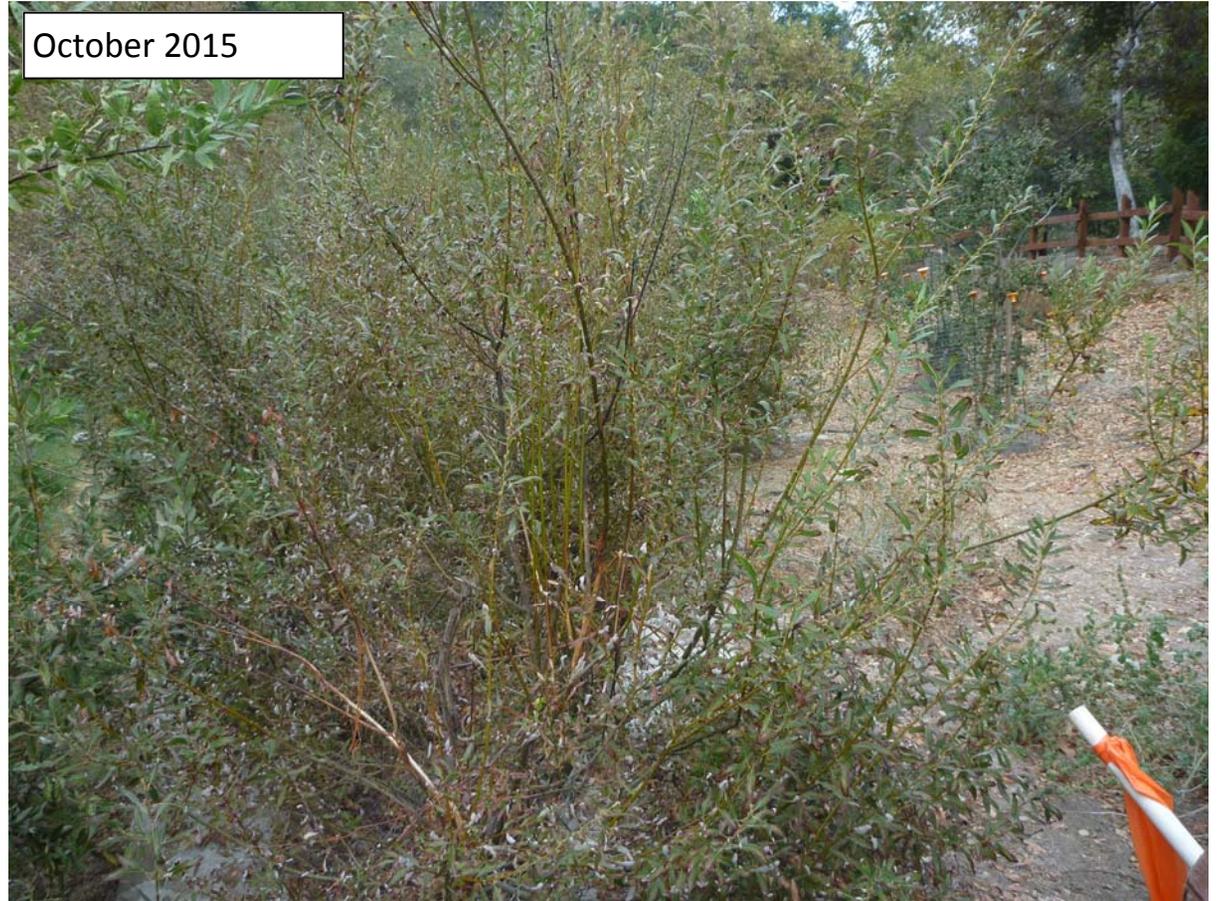
Figure 25. Photo point 11, Site 10, Years 0-2. Alum Rock Monitoring, Upper Penitencia Creek, Santa Clara County, California . Photo point 11 looking upstream at Site 10 floodplain toward foot bridge. Refer to Figure 2 of this report for photo point locations.

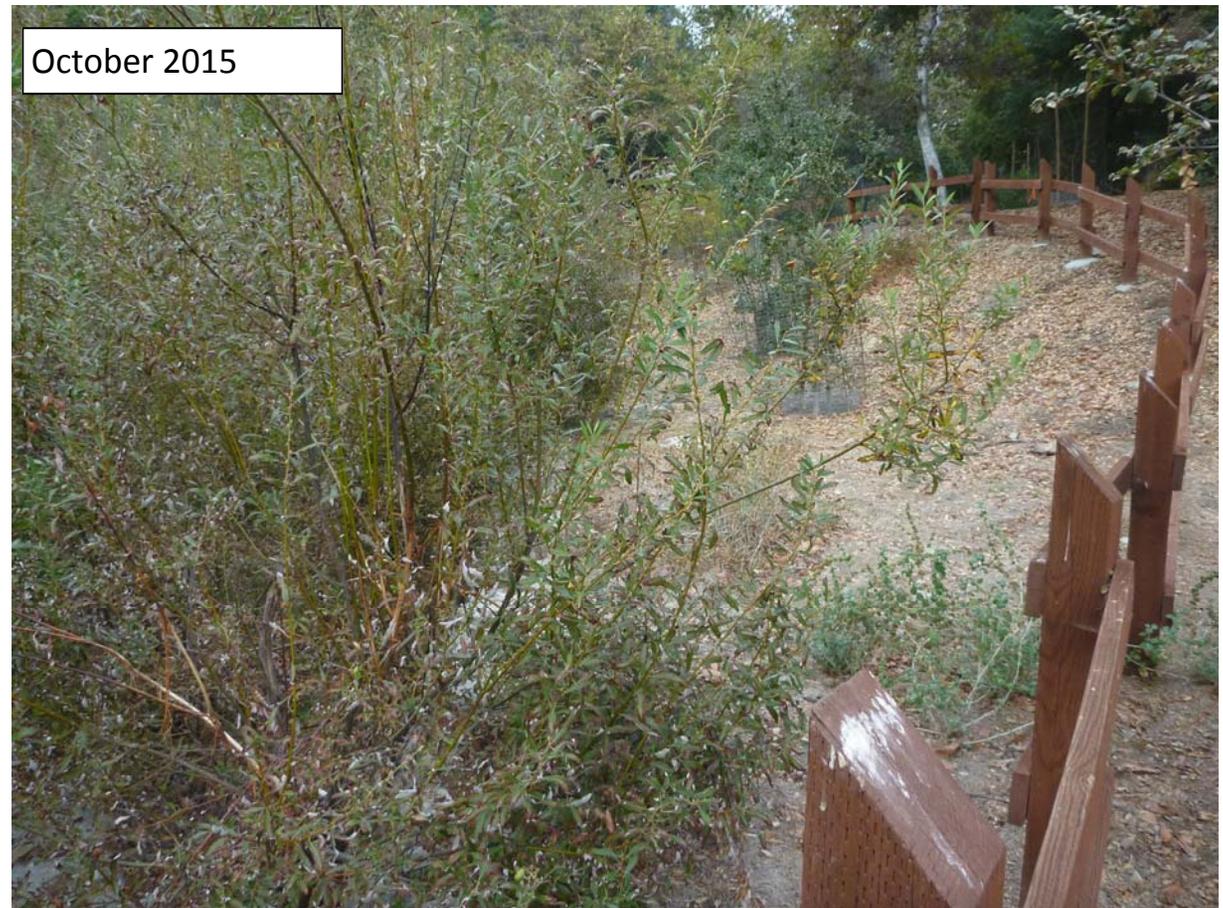
Figure 26. Photo point 12, Site 10, Years 0-2. Alum Rock Monitoring, Upper Penitencia Creek, Santa Clara County, California . Photo point 12 looking upslope at the downstream edge of the Site 10 floodplain. Refer to Figure 2 of this report for photo point locations.

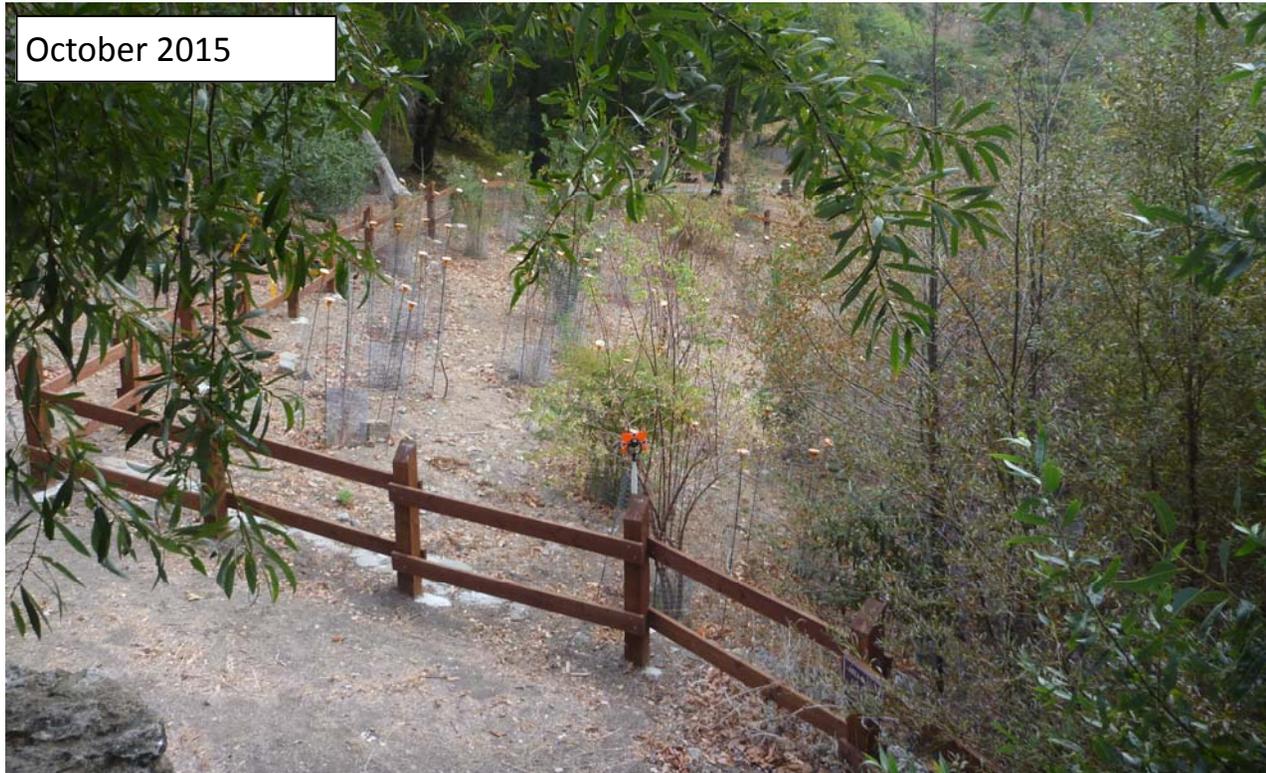
Figure 27. Photo point 13, Site 10, Years 0-2. Alum Rock Monitoring, Upper Penitencia Creek, Santa Clara County, California . Photo point 13 looking downstream from foot bridge at Site 10 floodplain. Refer to Figure 2 of this report for photo point locations.

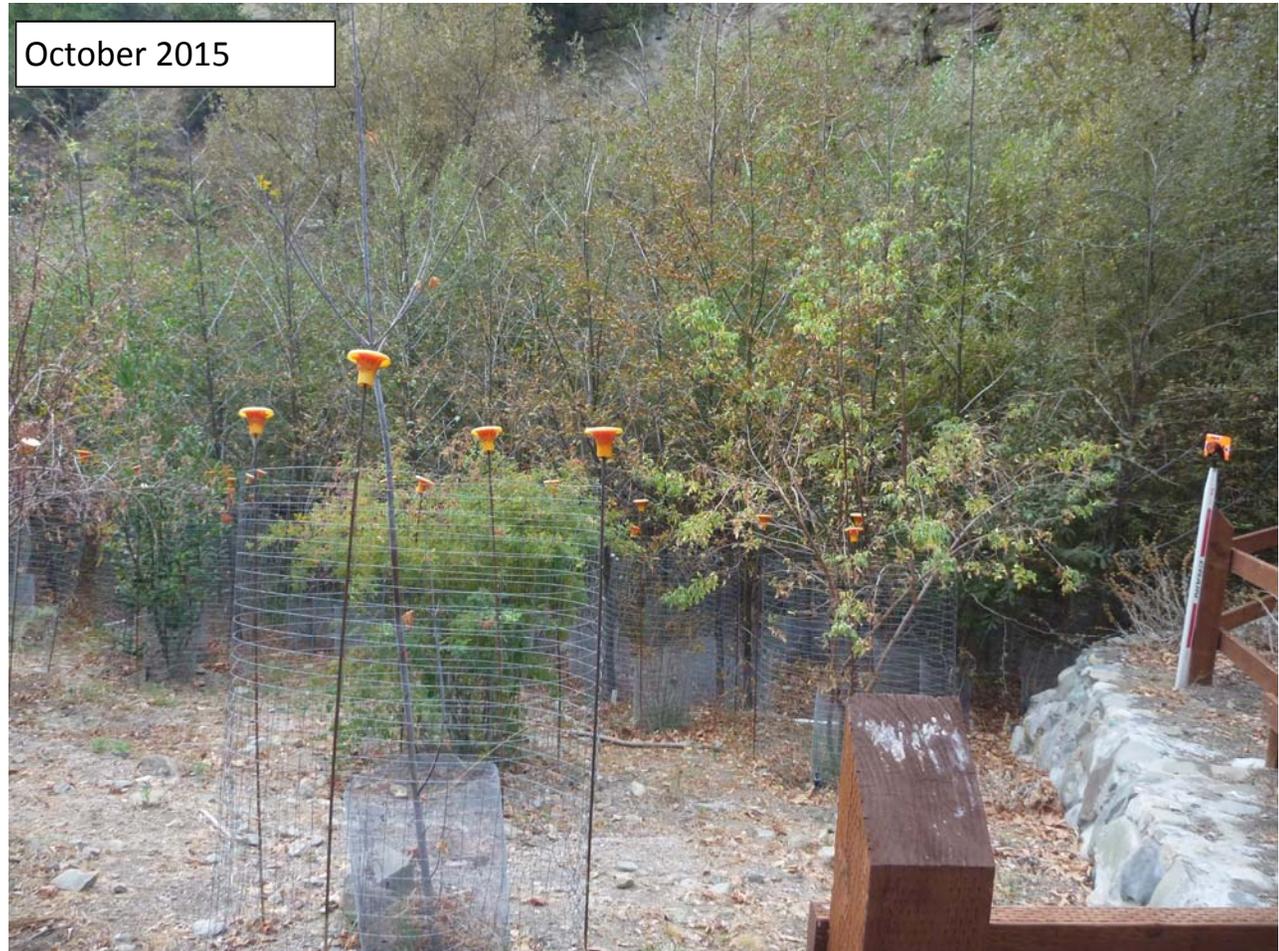
Figure 28. Photo point 14, Site 10, Years 0-2. Alum Rock Monitoring, Upper Penitencia Creek, Santa Clara County, California . Photo point 14 looking from upslope across XS 101 at Site 10 floodplain. Refer to Figure 2 of this report for photo point locations.

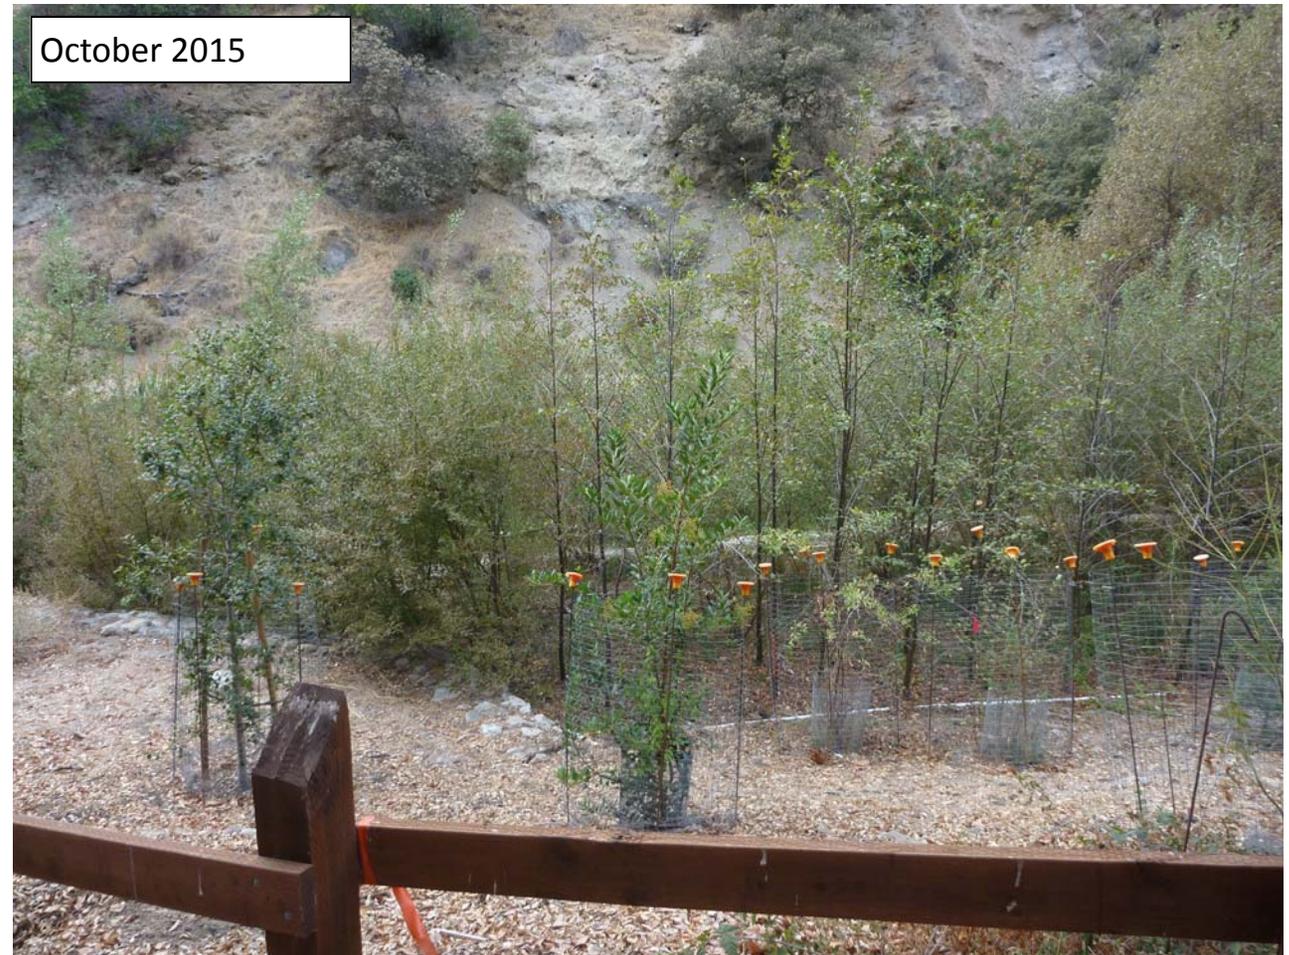
Figure 29. Photo point 15, Site 10, Years 0-2. Alum Rock Monitoring, Upper Penitencia Creek, Santa Clara County, California . Photo point 15 looking from upslope across XS 102 at Site 10 floodplain. Refer to Figure 2 of this report for photo point locations.

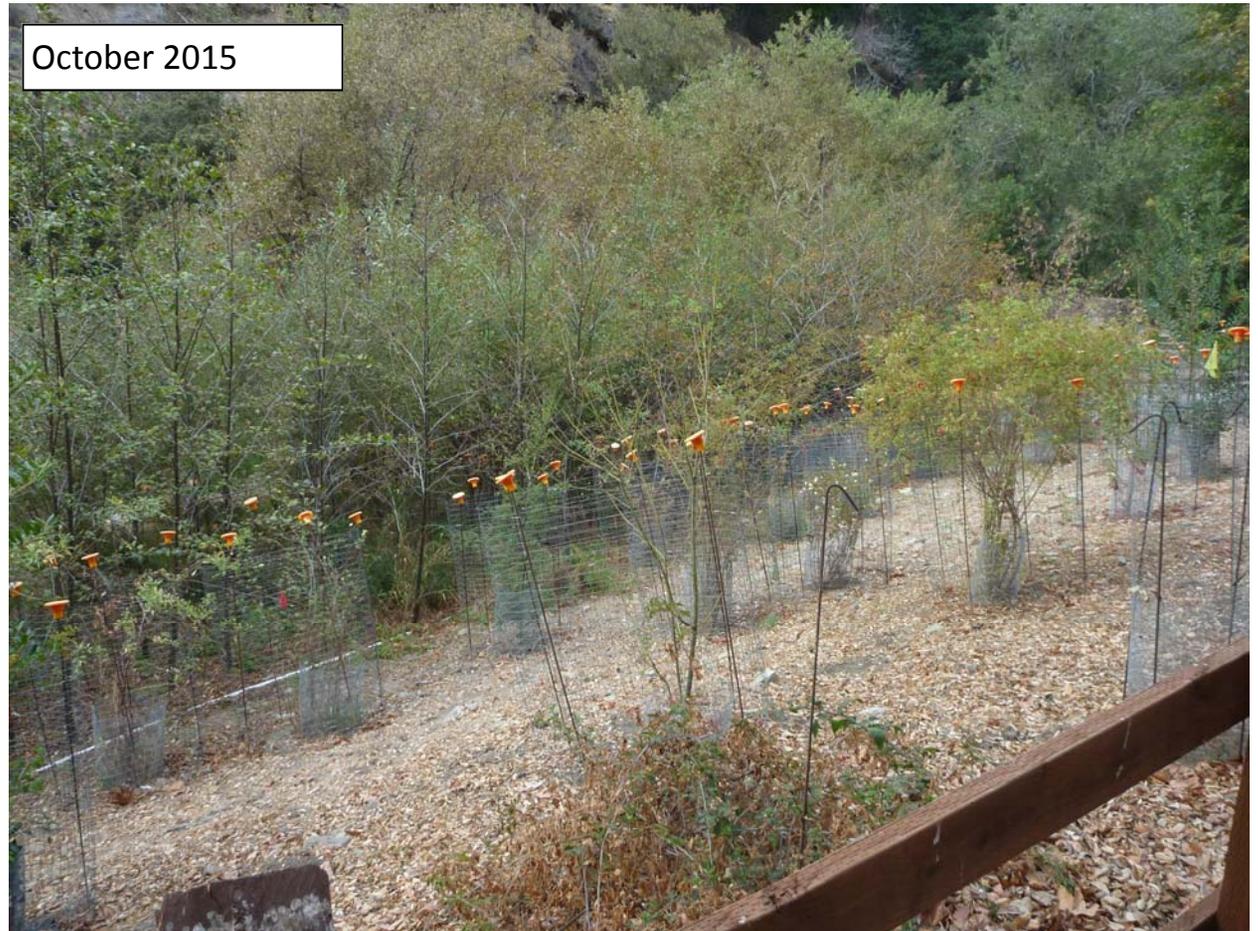
Figure 30. Photo point 16, Site 10, Years 0-2. Alum Rock Monitoring, Upper Penitencia Creek, Santa Clara County, California . Photo point 16 looking from upslope to the footbridge at Site 10 floodplain. Refer to Figure 2 of this report for photo point locations.

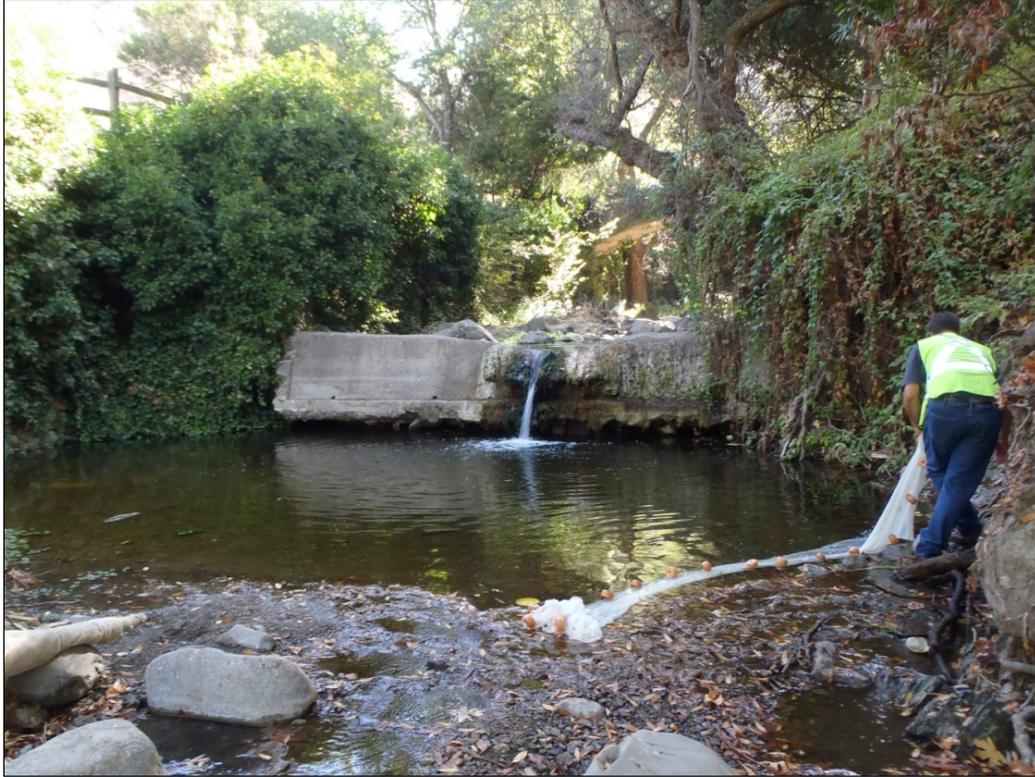
Fish passage in the Project reach was improved by modifying a 4.5-foot-high concrete weir. The crest of the weir was lowered to the level of the normal pool surface and a 225-foot-long roughened channel was constructed to improve passage for *O. mykiss* and other native fishes (Figures 1 and 2). Post-construction monitoring is required to “assess the biological performance of the fish passage improvement Project and evaluate the ability of the site to pass steelhead” (NMFS 2012). To meet this goal, a 5-year fisheries monitoring plan was developed by H. T. Harvey & Associates (HTH), approved by the National Marine Fisheries Service, and implemented beginning in September 2013 (HTH 2013a, 2014). The plan involves conducting electrofishing surveys and habitat typing to document the fish species and habitat associations in the Project reach. During monitoring, fish ecologists document all the fish species encountered while focusing on CCC steelhead. Both CCC steelhead and resident rainbow trout have been documented in Upper Penitencia Creek, including upstream of the Project reach (Leidy et al. 2005, Leicester 2011, Leicester and Smith 2012, Leicester and Smith 2013a, Leicester and Smith 2013b, Leicester and Smith 2014, Leicester and Smith 2015, HTH 2013b). Because *O. mykiss* may adopt anadromous or resident life history strategies, all anadromous steelhead and resident rainbow trout observed during surveys are referred to as *O. mykiss* in this report. Other Project monitoring components performed by other firms and not summarized in this report include vegetation monitoring and streambed hydrological monitoring, all of which, when combined, will improve understanding of the evolving habitat conditions and species use in the restored channel.

Figure 1. Concrete Weir before Modification, August 8, 2012 (Looking Upstream)

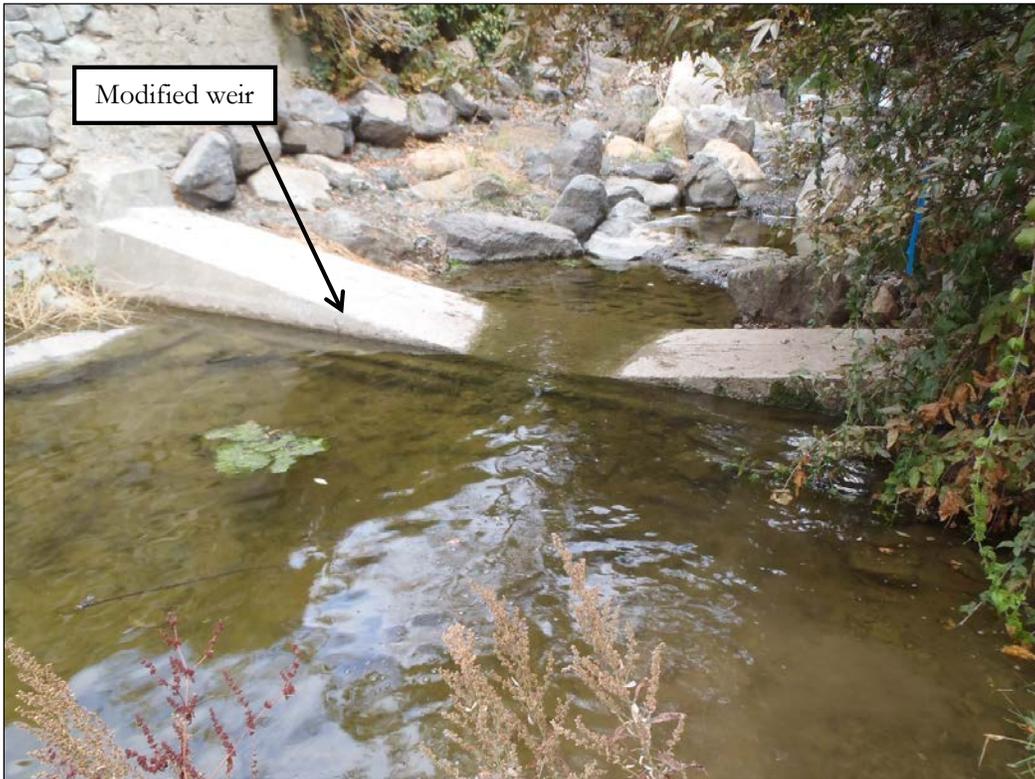
Figure 2. Modified Concrete Weir, October 15, 2015 (Looking Upstream)

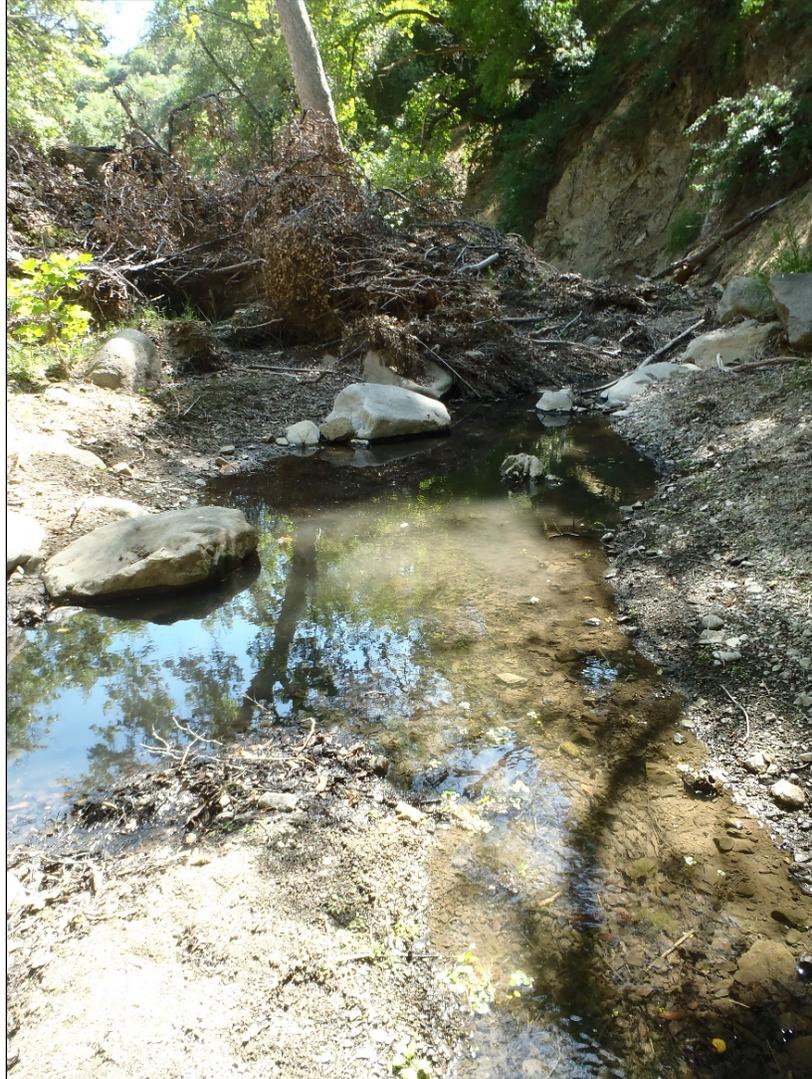
Figure 12. Landslide Dam in Upstream Reach

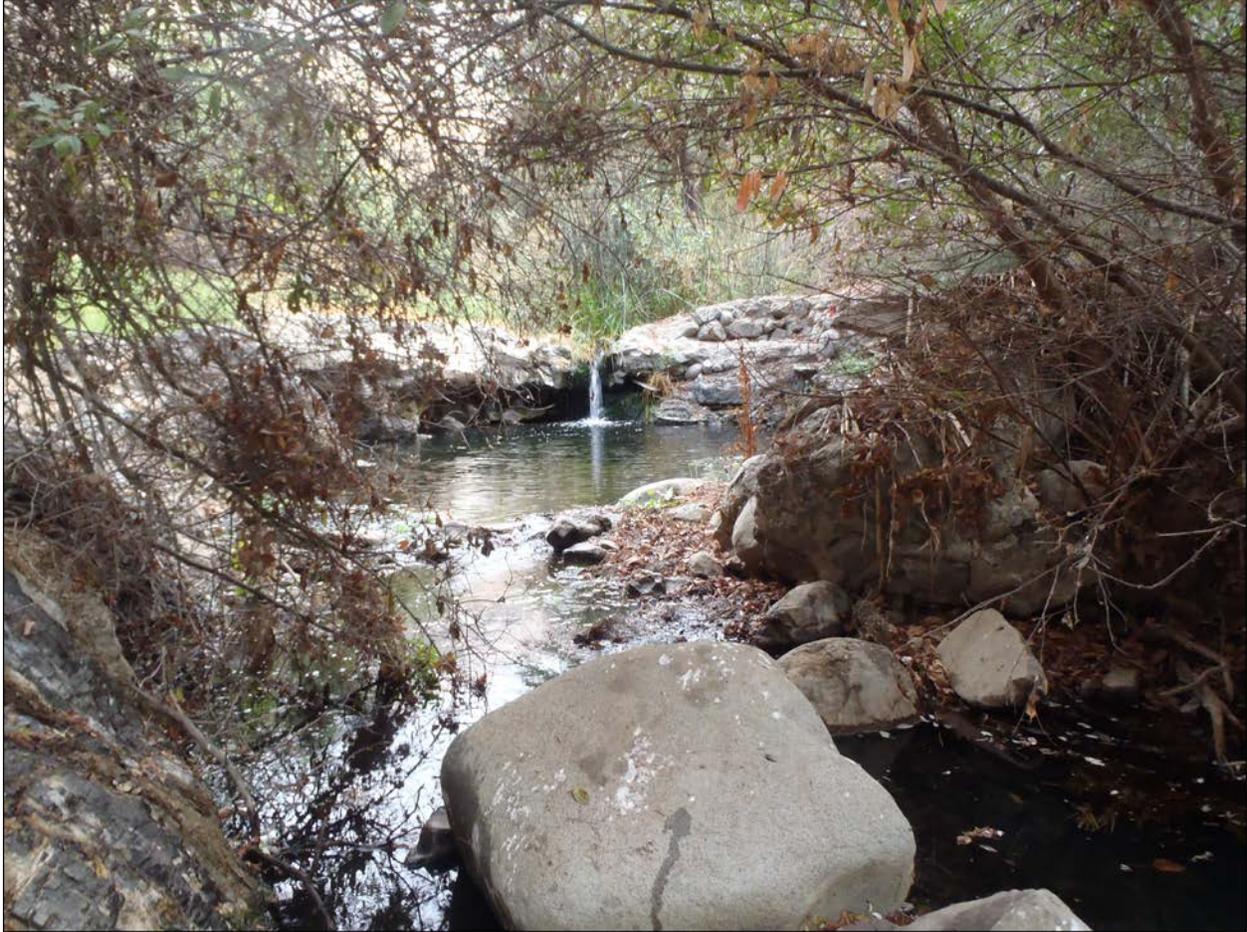
Figure 13. Concrete Barrier in Upstream Reach
