**Wrigley Creek Improvement Project
Milpitas, California**

Year 4 (2014) Monitoring Report

Project #2995-04

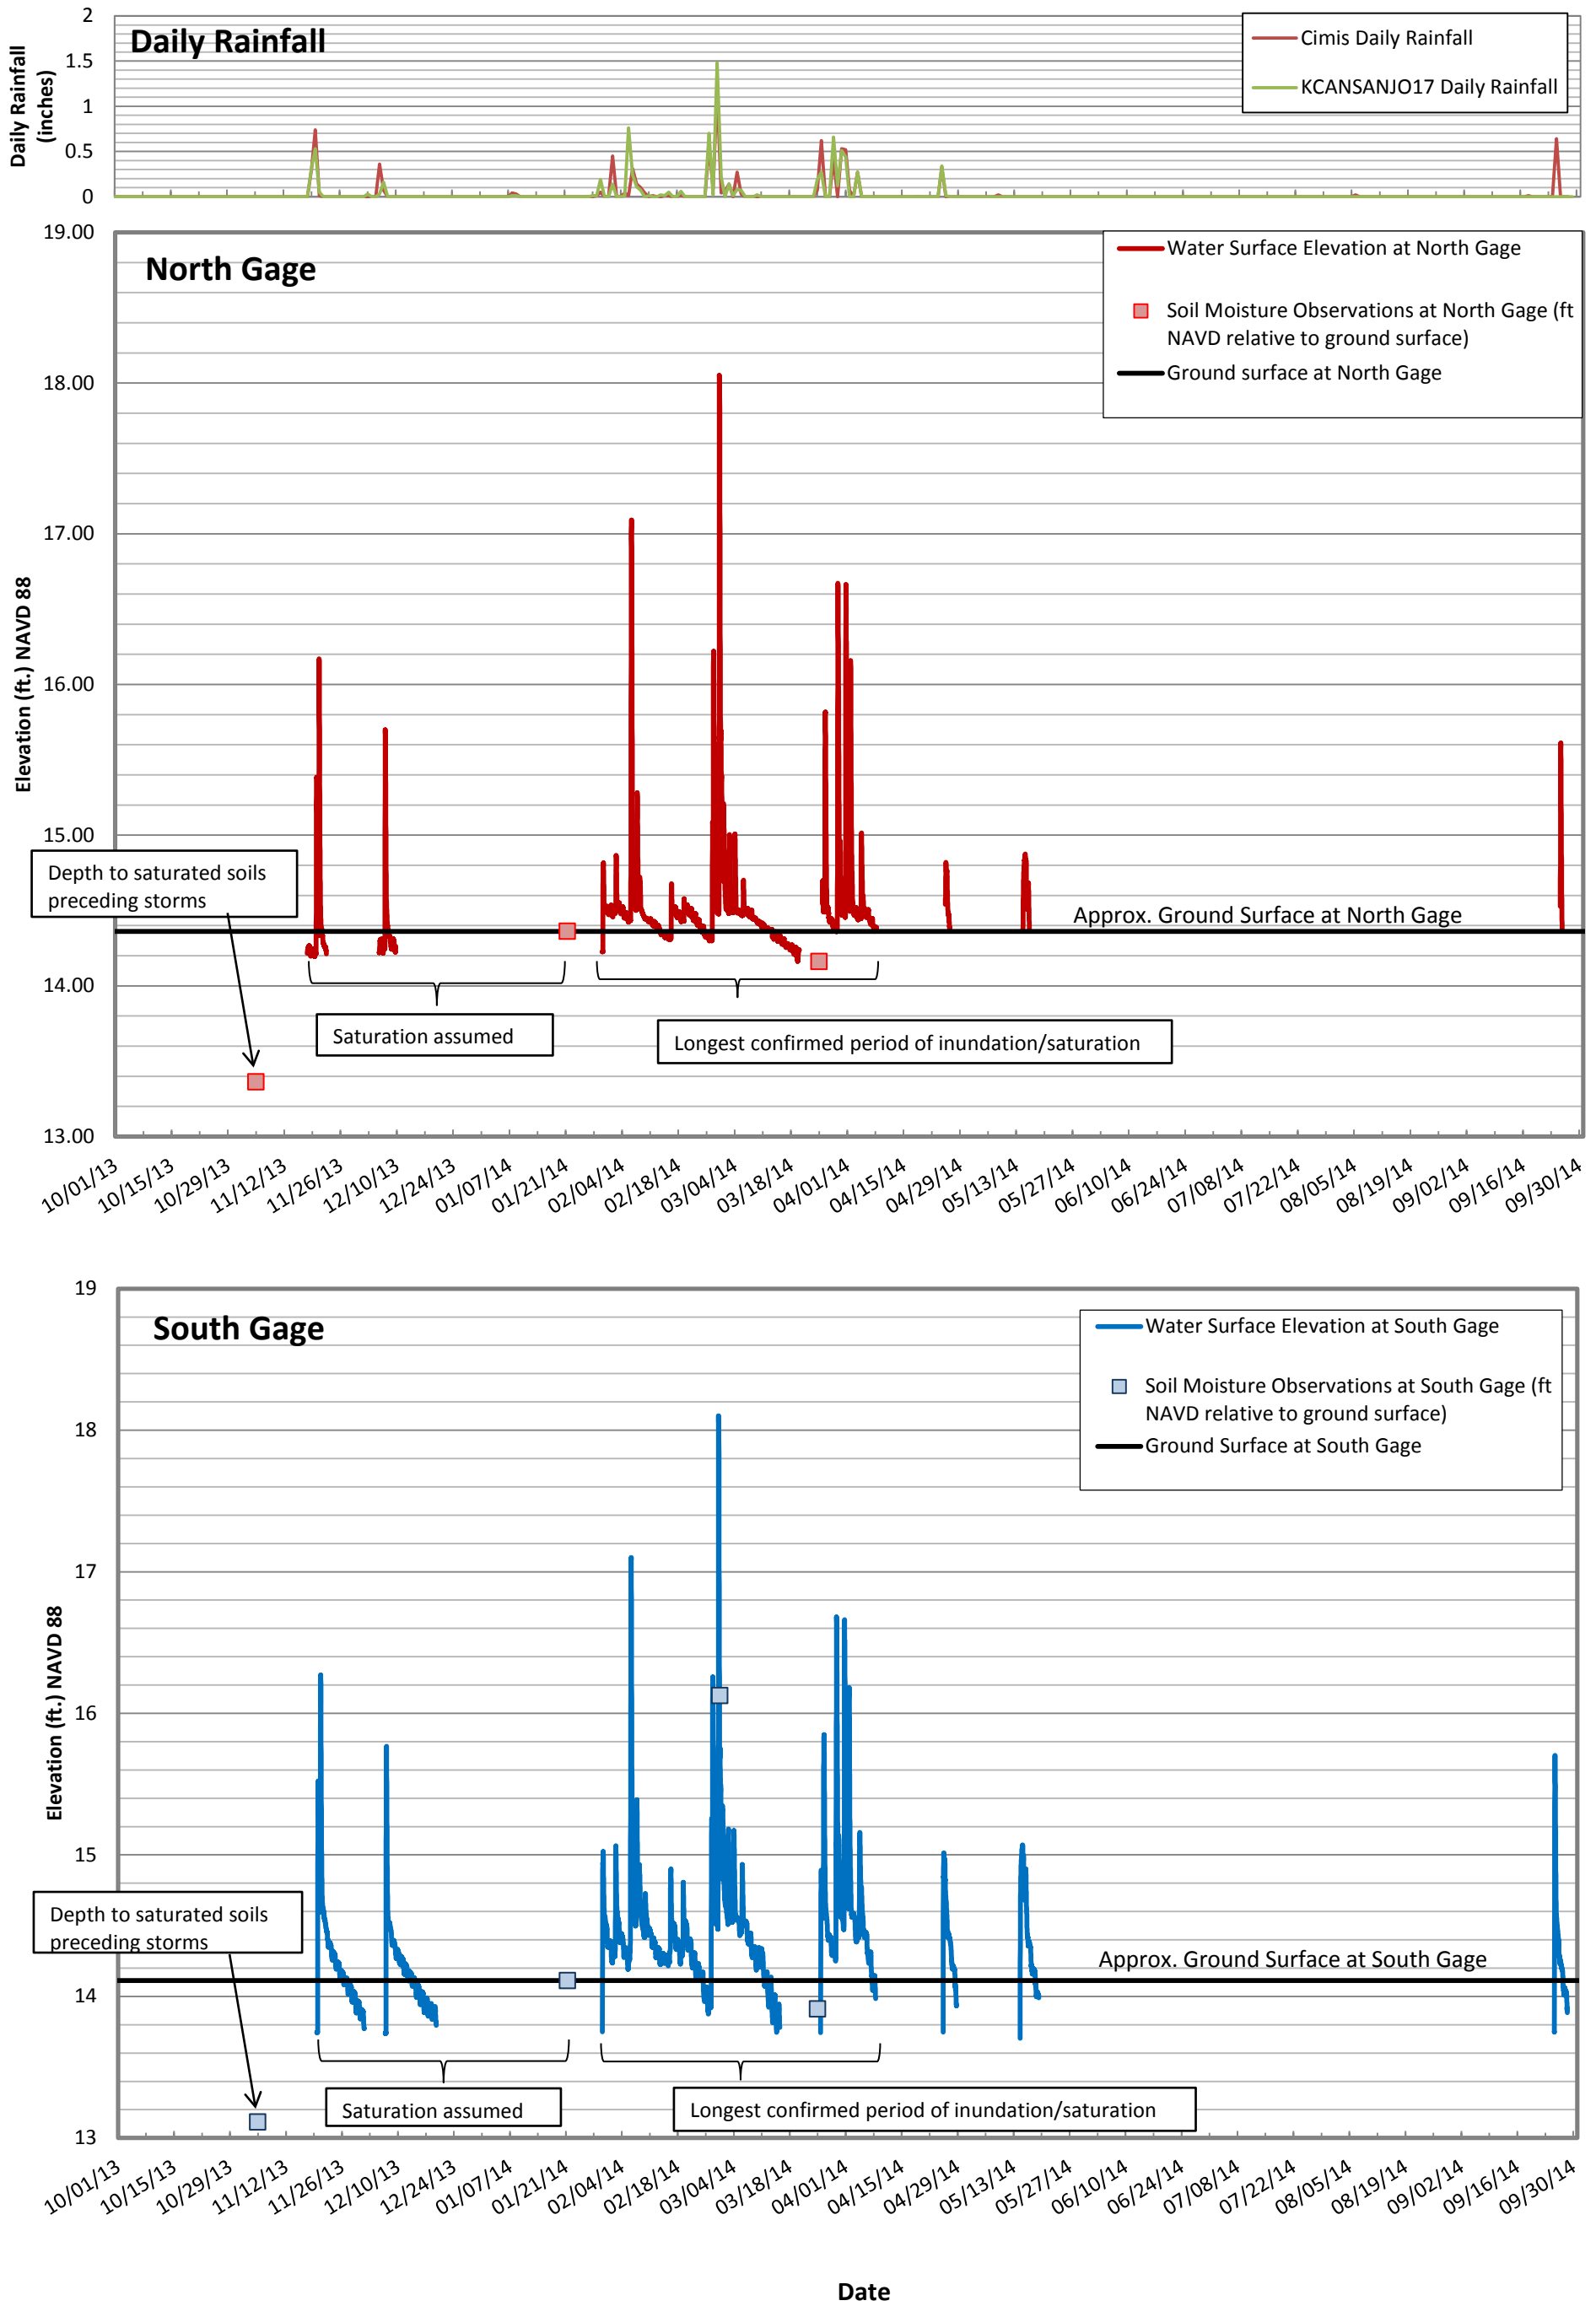
Figure 4. Annotated stage record - Wrigley Creek Mitigation Performance Monitoring, Water Year 2014, Milpitas, California Stage record for the north and south stations with storms shown by the steep spikes in stage followed by a gradual decline as the monitoring locations drain. The two stage records are presented in NAVD88. Note that the pressure transducers are installed below the ground surface. Soil moisture observations are elevations in NAVD and should be compared to the adjacent ground surface.

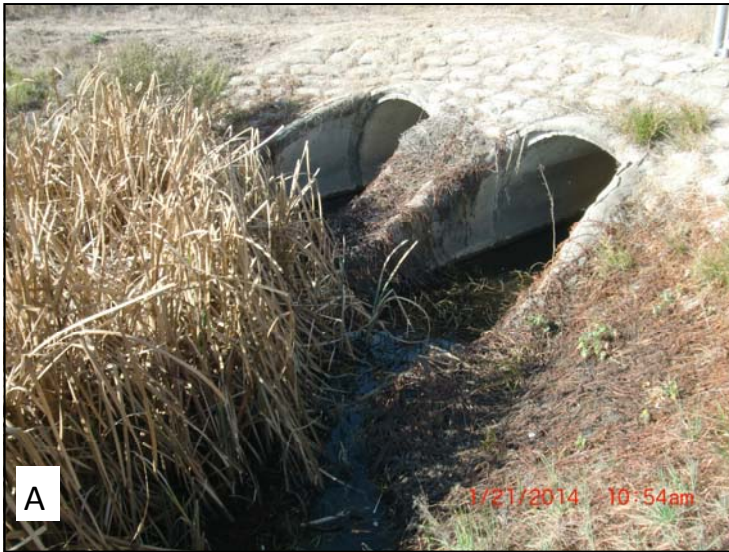
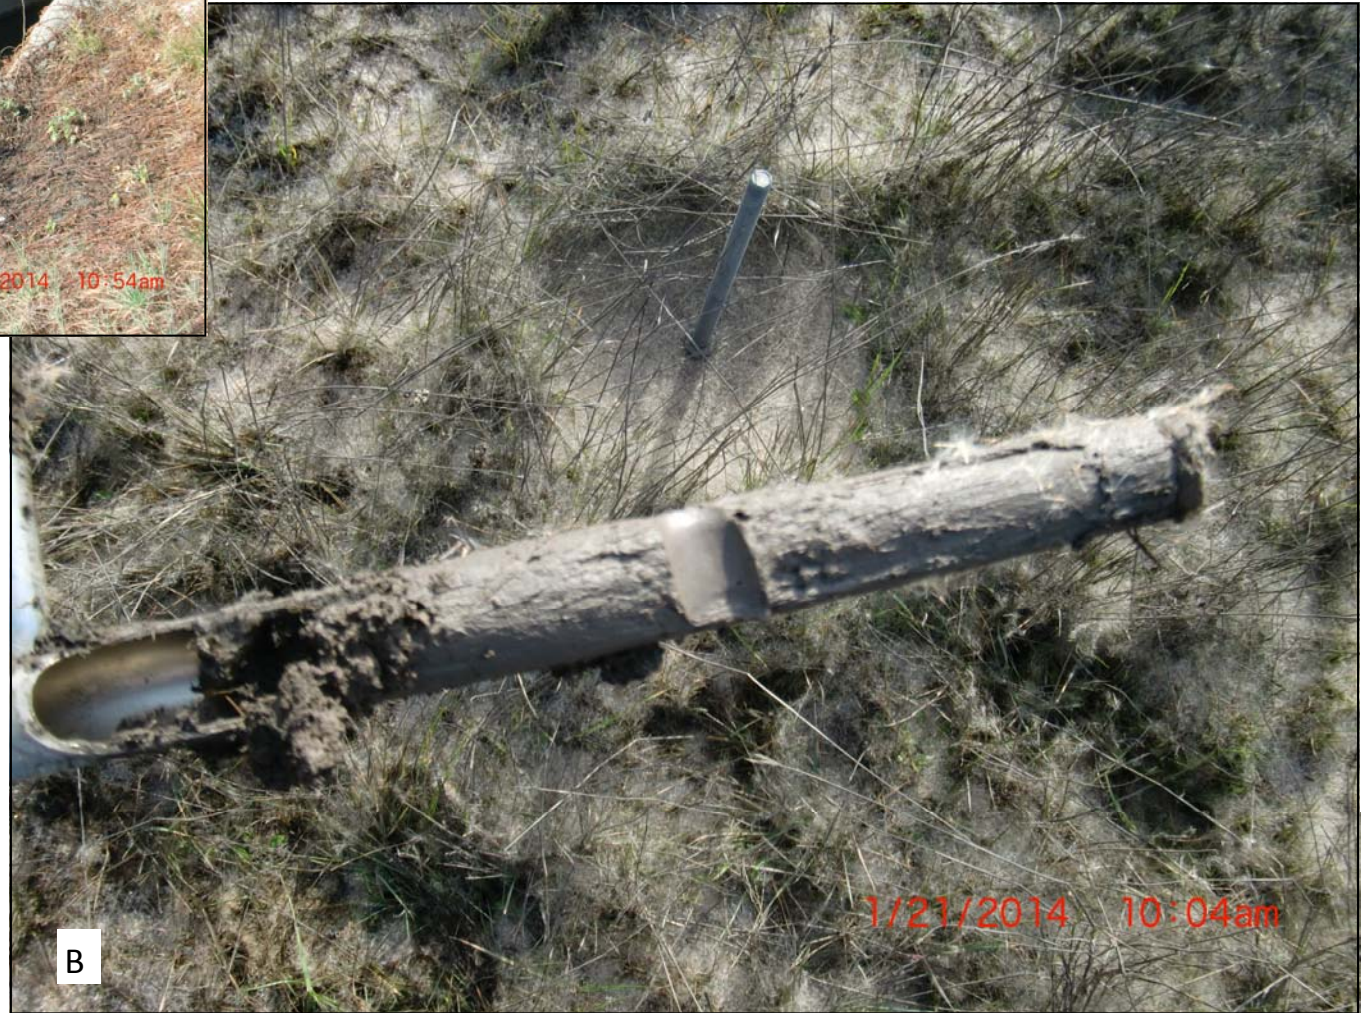
Figure 5. North gage field photos, January 21, 2014. Wrigley Creek Mitigation Performance Monitoring, Santa Clara County, California . Photo A shows ponded water downstream of the north gage at the downstream culvert inlets, which supports continually saturated soil moisture during an inter-storm period. This moist soil was directly observed with a soil sampler (Photo B).

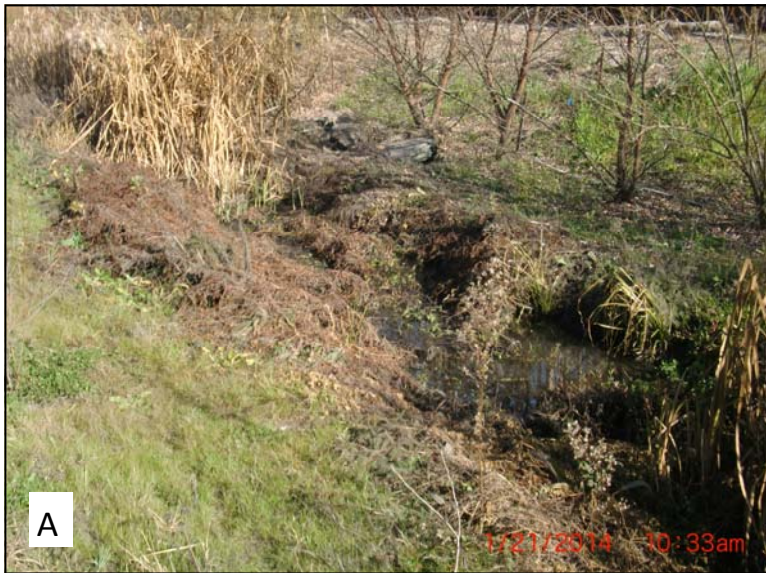
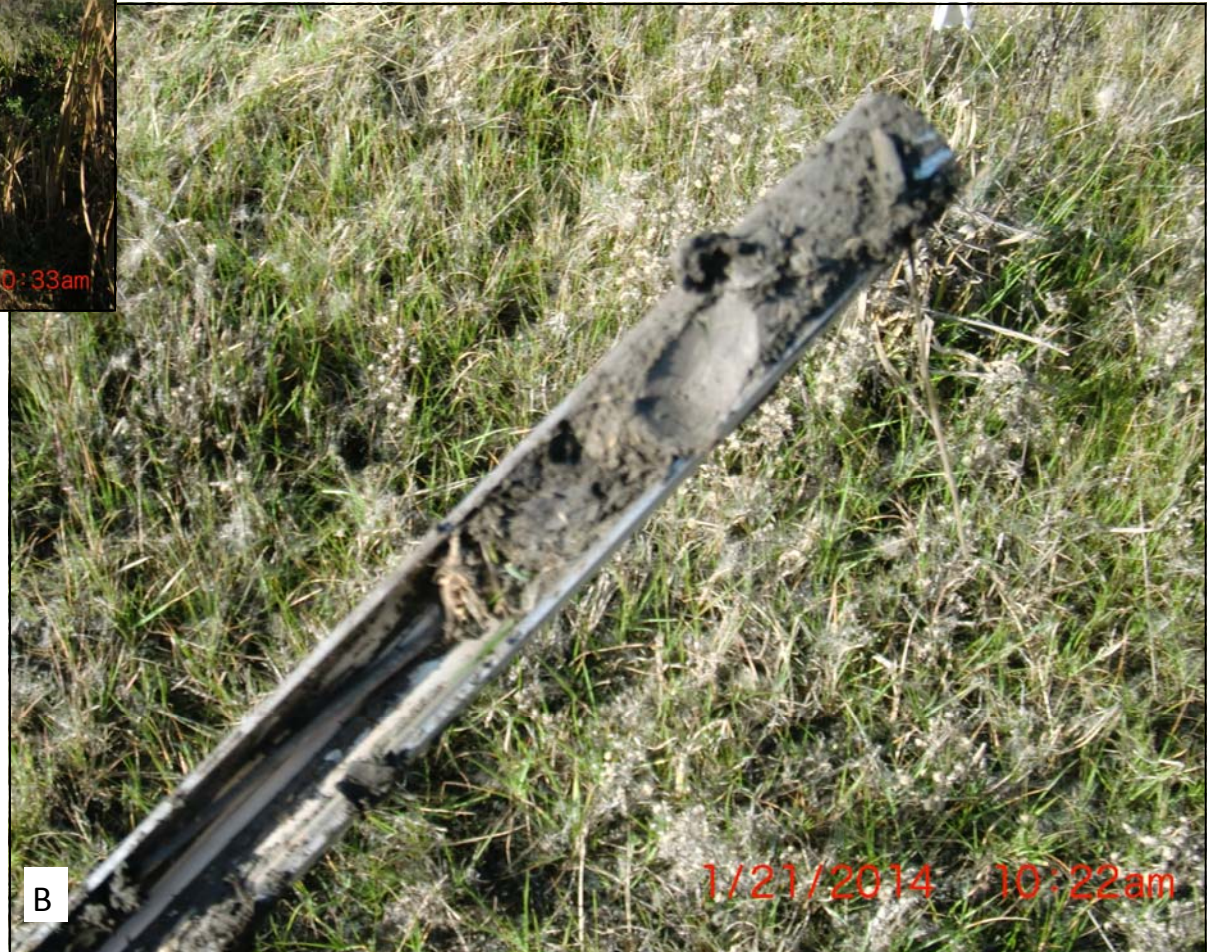
Figure 6. South gage field photos, January 21, 2014. Wrigley Creek Mitigation Performance Monitoring, Santa Clara County, California . Photo A shows ponded water upstream of the south gage, suggesting continually saturated soil during an inter-storm period. This moist soil was directly observed with a soil sampler (Photo B).

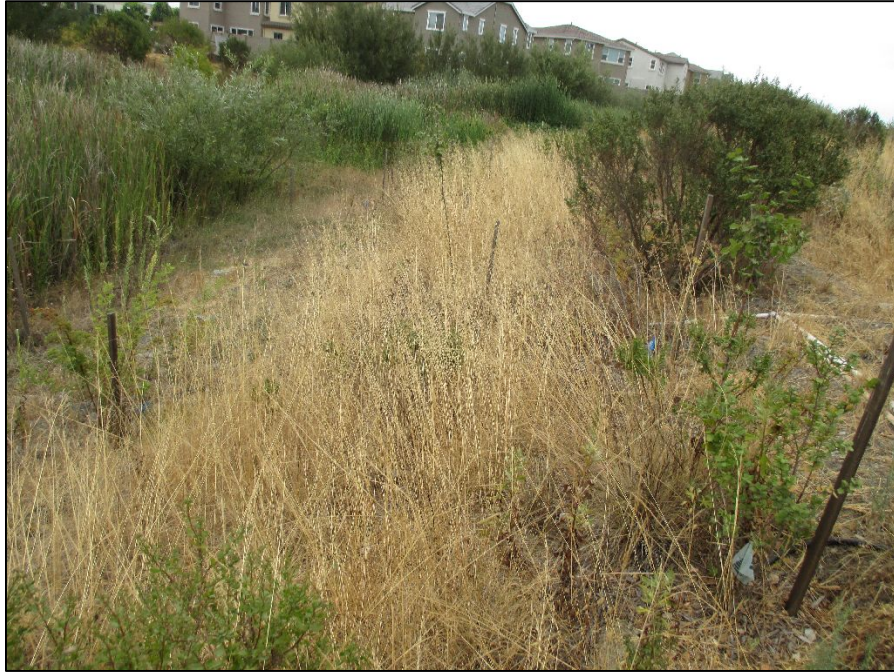
Photo 11. Dense Stand of purple needlegrass on Western Creek Bank Slope in the Vicinity of Transect 3 (5 August 2014)

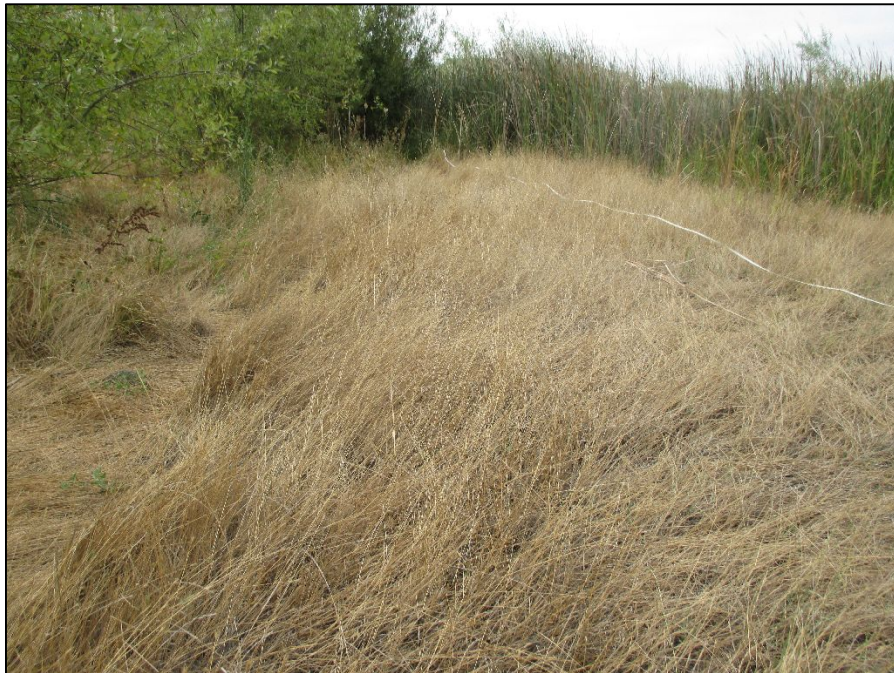
Photo 12. Dense Stand of meadow barley on Eastern Floodplain in the Vicinity of Transect 6 (5 August 2014)

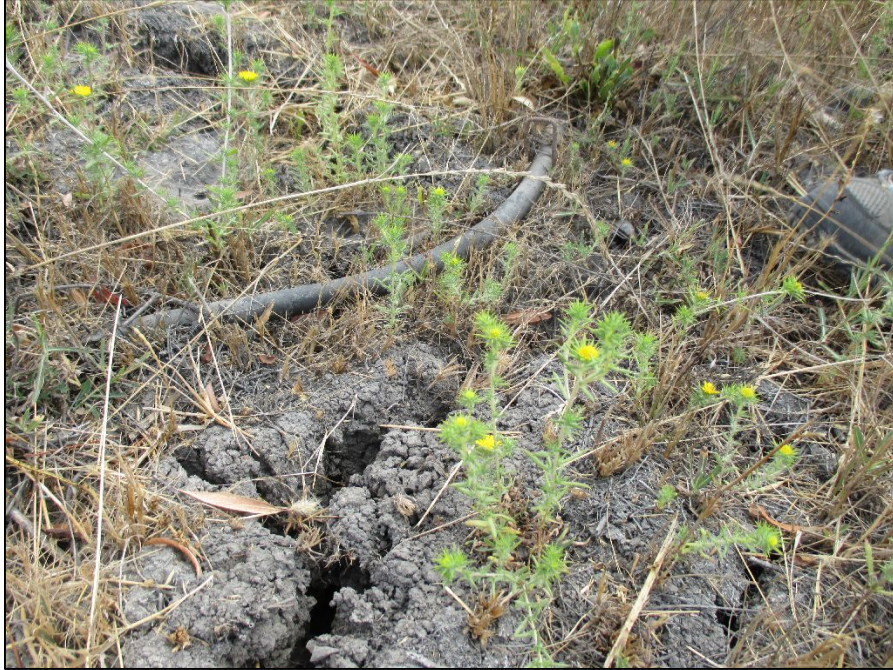
Photo 13. Congdon's tarplant in Western Floodplain (15 July 2014)
