Appendix D: Crosswalk Assessment

Date: February 10, 2016
To: Brent Pearse, VTA
From: Carrie Modi and Matt Haynes, Fehr & Peers
Subject: Story-Keys Complete Streets Study: Crosswalk Assessment Memo

Crosswalks and Bus Stops on the Story-Keys Corridor

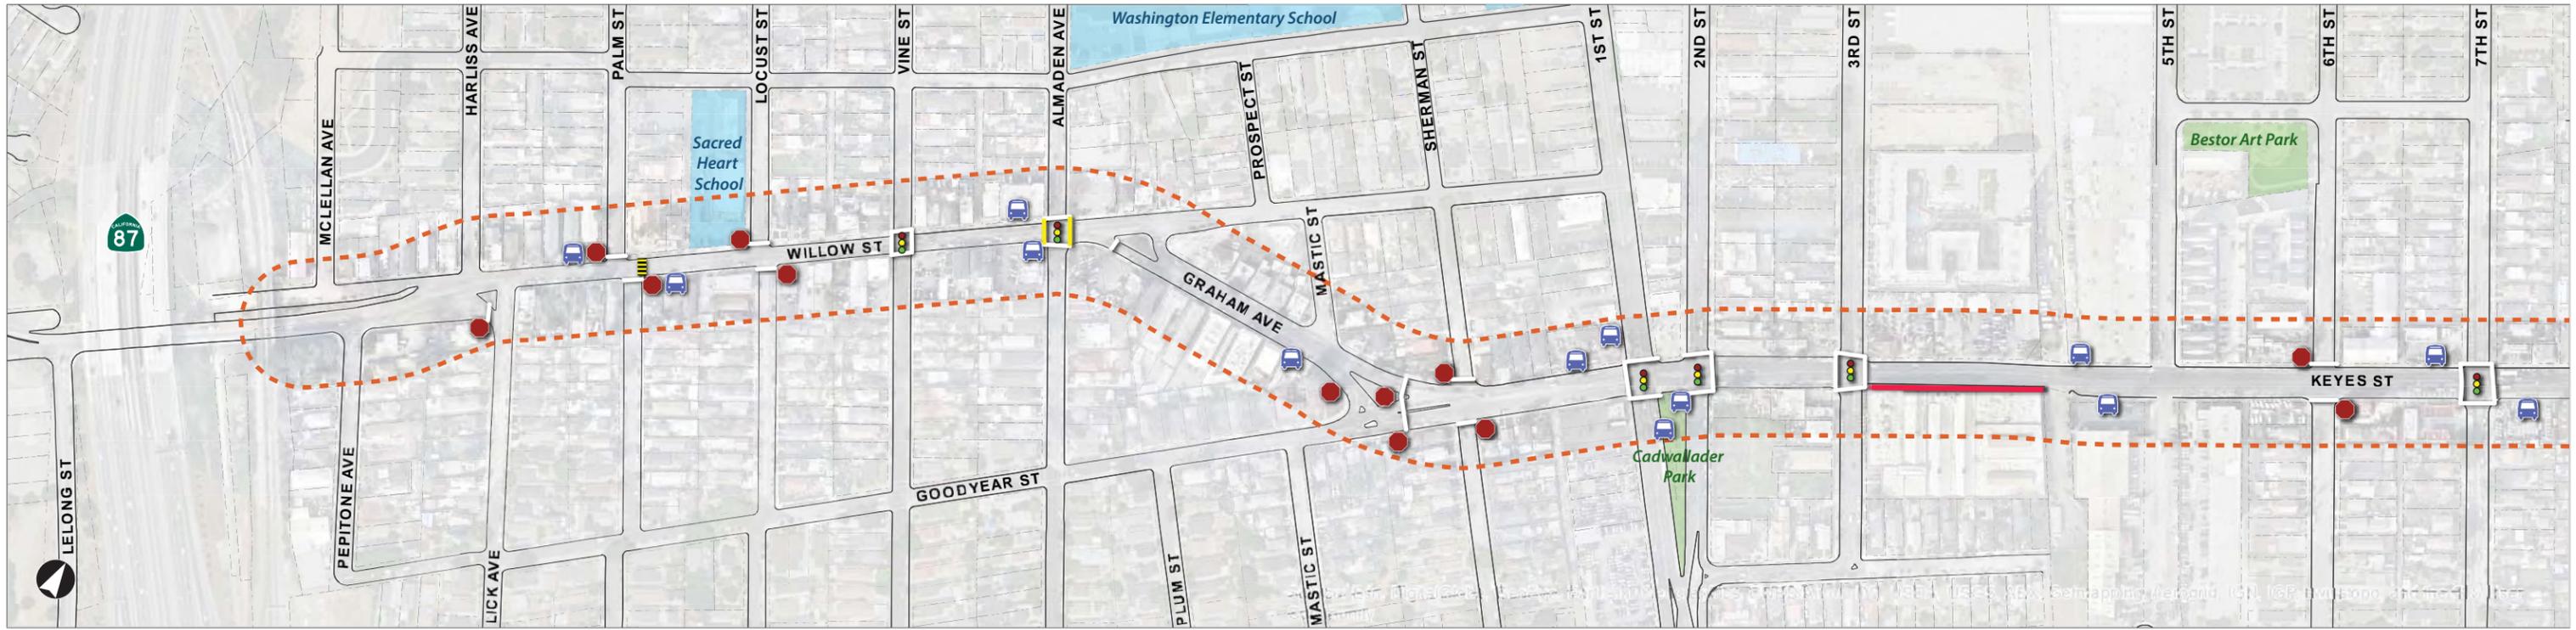
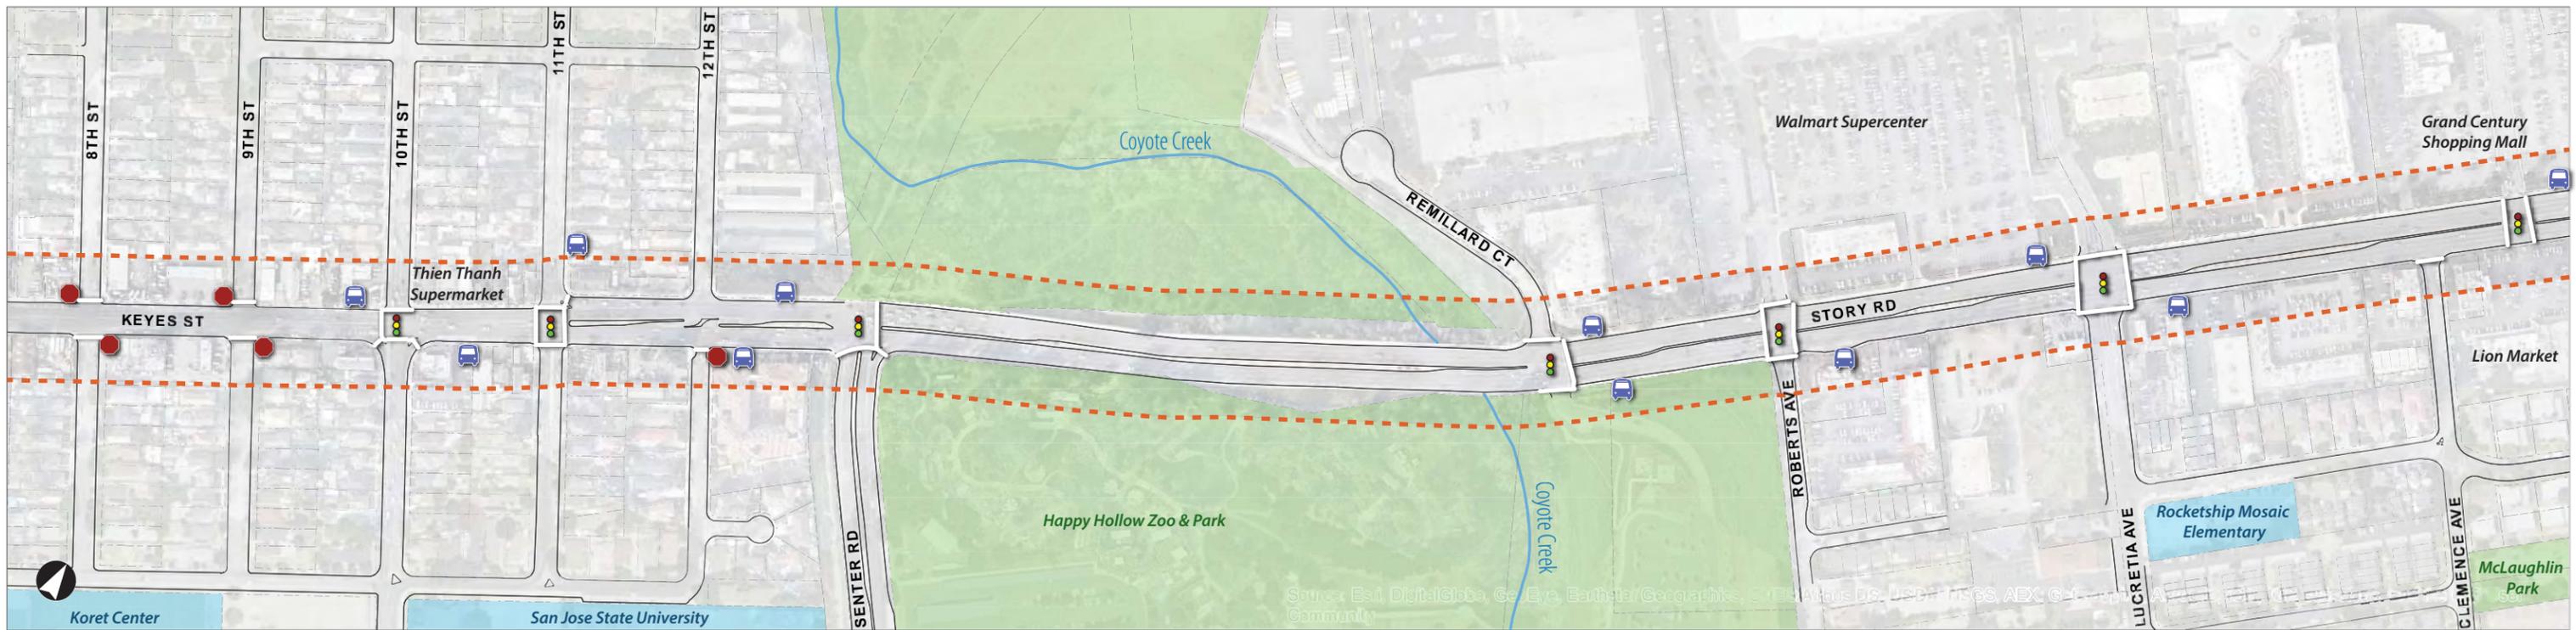
To assess existing pedestrian conditions, a marked crosswalk inventory was completed and general conditions related to the safety and ease of crossing the corridor were assessed. **Figures 1 and 2** present the inventory of existing marked crosswalk on the corridor and identify locations for new and enhanced crosswalks per the City's Vision Zero implementation efforts, as described later in this memorandum. **Appendix A** presents the inventory in tabular form.
