**Upper Penitencia Creek Improvement Project  
Year 4 (2016) Monitoring Report**

**Project 3518-03**

**Santa Clara Valley Transportation Authority**

February 2017

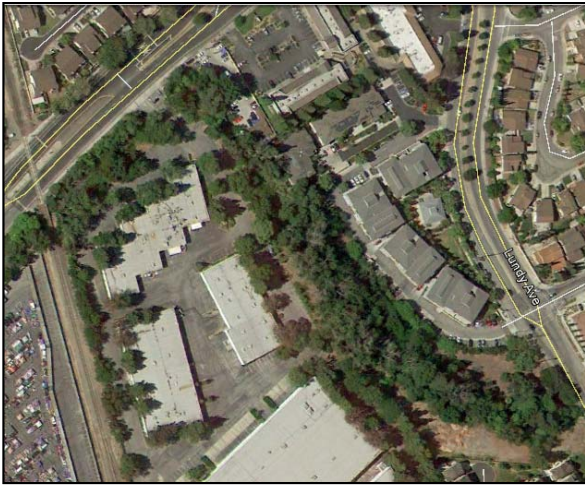
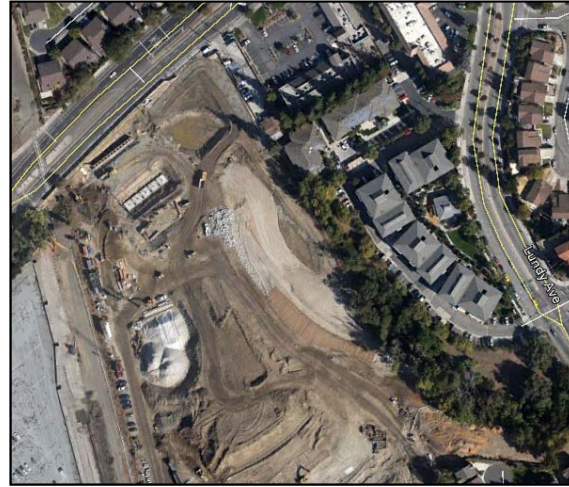
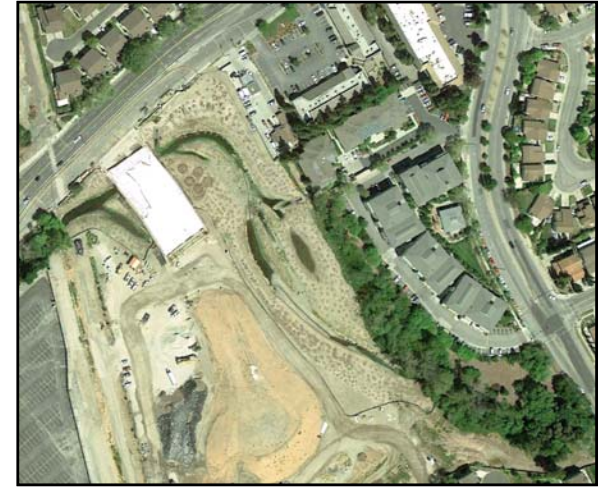
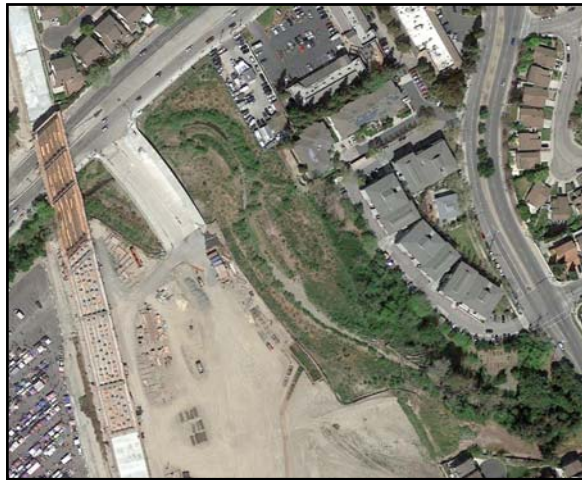
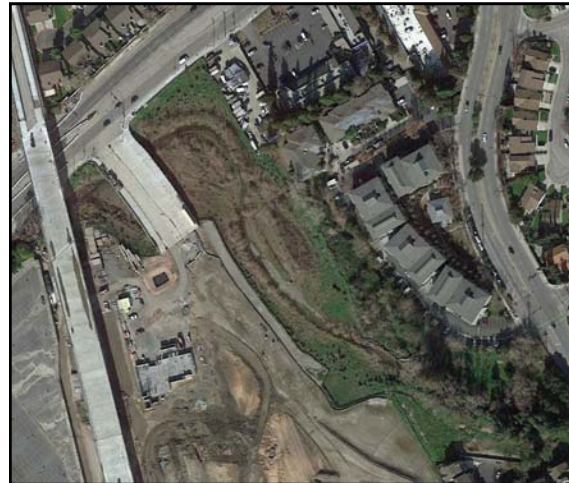
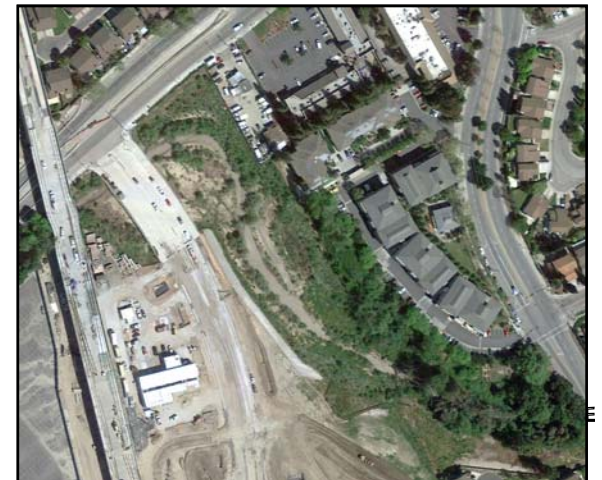
A. May 2012 , Before construction

B. September 2012, channel construction

C. April 2013, 6 months after channel construction.

D. June 2015, 3 years after construction

E. January 2016, after Jan 18, 2016 flood

F. April 2016, 4 years after construction

**Figure 2. Sequence of project completion and channel evolution, Upper Penitencia Creek, San Jose, California**

Aerial photographs taken between May 2012 and April 2016 show the project before, during and after construction.

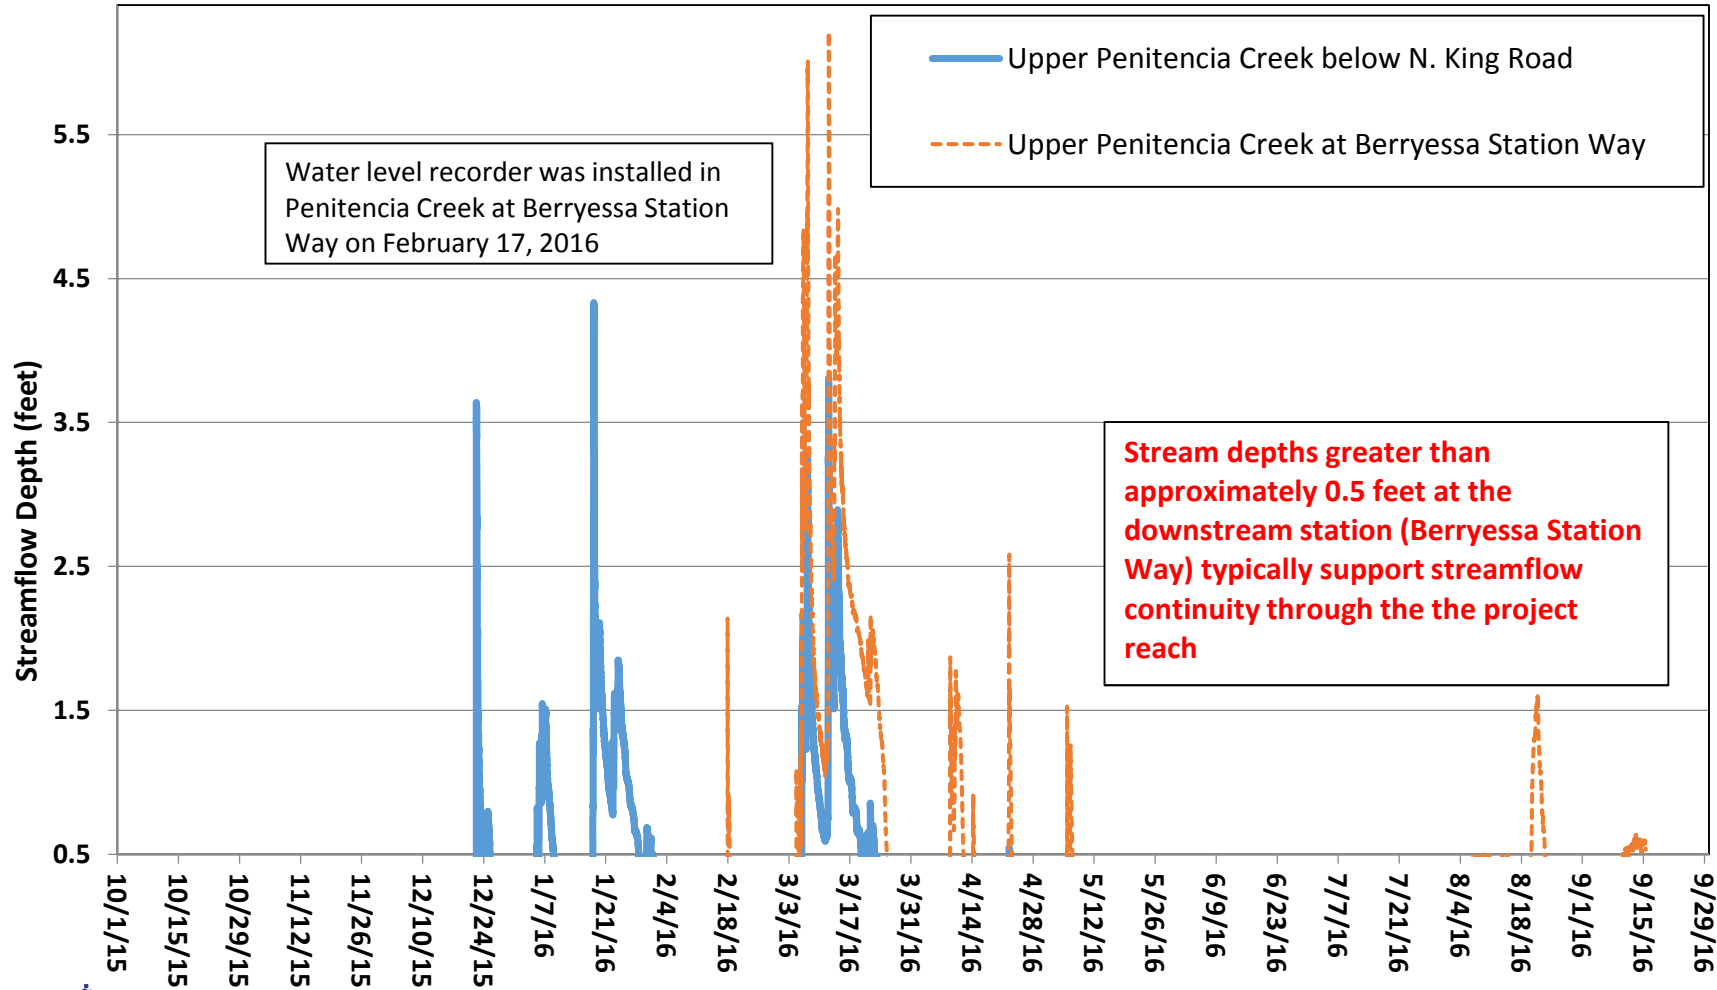
In February 2016, at the request of VTA, Balance installed a continuous water-level monitoring station near the downstream end of the project reach (downstream station) (see Figure 1) to verify that flows through the project reach were continuous. Data from this station is limited to relative stream depth and is compared to stream depths measured at the upstream station as a general tool to evaluate continuity of flow through the project reach (**Figure 5**). Because instruments were installed at the deepest pool location, active streamflow does not occur at the downstream station until recorded pool depths exceed roughly 0.5 feet.

Figure 5. Estimation of streamflow continuity through project reach using continuously measured stream depths at two stations, Penitencia Creek, San Jose, California, water year 2016.

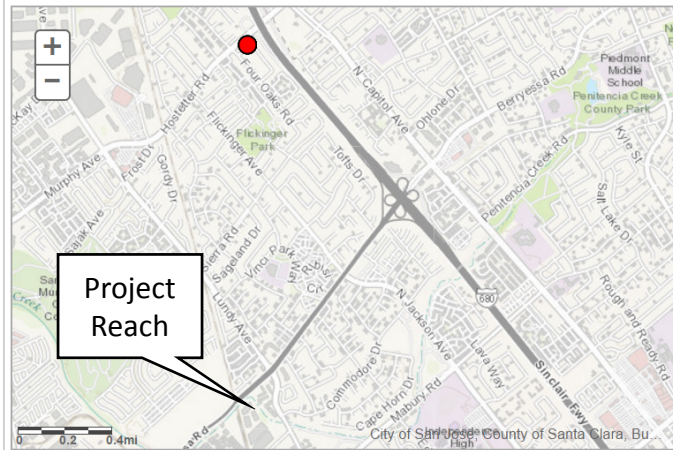
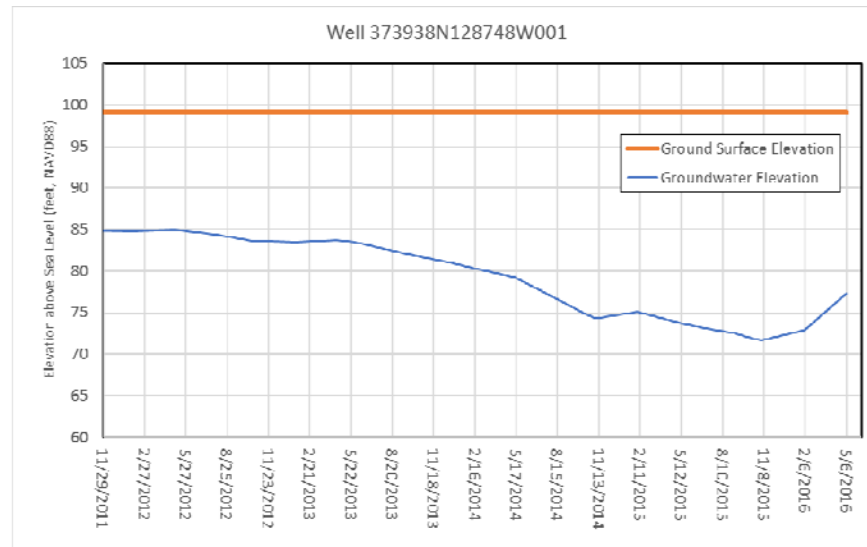
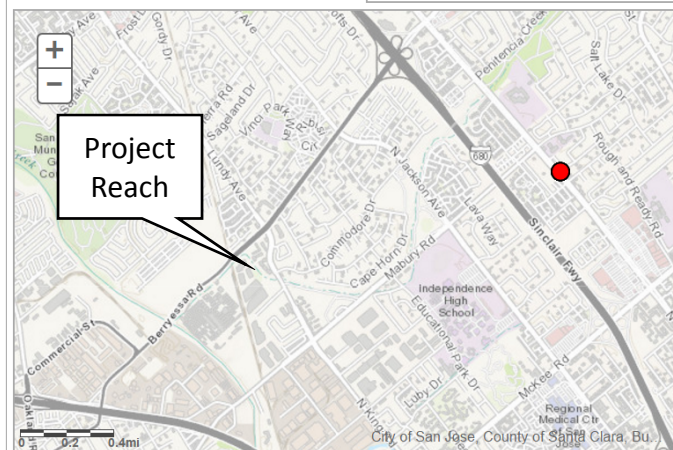
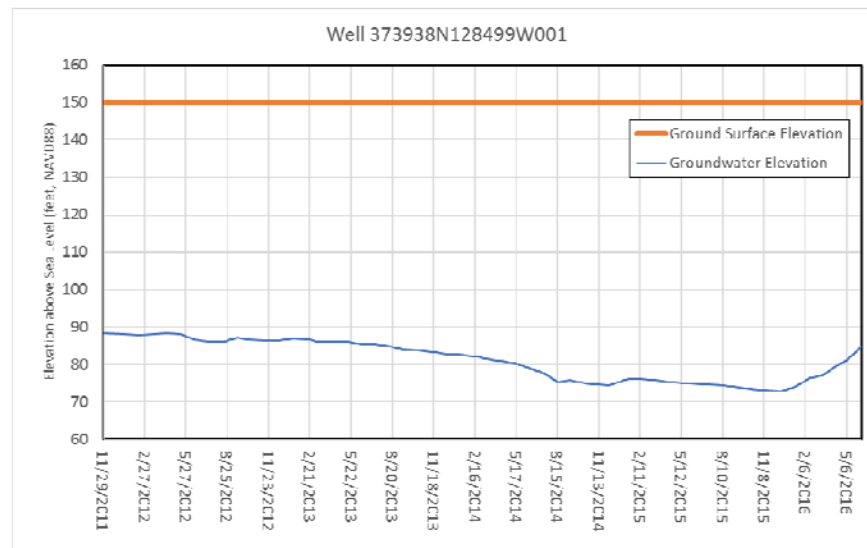
Groundwater provides a hydraulic floor that sustains perennial flow in most alluvial channels. Changes in depth to groundwater can have measurable effects on streamflow magnitude, duration, and continuity. The California Department of Water Resources (2016) monitors groundwater levels for at least 2 wells within 1.5 miles of the project reach (Well #373938N1218748W001 and Well #373772N1218499W001). These data indicate that while groundwater levels did increase in WY2016 in response to an average rainfall year, groundwater levels continue to be below those measured in 2011 and 2012 by as much as 3.6 to 7.6 feet (**Figure 6**). A falling groundwater table can be the result of drought (absence of groundwater recharge), groundwater pumping or both. The Santa Clara Valley Water District operates several groundwater recharge ponds around the San Jose area to minimize rapid declines in groundwater and associated subsidence. Two such recharge ponds (Bob Gross Recharge Ponds) are located adjacent to Upper Penitencia Creek and upstream of the project reach. These ponds were off-line in WY2014, WY2015 (Sparkman, J., pers. comm., 2015), and presumably in WY2016, due to the absence of adequate streamflow for diversion to the ponds. In the absence of groundwater recharge and with the continued pumping of groundwater, the rate of groundwater decline is likely exacerbated.

**Figure 6. Groundwater conditions near Upper Penitencia Creek, San Jose, California**  
 After consecutive years of a falling groundwater table, normal precipitation has increased the groundwater table slightly; however groundwater elevations remain below 2011-2012 levels.

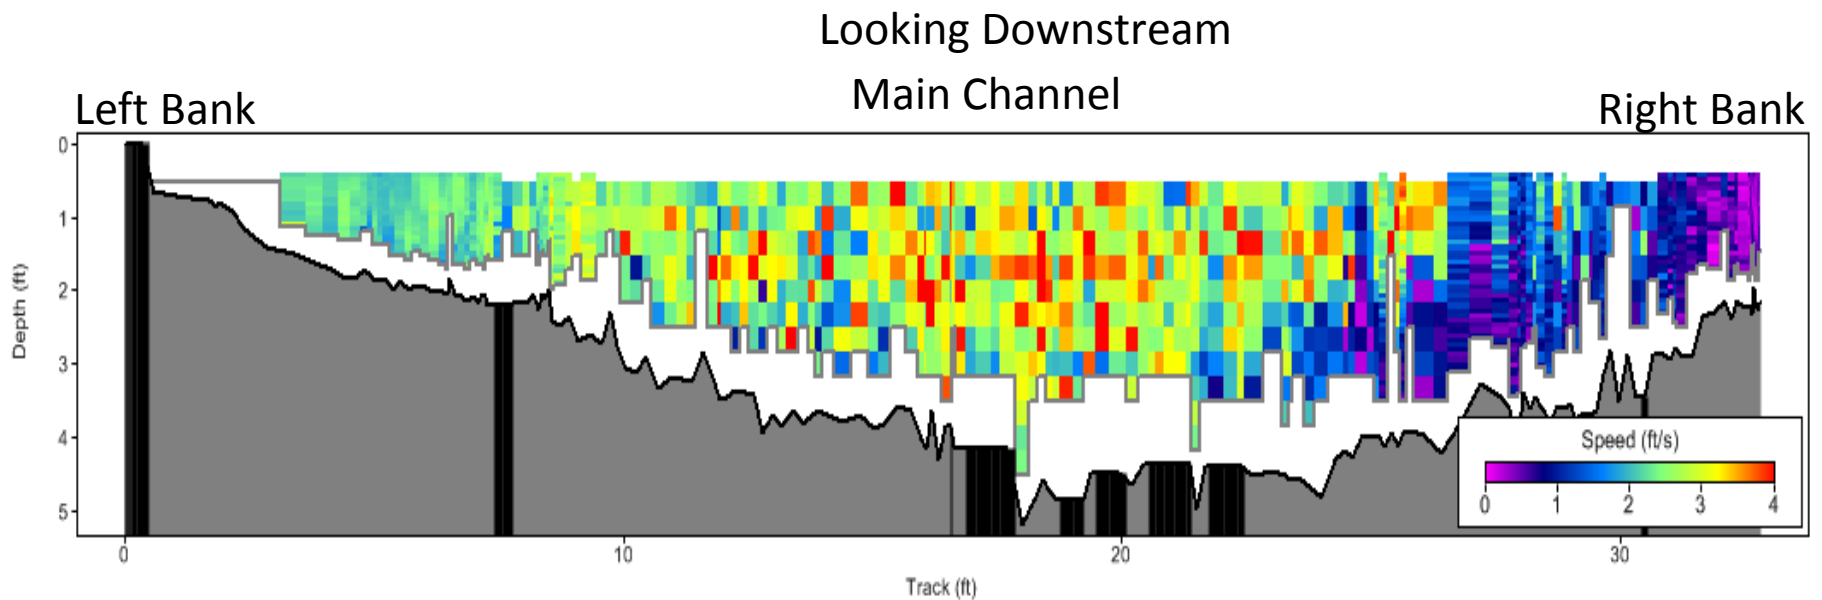
In spite of intermittent streamflow conditions, we measured periods when streamflow was continuous through the project reach and likely passable by salmonids. In Year 4, one habitat velocity compound-transect was recorded at the established cross-section (station 4+00) using an Acoustic Doppler Current Profiler (ADCP). Habitat depth and streamflow velocities were measured continuously across the section when streamflow was approximately 143 cfs and on the falling limb of the January 18, 2016 peak flow event (**Figure 7**). The active channel conveyed most of the flow while the secondary high-flow channel and floodplain were observed to be ponded or slightly backwatered. At a streamflow that was less than the designed bankfull discharge, 143 cfs still generated stream depths between 1.0 ft and 5.0 ft at station 4+00, with streamflow velocities between zero and 4.0 feet per second (ft/s). At this cross-section, flow

**Figure 7. Habitat depth and velocity cross-section for 143 cfs, Upper Penitencia Creek, San Jose, California.** Data were recorded with a Acoustic Doppler Current Profiler (ADCP). Depths between less than 1.0 ft and 5.0 ft were measured across the channel with a range of velocities between near zero feet per second (ft/s) and 4.0 ft/s. Under this streamflow, only the main channel was active (shown), while the secondary, high-flow channel and floodplain were ponded.

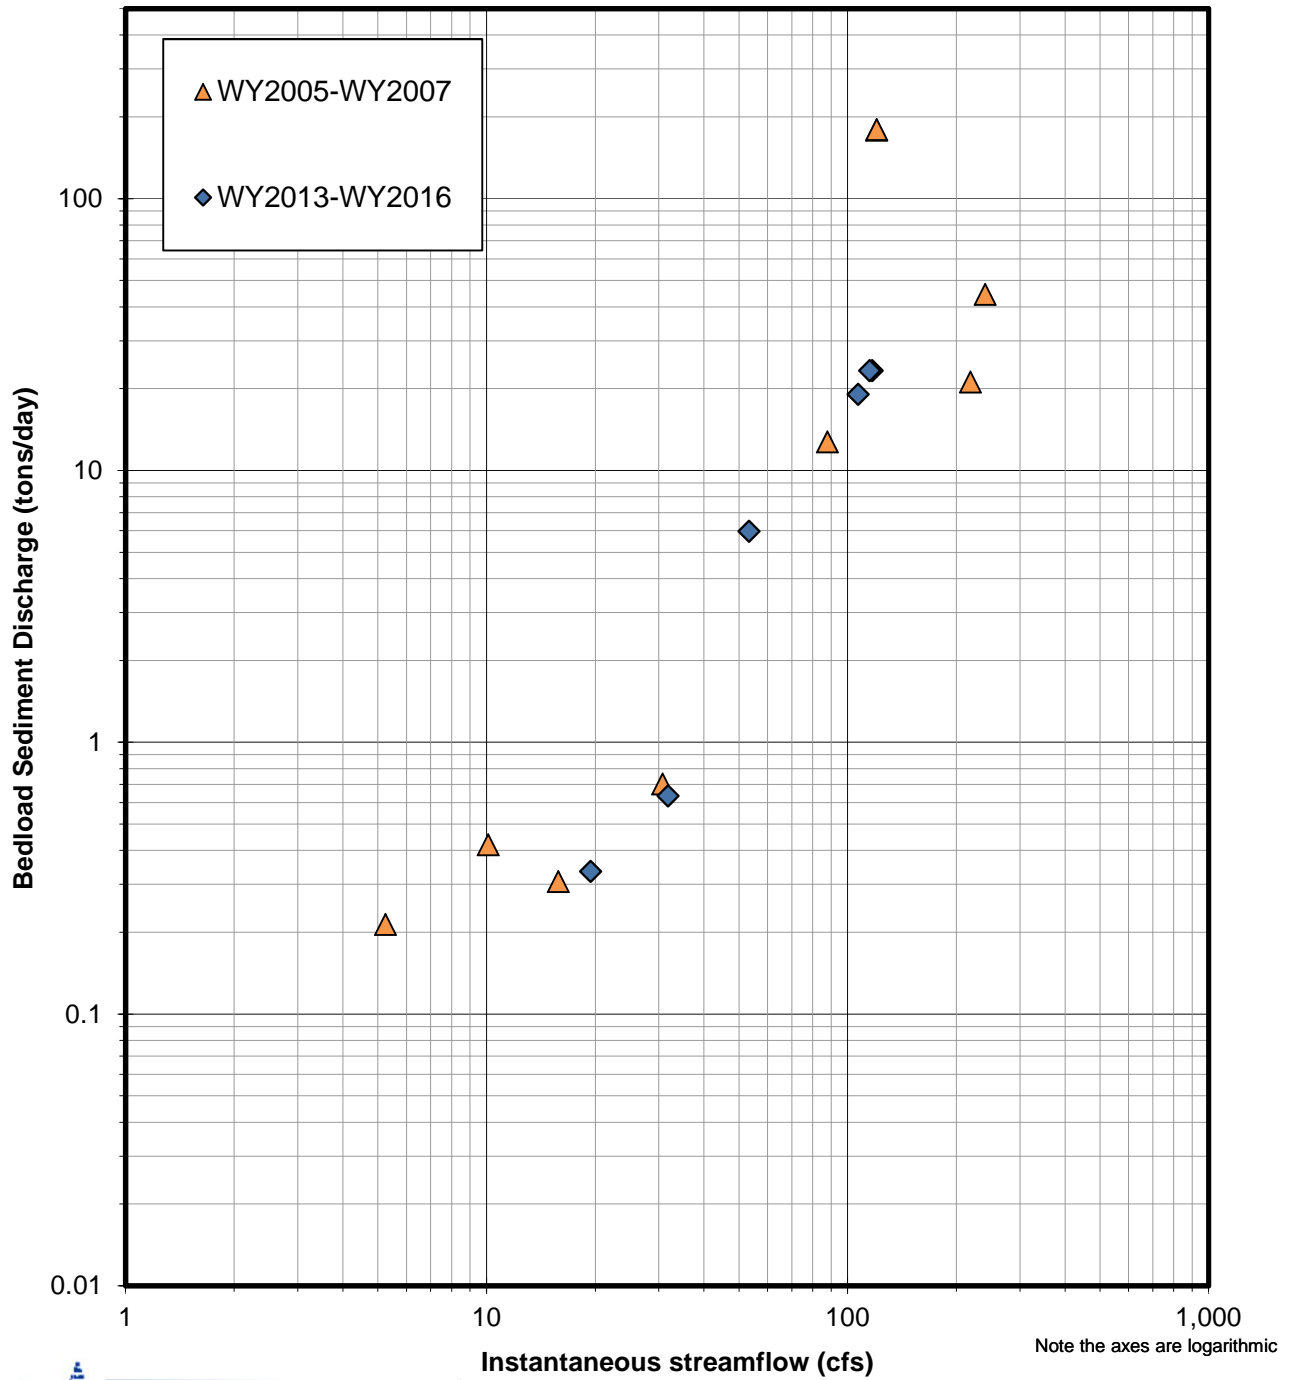
Bedload sediment transport was measured on several occasions in Year 4 and across a range of streamflows. Last year's measurements along with the historical bedload transport observations (WY2005-WY2007, Baggett and others, 2009) suggest that transport behavior through the project reach is similar to pre-project conditions (**Figure 8**). This is encouraging and implies that the design process was adequate from a transport perspective.

**Figure 8. Relationship between streamflow and bedload sediment discharge, Penitencia Creek near North King Road, San Jose, California, pre-project (WY2005-WY2007) and post-project (WY2013-WY2016)**

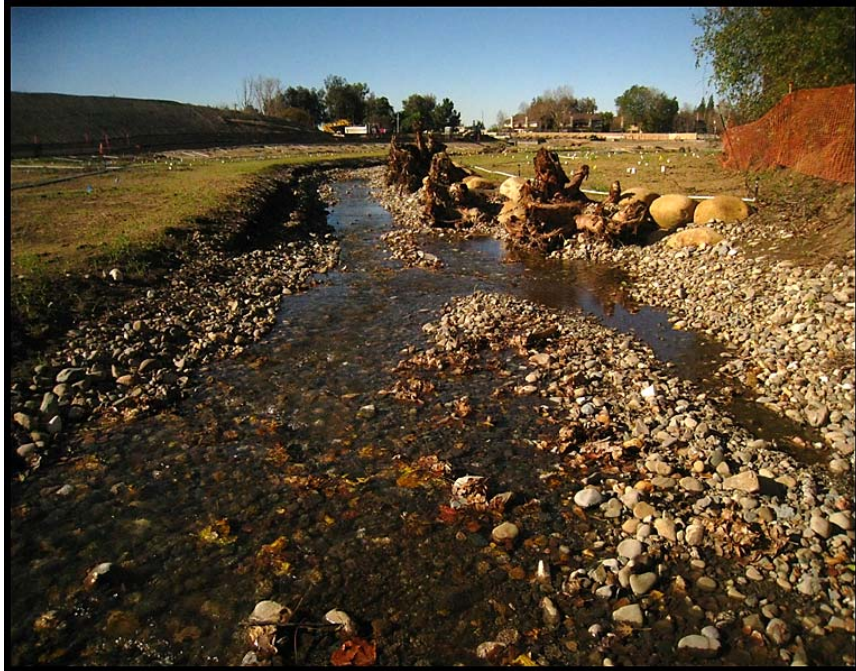
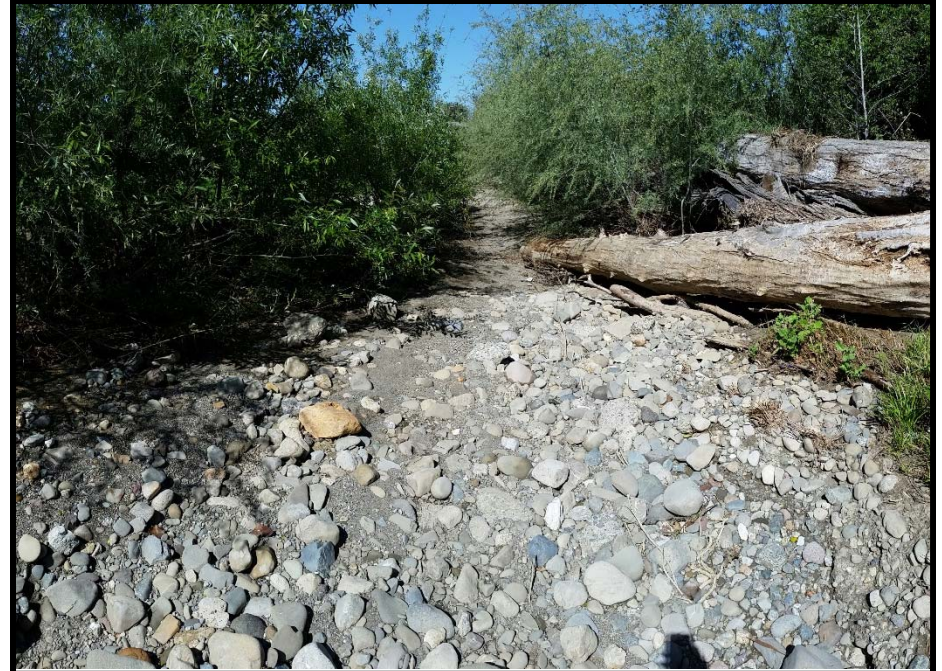
Photo Point #1: Station 10+75, December 2012 Year 1.

Photo Point #1: Station 10+75, March 2016, Year 4.

**Appendix B1. View downstream, entrance to project reach, Station 10+75, Upper Penitencia Creek, San Jose, California.** Riparian vegetation continues to mature and establish the banks. Two large cottonwood trees fell into the channel in Year 4, constricting the channel slightly at this station.

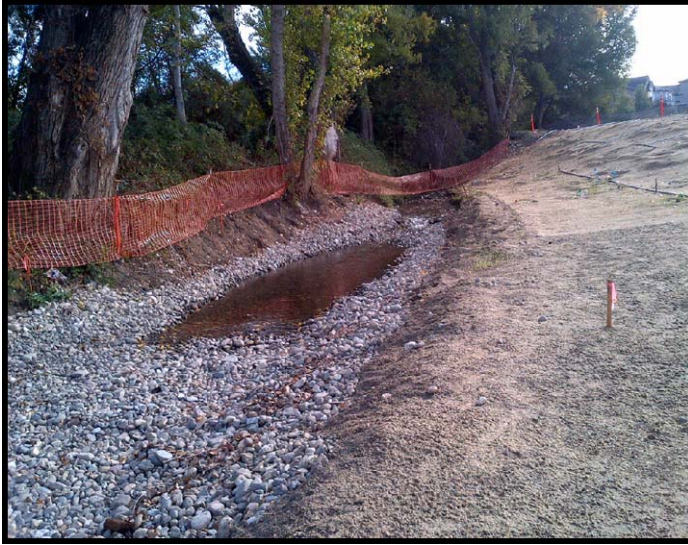
Photo Point #2: Station 10+00, December 2012 Year 1.

**Appendix B2. View upstream, entrance to project reach, Station 10+00, Upper Penitencia Creek, San Jose, California.** Riparian vegetation continues to mature and establish the banks. A large cottonwood tree fell into the channel in Year 4, creating the potential for an instream wood jam to occur in the future.

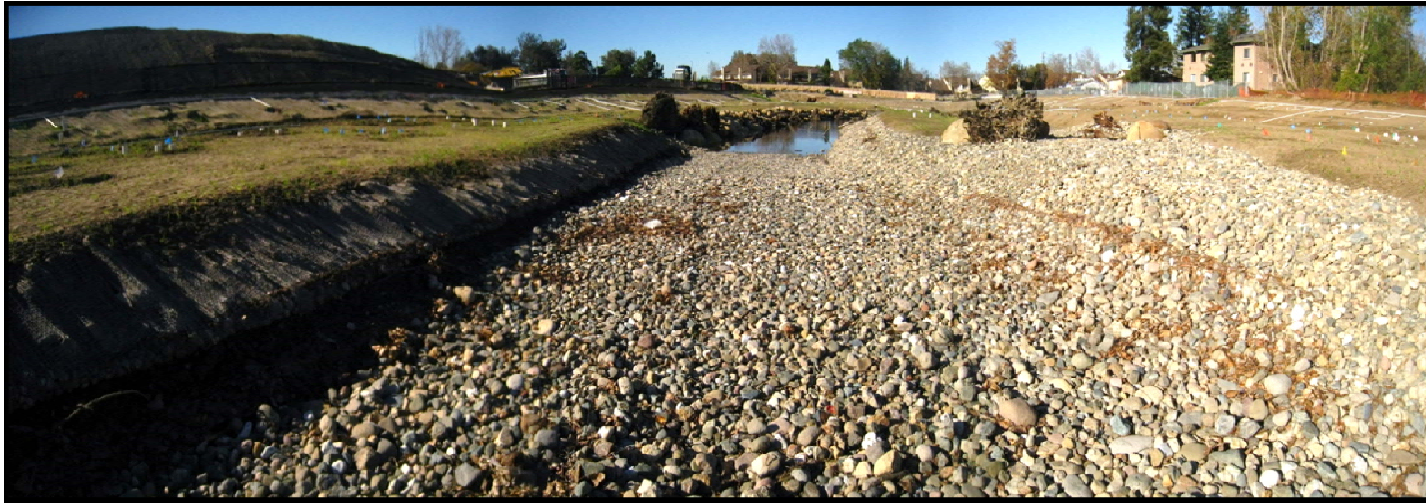
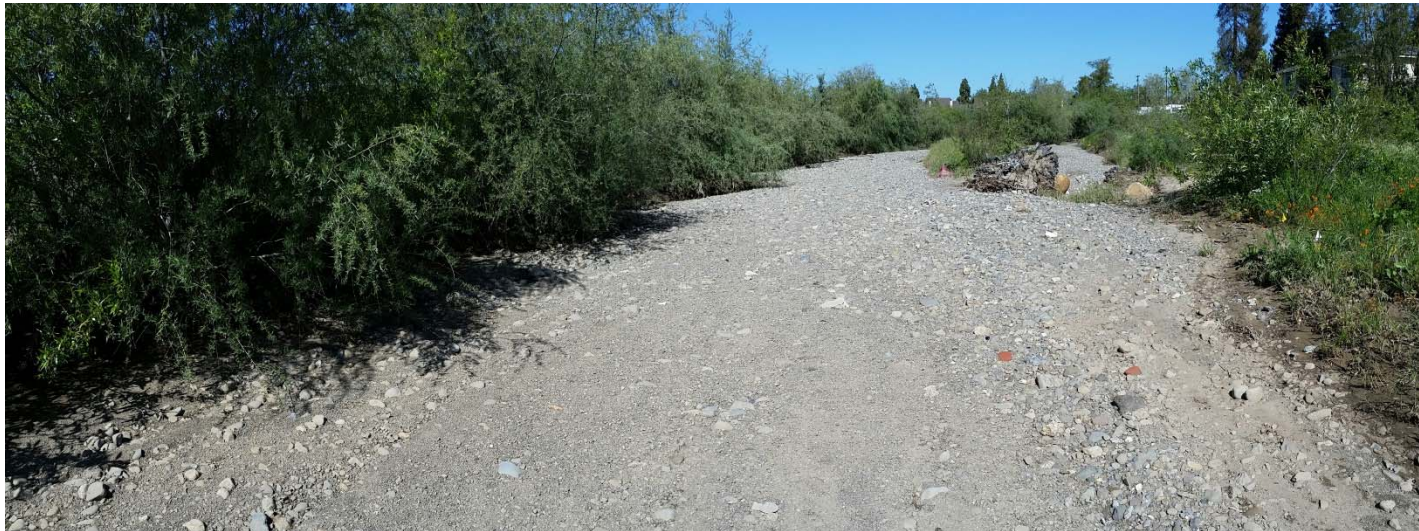
**Photo Point #3: Station 8+75, December 2012 Year 1.**

**Photo Point #3: Station 8+75, March 2016, Year 4.**

**Appendix B3. View downstream, entrance to upper high-flow channel, Station 8+75, Upper Penitencia Creek, San Jose, California.** After measurable precipitation and runoff in WY2016, the channel has exhibited a flux of sediment movement and aggradation typical of channels on alluvial fans.

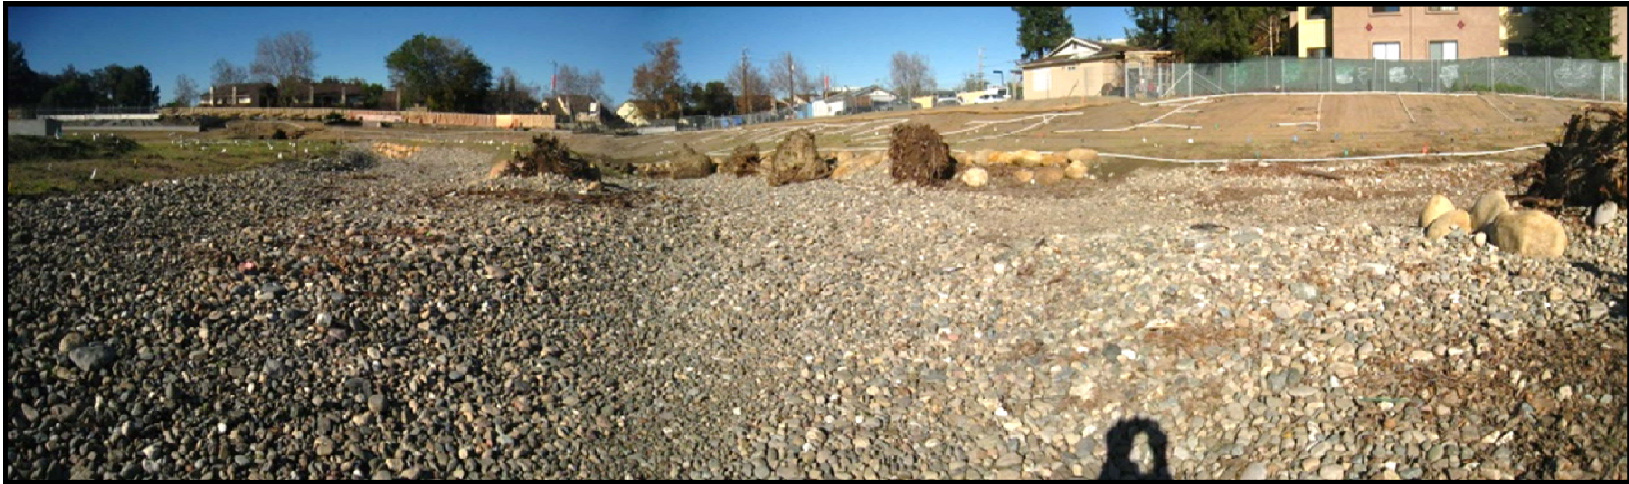
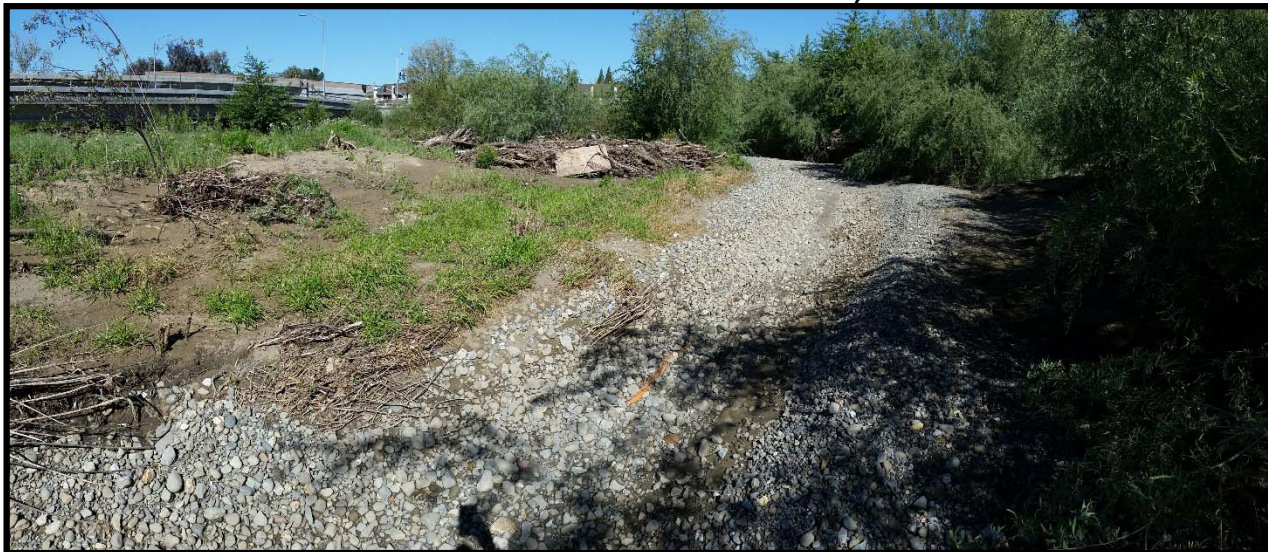
**Photo Point #4: Station 5+75, December 2012 Year 1.**

**Photo Point #4: Station 5+75, March 2016, Year 4.**

**Appendix B4. View downstream, entrance to lower high-flow channel, Station 5+75, Upper Penitencia Creek, San Jose, California.** Recent runoff events have supplied instream wood to the high flow channels and floodplain

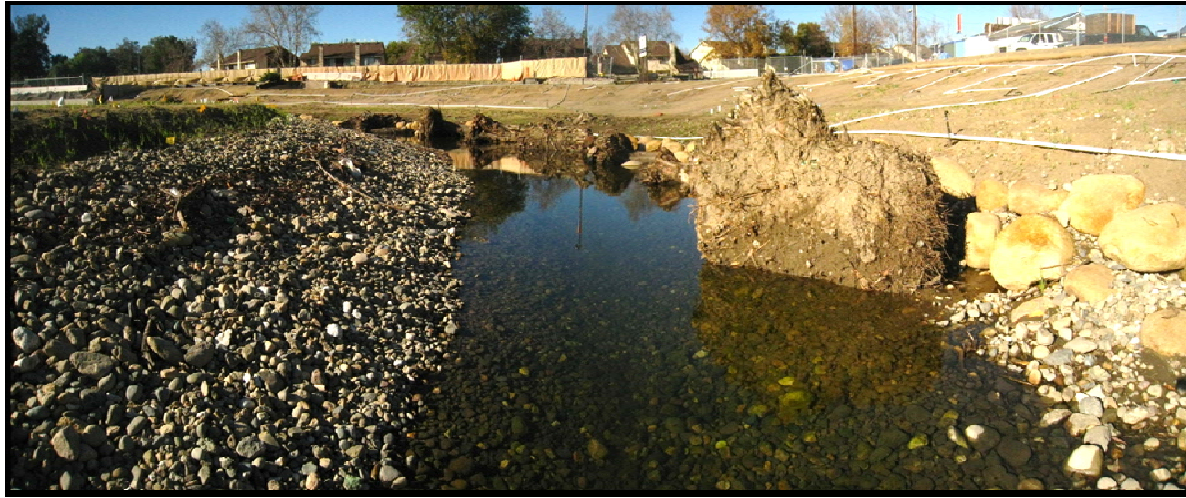
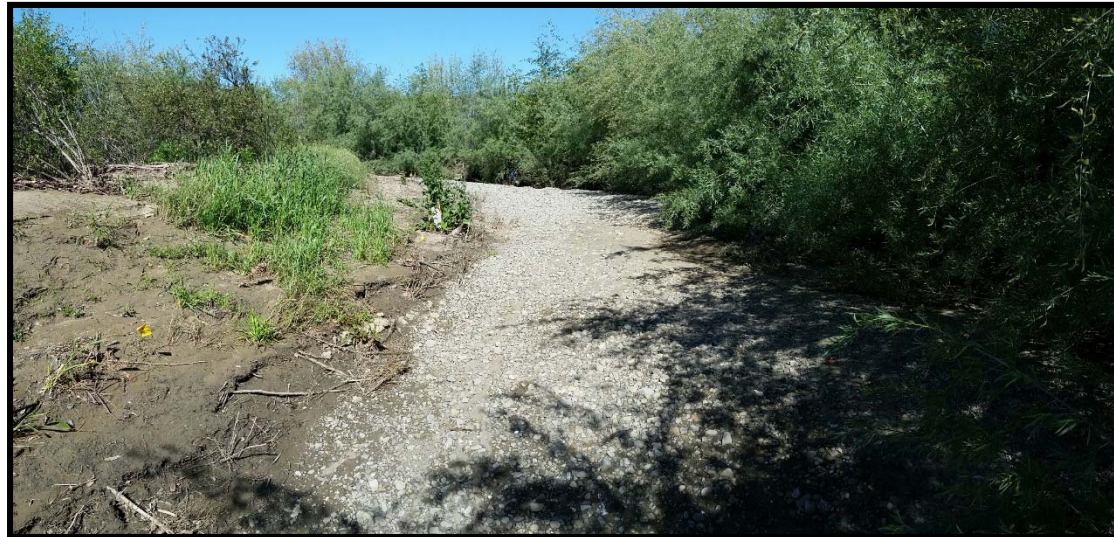
**Photo Point #7: Station 5+00, December 2012 Year 1.**

**Photo Point #7: Station 5+00, March 2016, Year 4.**

**Appendix B7. View downstream, 90-degree bend, Station 5+00, Upper Penitencia Creek, San Jose, California.** Riparian continues to mature and shade pool habitat at rootwads; bar development continues to evolve.

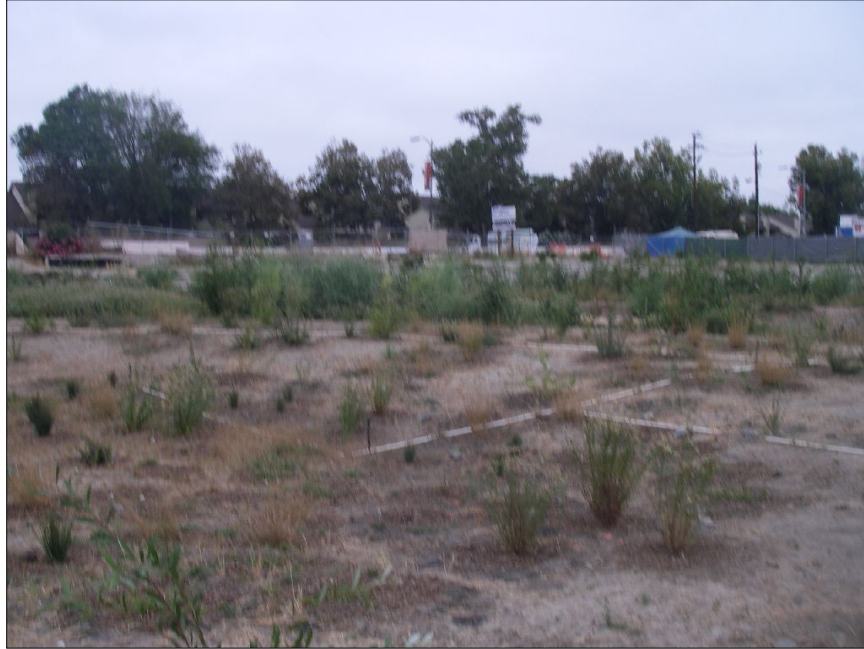
**Photo 7. Photodocumentation Point 7C, looking north at the Floodplain Planting Zone in the northwestern portion of the mitigation site (August 28, 2013)**

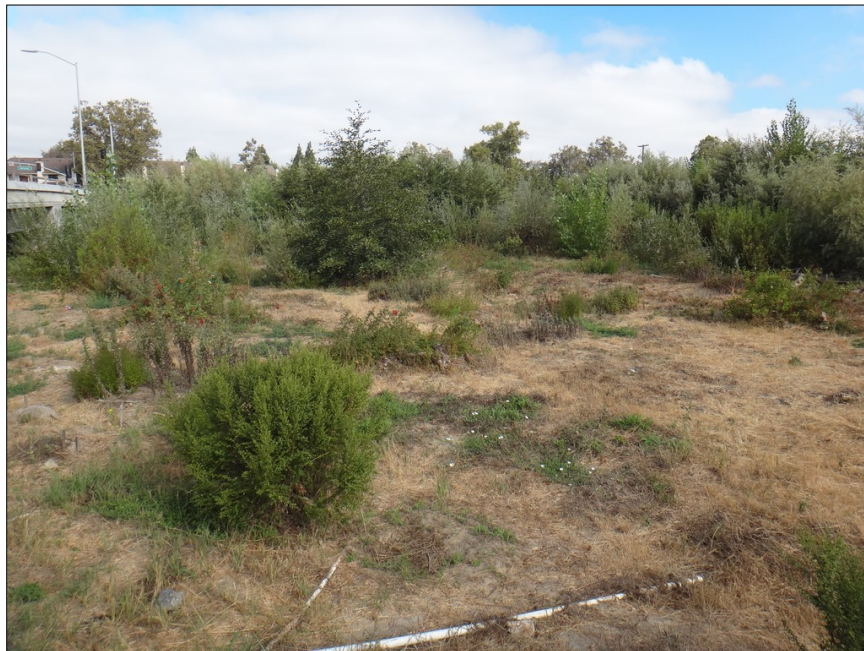
**Photo 8. Photodocumentation Point 7C, looking north at the Floodplain Planting Zone in the northwestern portion of the mitigation site (September 1, 2016)**

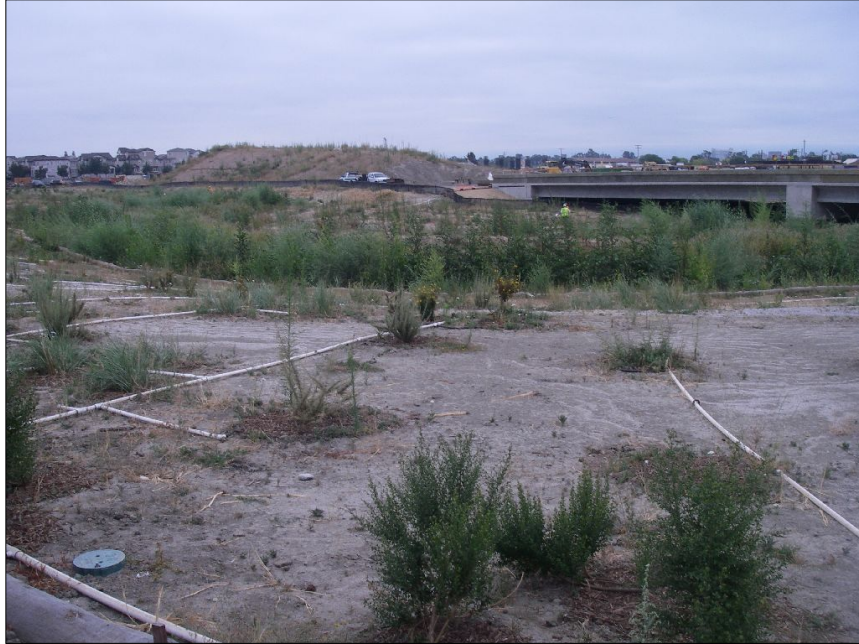
**Photo 9. Photodocumentation Point 13B looking south across the Upper Slope Planting Zone to the Floodplain Planting Zone (August 28, 2013)**

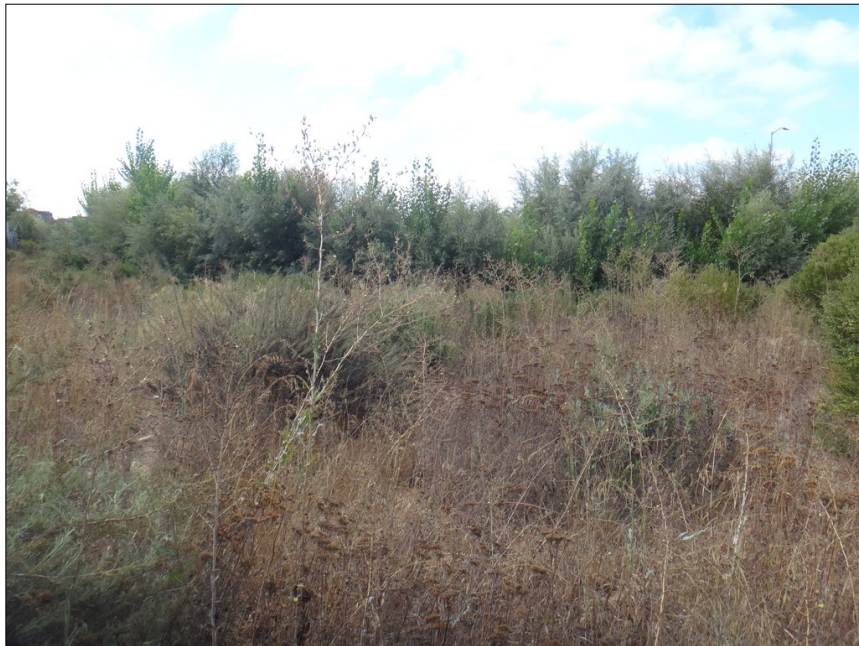
**Photo 10. Photodocumentation Point 13B looking south across the Upper Slope Planting Zone to the Floodplain Planting Zone (September 1, 2016)**

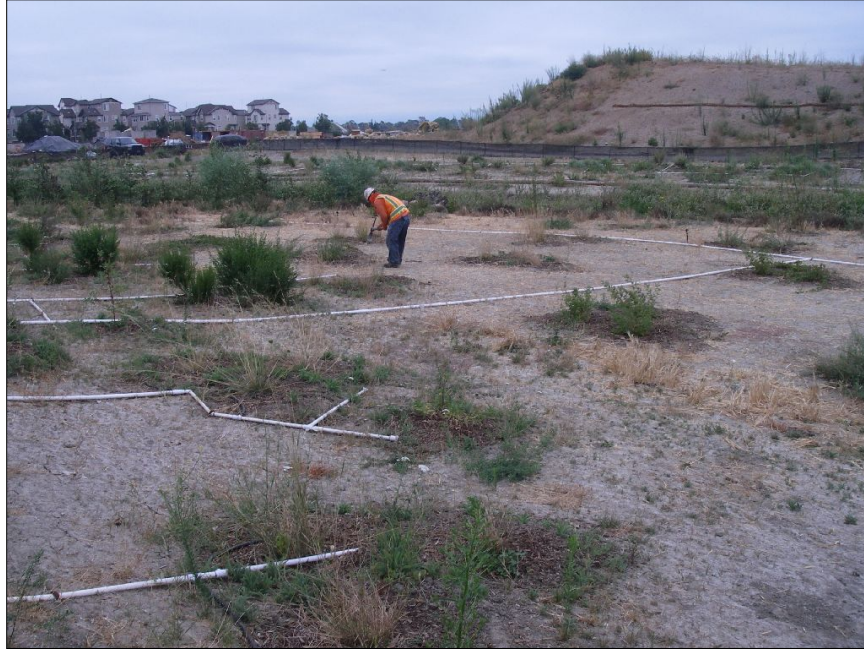
**Photo 11. Photodocumentation Point 18B, looking south at the Floodplain Planting Zone (August 28, 2013)**

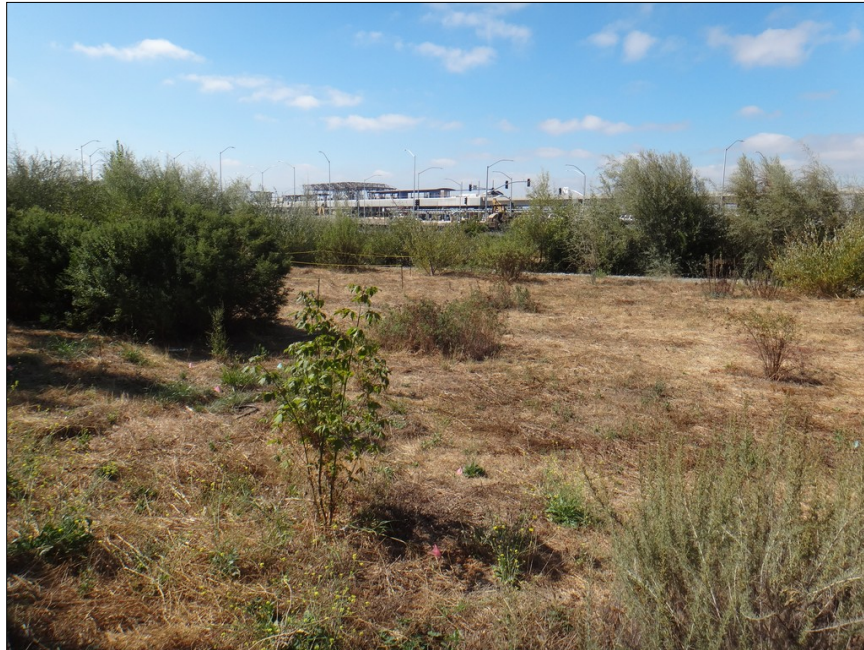
**Photo 12. Photodocumentation Point 18B, looking south at the Floodplain Planting Zone (September 1, 2016)**
