ALUM ROCK FISH PASSAGE PROJECT MITIGATION MONITORING REPORT YEAR FOUR, 2016

Santa Clara Valley Transportation Authority
3331 North First Street, Bldg. B-2
San Jose, CA 95143-1906
Contact: Ann Calnan
408.321.5976

ICF
75 E. Santa Clara Street, Suite 300
San Jose, CA 95113
Contact: Donna Maniscalco
408.216.2802

April 2017

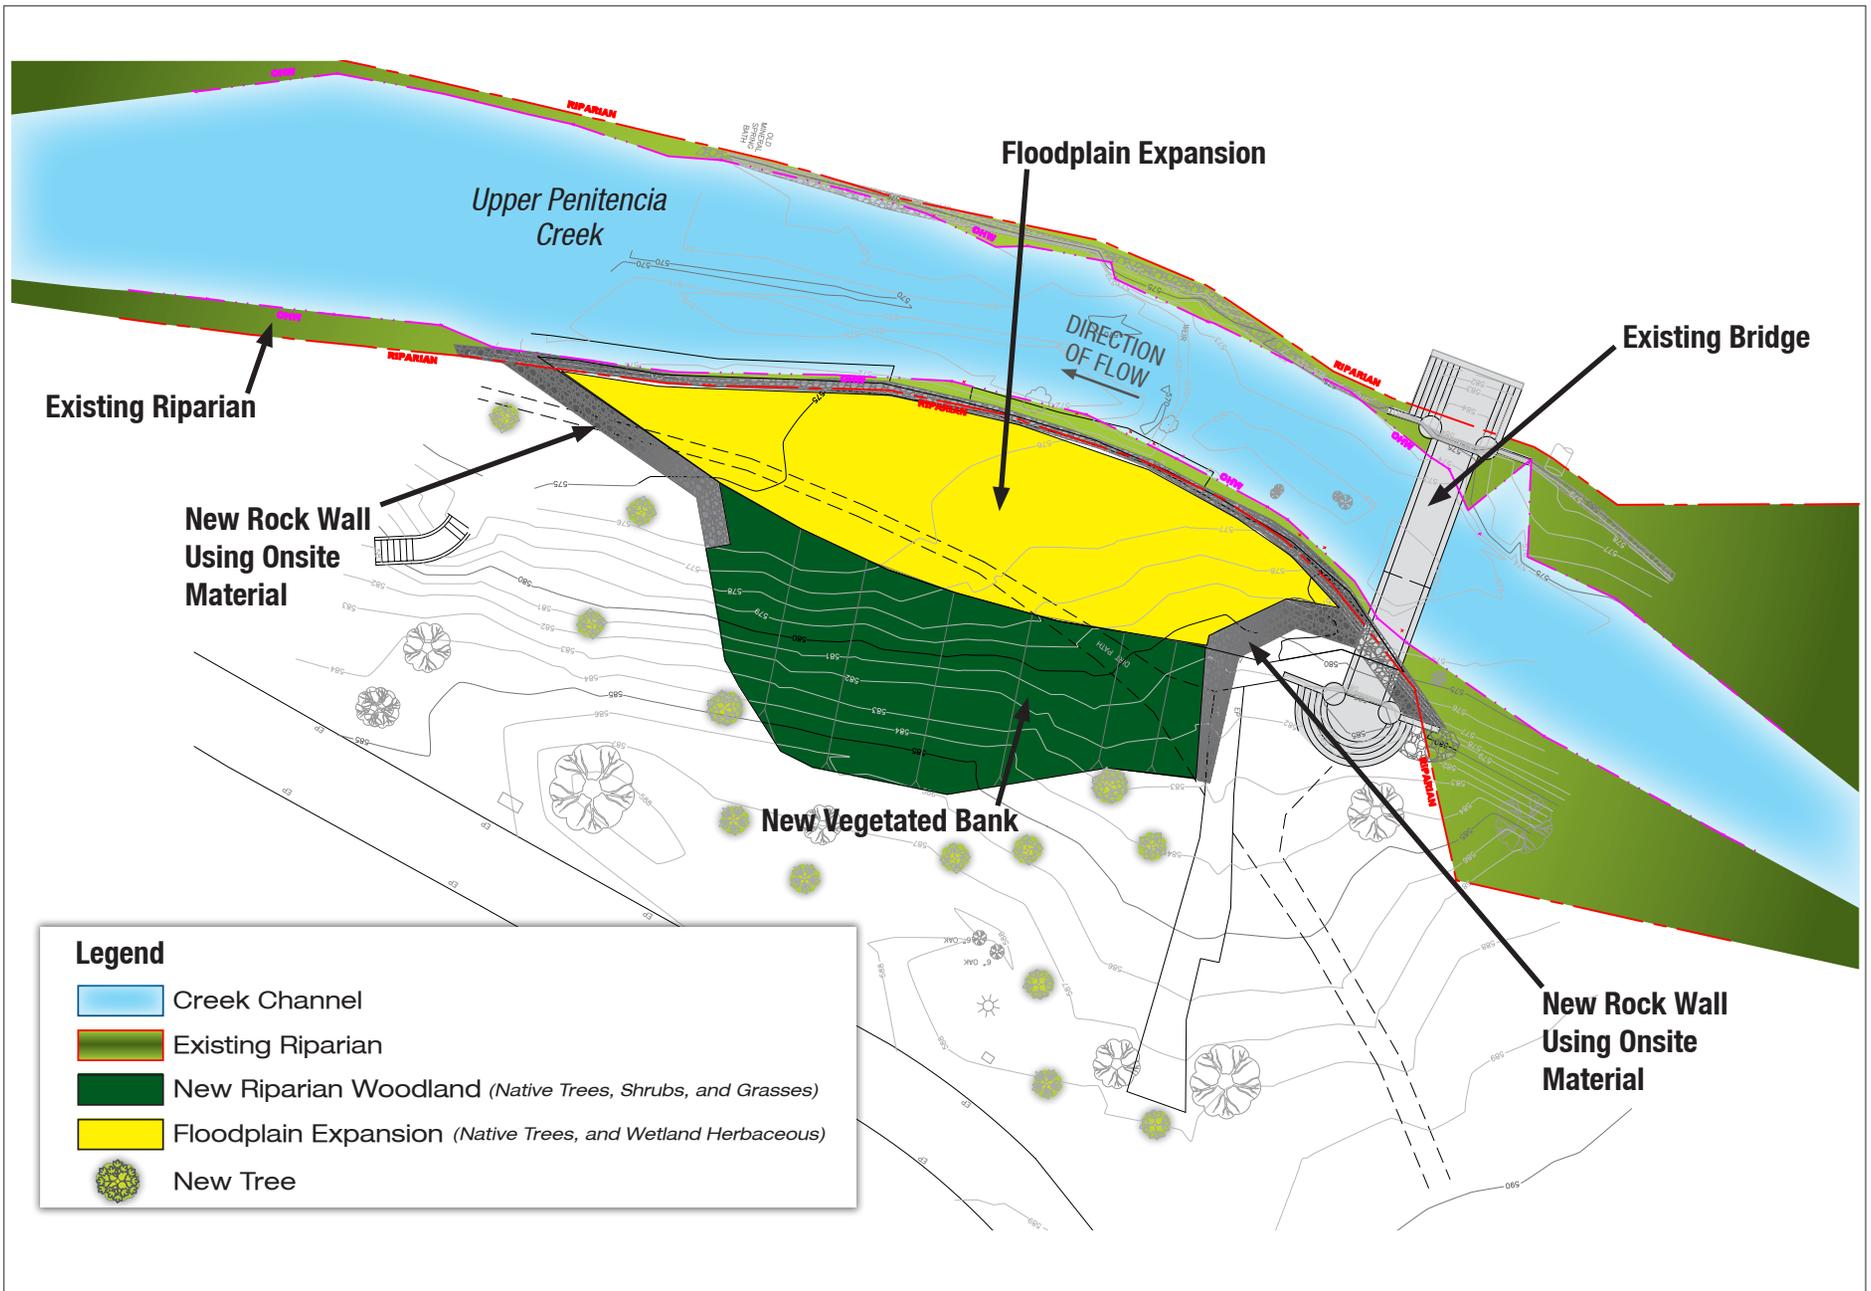
Figure 2
Site 10 Floodplain Restoration
Alum Rock Park Bank Repair and Stream Restoration Project
Santa Clara Valley Transportation Authority

The quantitative surveys of the floodplain (Site 10) were a challenge this year due to the vigorous willow and alder growth. This proved to be a major obstacle in surveying XS 101 – only the upstream portion of the survey could be completed in a timely manner. The ability to capture accurate survey data in a cost-effective manner is diminishing each year. As such, it is recommended that starting next year (2018), there is a shift to qualitative descriptions, sediment plate measurements, and photo points to assess the condition of the floodplain, and eliminate the total station surveys. There is an established baseline survey dataset that can be re-occupied, should issues arise with the site that would require measurements along the profiles.

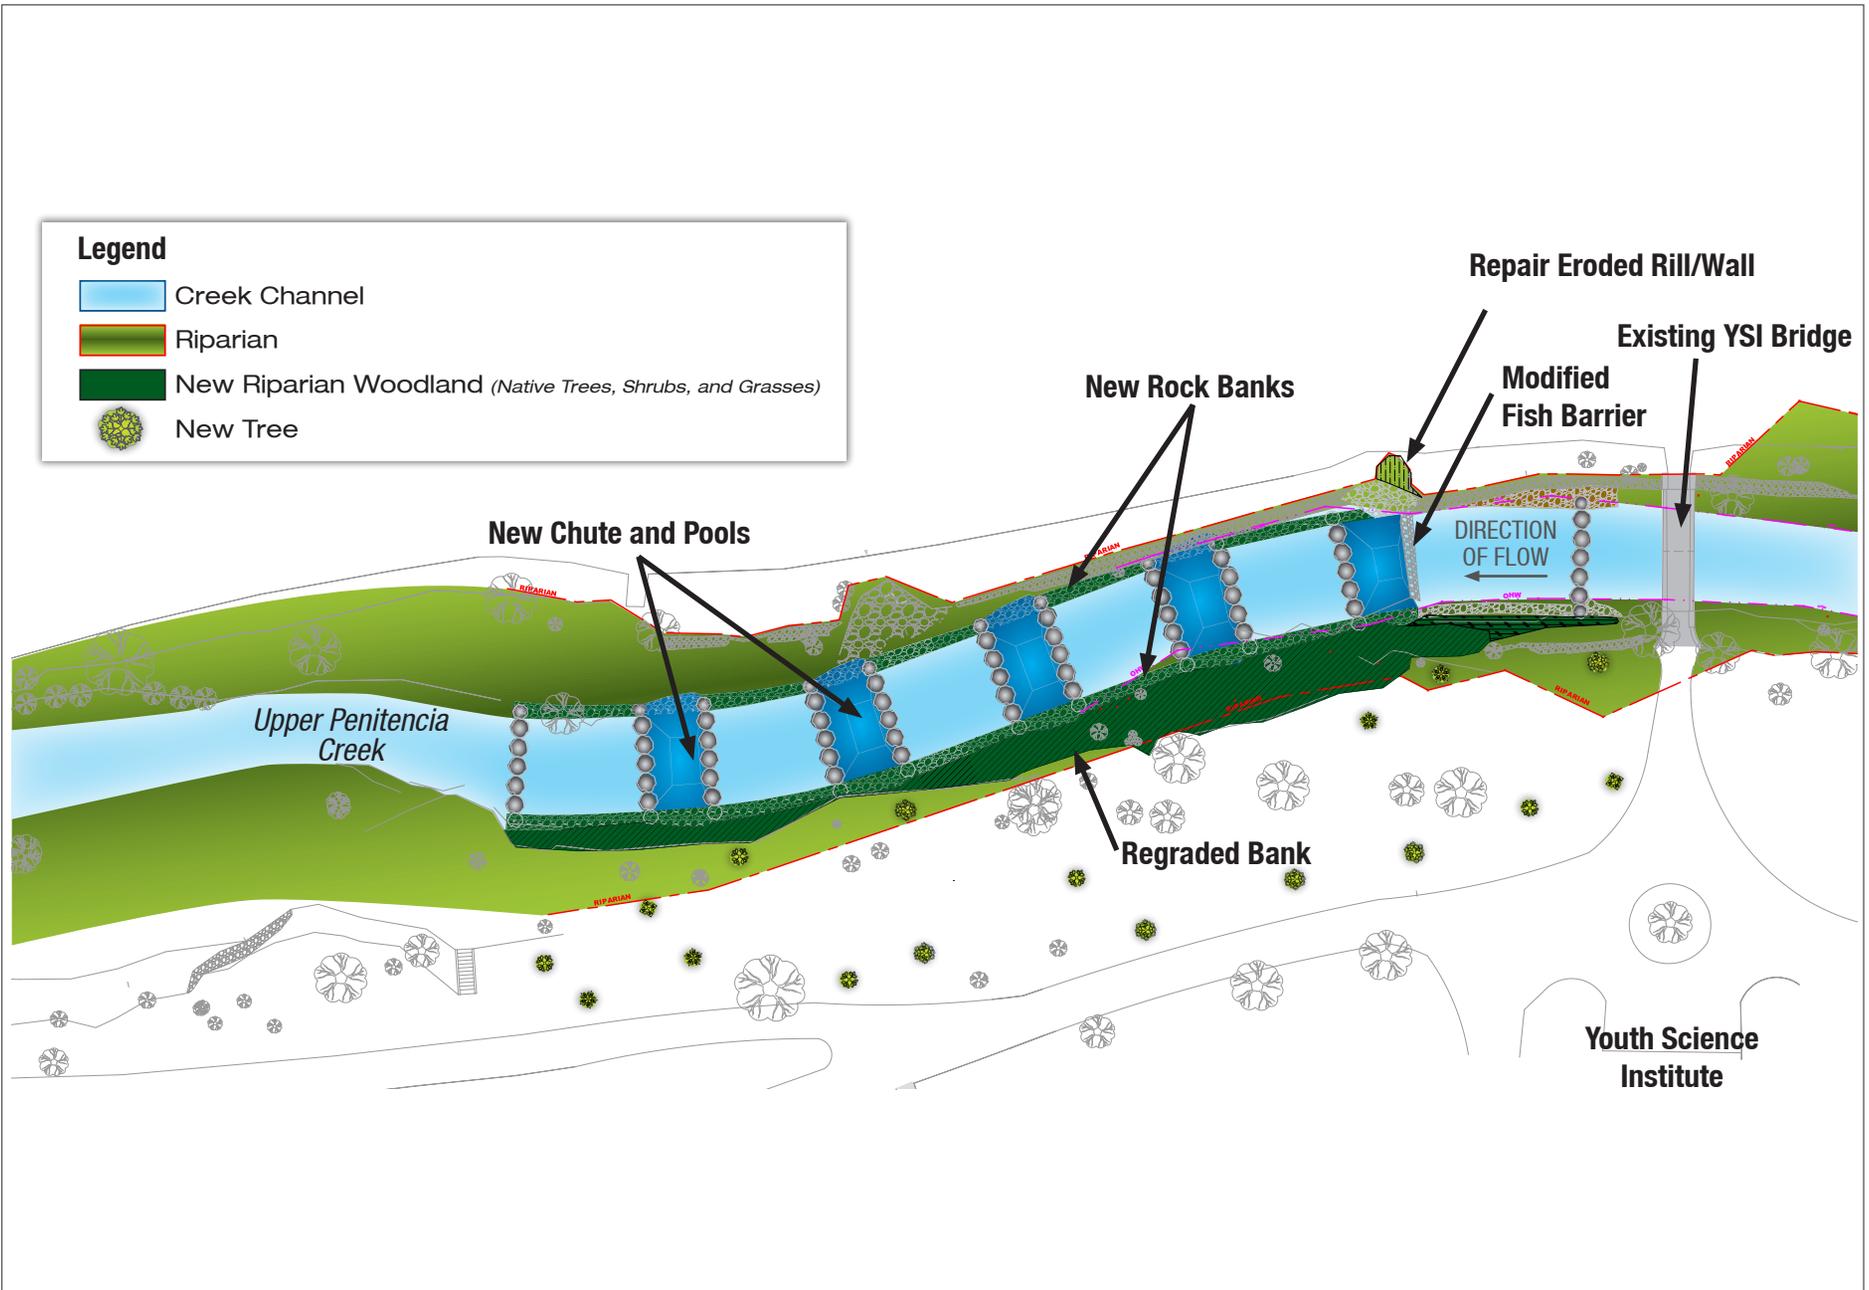
Figure 3
Site 13 Fish Passage Improvement Restoration
Alum Rock Park Bank Repair and Stream Restoration Project
Santa Clara Valley Transportation Authority

Visual inspections and photo point comparisons from Year 1 to Year 4 of Project Site 13 show that despite the increased volume of flow passing through the project site in WY2016, the fish passage seems to be functioning as intended and the rock band structures and pools were in good condition. This year some larger rocks (~2 feet in diameter) moved slightly, and there was continued reworking of finer bed sediment, but in general these changes were localized and did not appear to be degrading the constructed elements. Like last year, some mobilization of the bed and reworking of gravel to cobble-size sediments was also observed. These reworked sediments provide an additional increase in habitat complexity and are not expected to interfere with the structural integrity of the channel. Vegetation that had largely been scoured out at the time of last year's survey (WY2015) has grown back vigorously, and the site remains largely free of thick algal mats.

The flows of WY2016 continued to move large wood in the channel. A large log that shifted a few feet up the bank in WY2015 has now accumulated several more pieces of small to large-sized wood, and a similar debris pile has formed on the right bank, potentially improving habitat structure and function. Additionally there is a sizeable log on the south bank, downstream of the YSI Bridge, which was transported during one of the season's more significant flows.

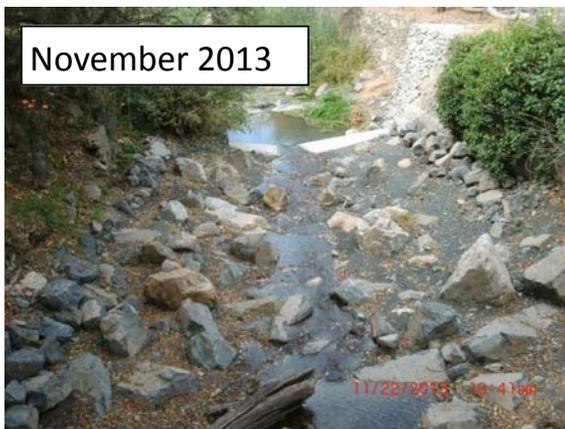
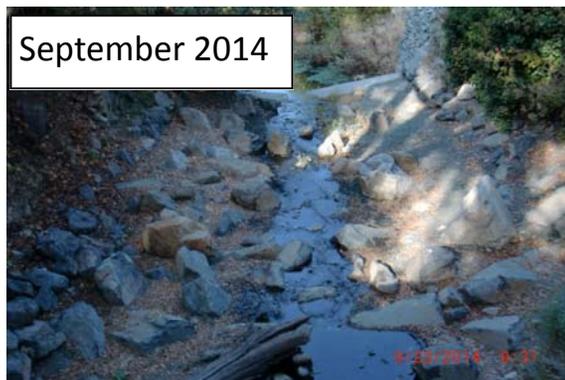
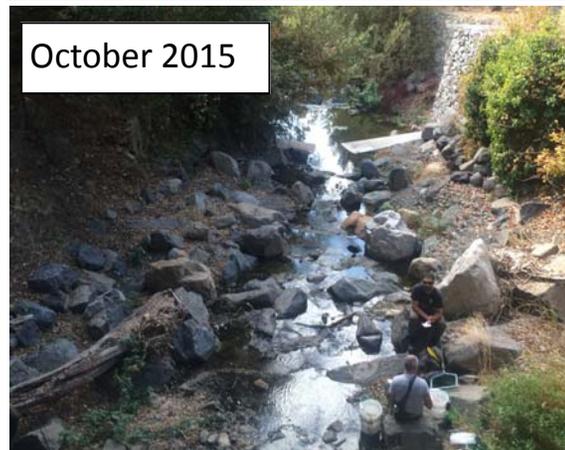
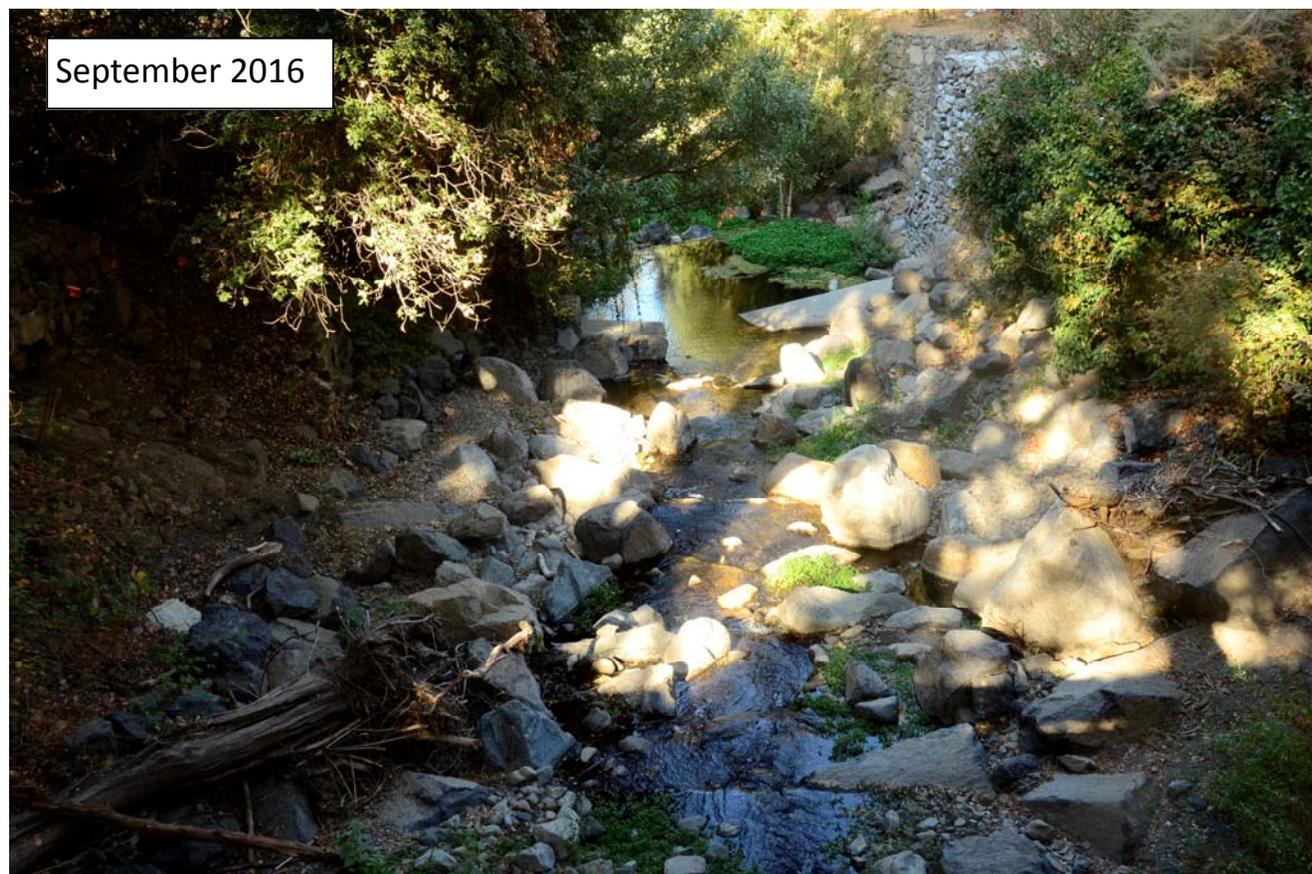
Figure 7. Photo point 1, Site 13, Years 0-3. Alum Rock Monitoring, Upper Penitencia Creek, Santa Clara County, California . Photo point 1 photographs taken from pedestrian bridge, looking downstream at the first rock band structure and chute of the fish passage project. Refer to Figure 1 of this report for photo point locations.

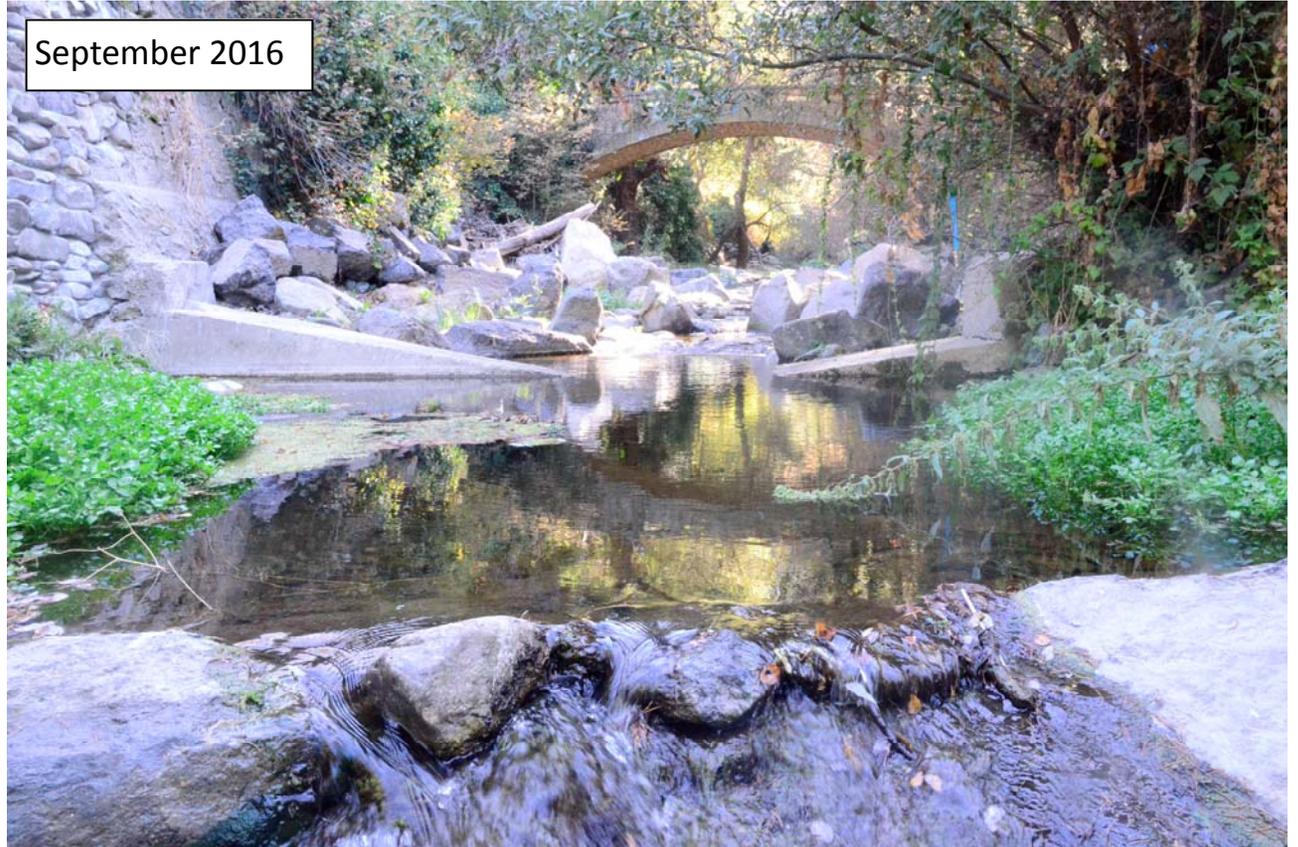
Figure 9.

Photo point 3, Site 13, Years 0-3. Alum Rock Monitoring, Upper Penitencia Creek, Santa Clara County, California . Photo point 3 photographs looking upstream across pool 1 at the modified concrete grade control structure and pedestrian bridge in the fish passage project. Refer to Figure 1 of this report for photo point locations.

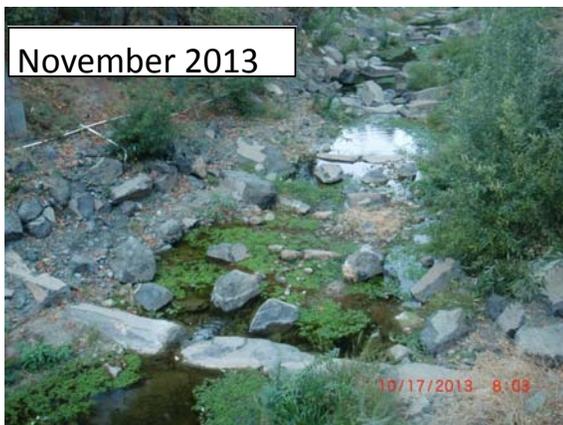
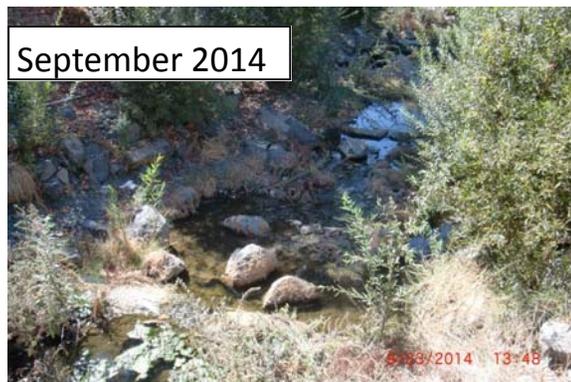
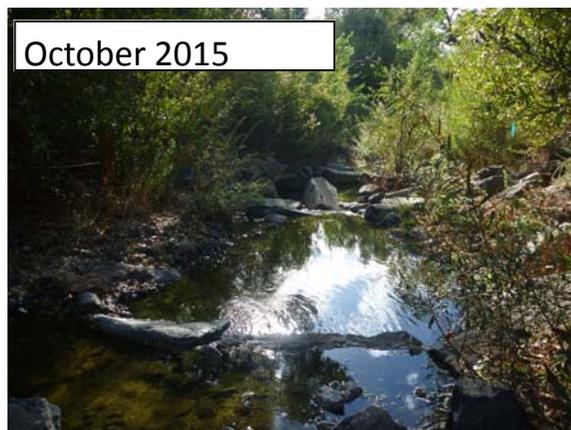
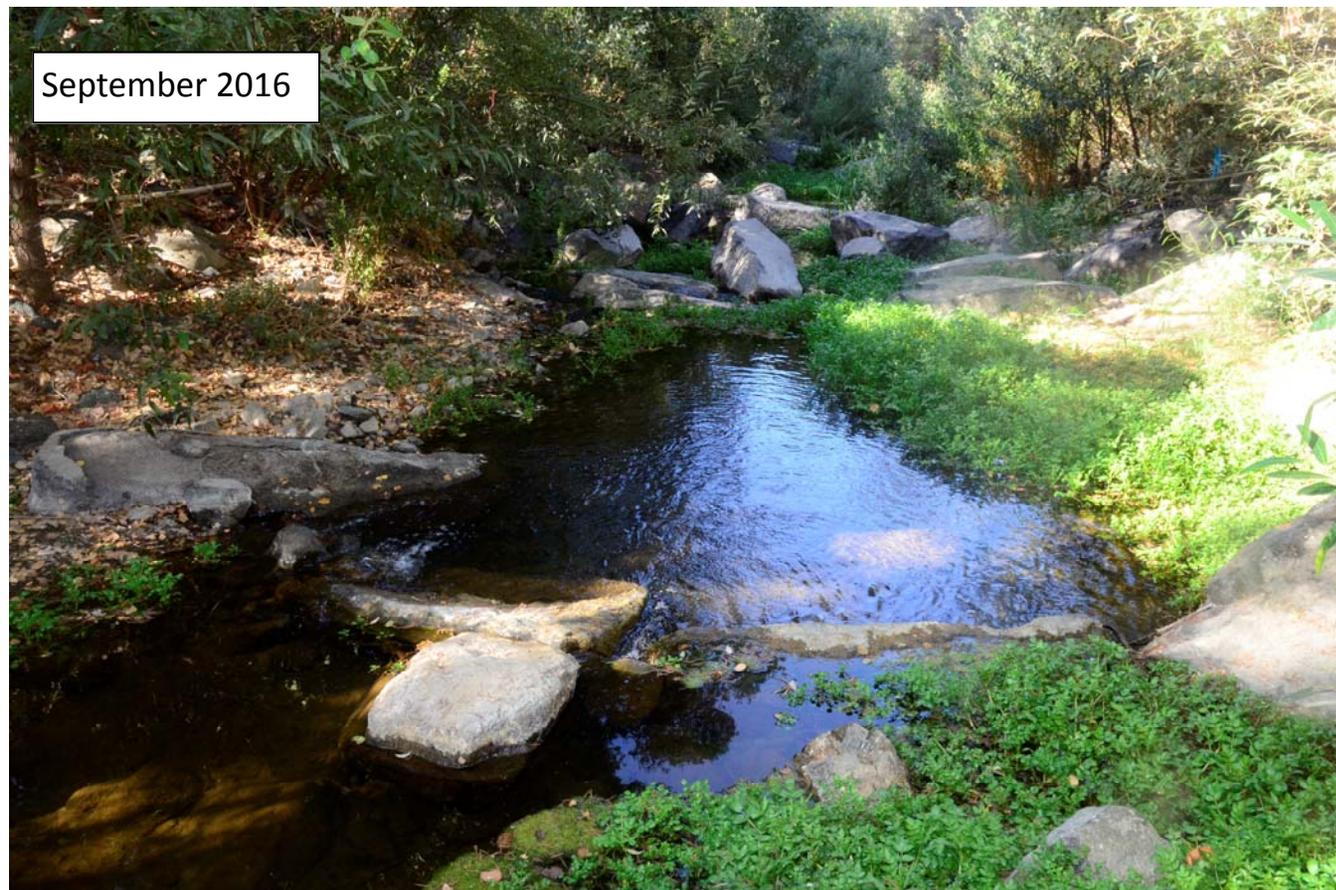
Figure 10. Photo point 4, Site 13, Years 0-3. Alum Rock Monitoring, Upper Penitencia Creek, Santa Clara County, California . Photo point 4 photographs taken on right bank from top of the modified concrete grade control structure wall looking downstream across chute 2 along the fish passage project. Refer to Figure 1 of this report for photo point locations.

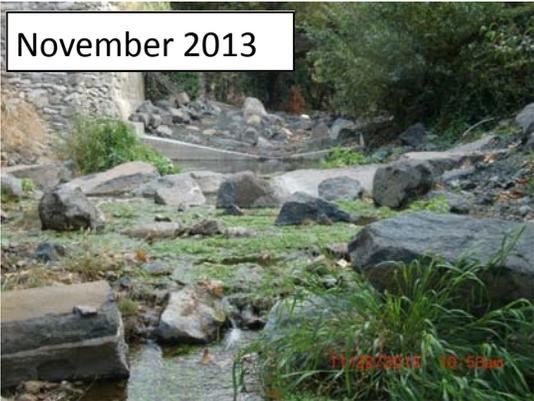
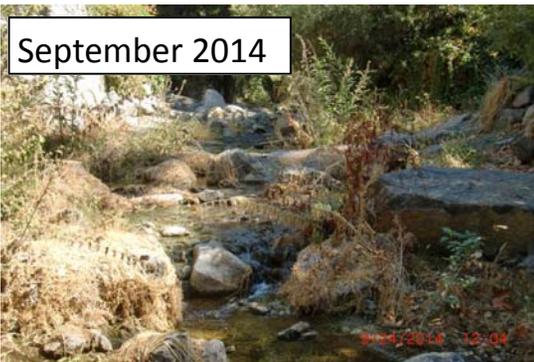
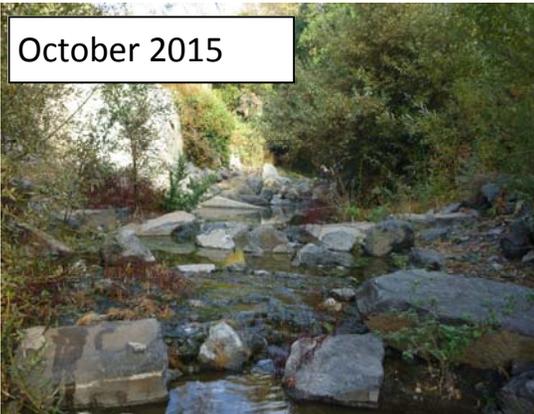
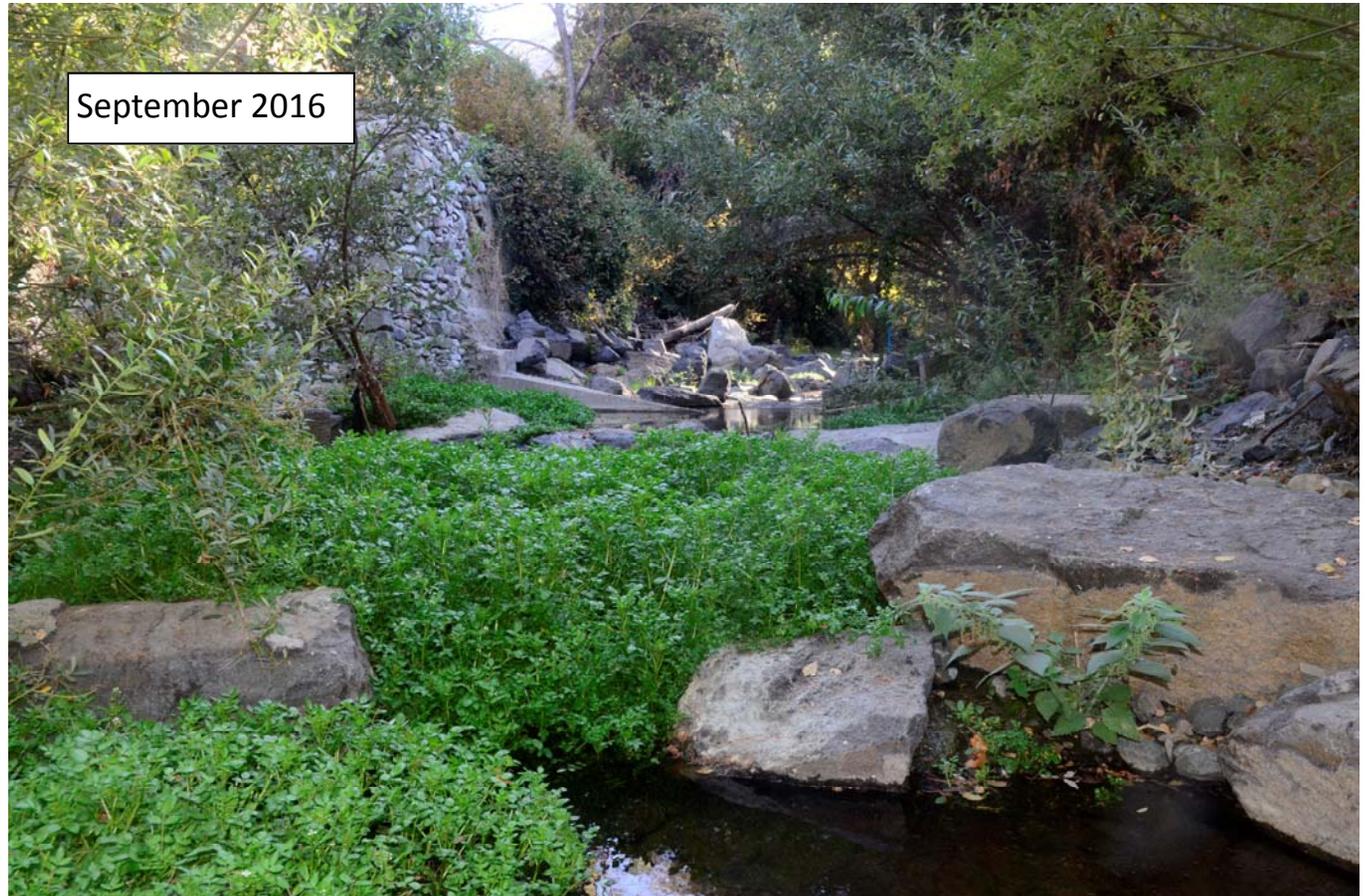
Figure 11. Photo point 5, Site 13, Years 0-3. Alum Rock Monitoring, Upper Penitencia Creek, Santa Clara County, California . Photo point 5 photographs looking upstream across chute 2 to modified concrete grade control structure and bridge in the fish passage project. Refer to Figure 1 of this report for photo point locations.

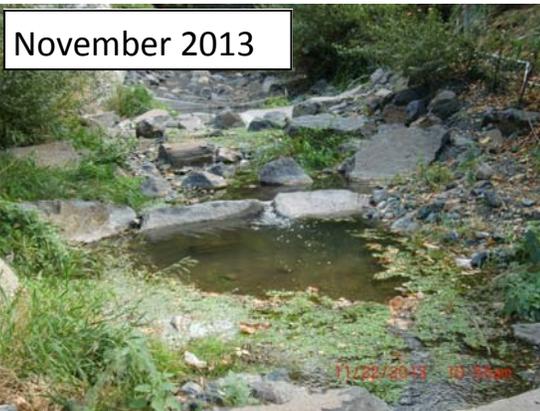
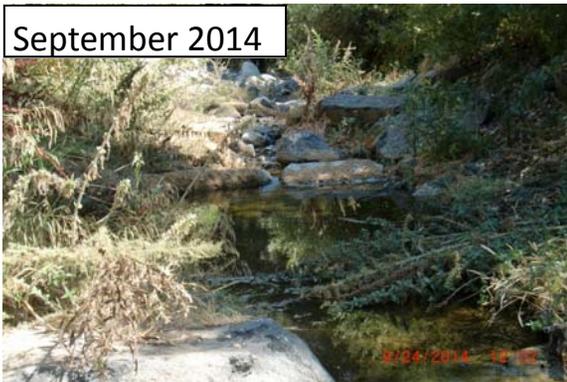
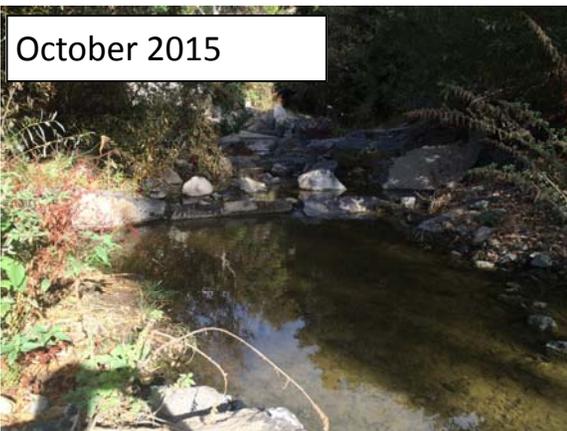
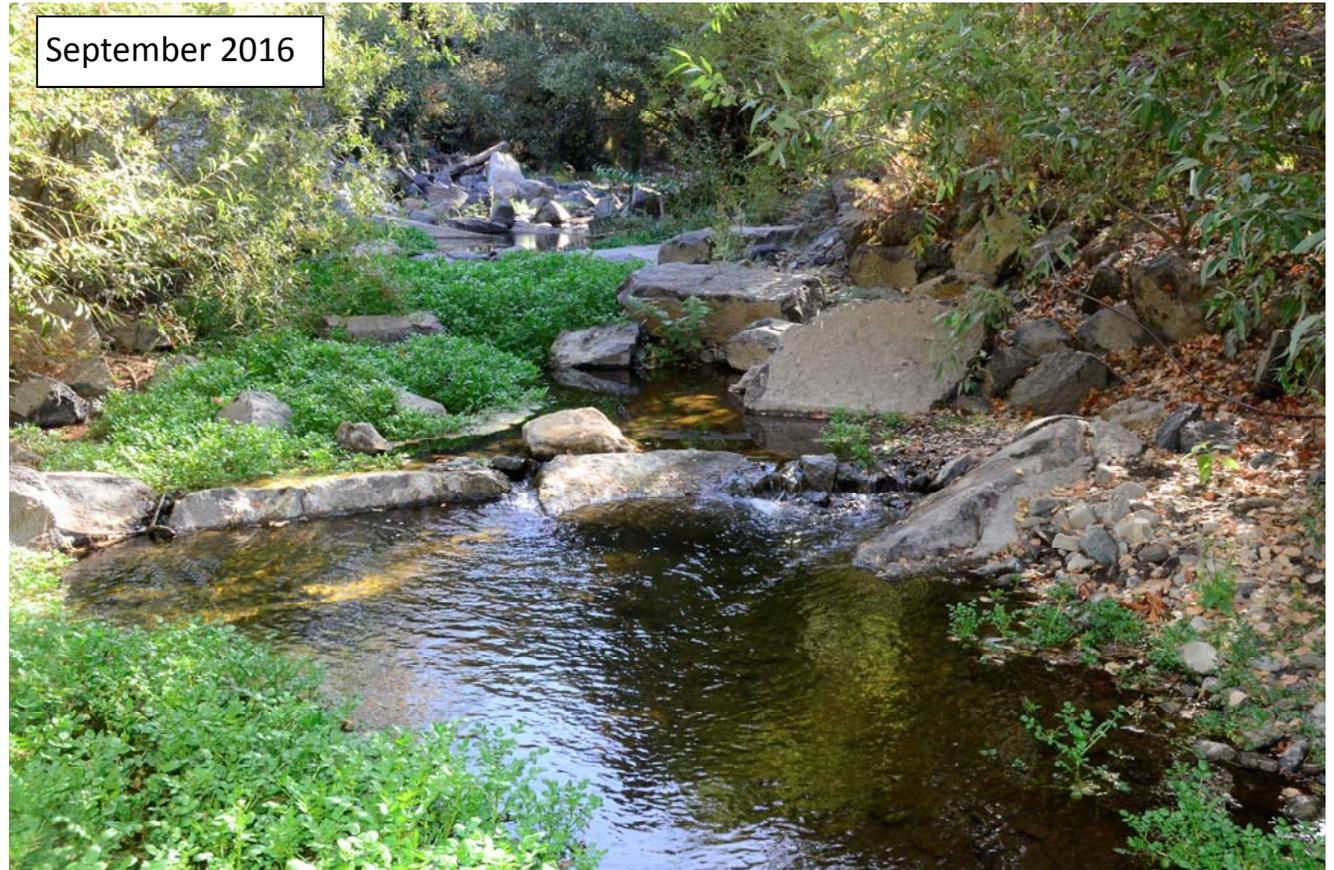
Figure 12. Photo point 6, Site 13, Years 0-3. Alum Rock Monitoring, Upper Penitencia Creek, Santa Clara County, California . Photo point 6 photographs looking upstream across pool 2 and chute 2 in the fish passage project. Refer to Figure 1 of this report for photo point locations.

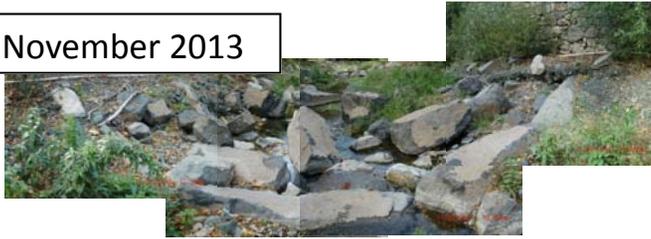
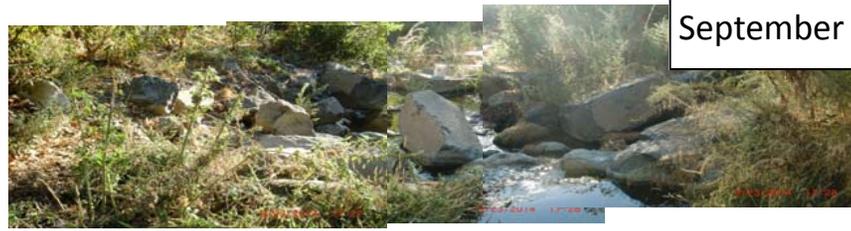
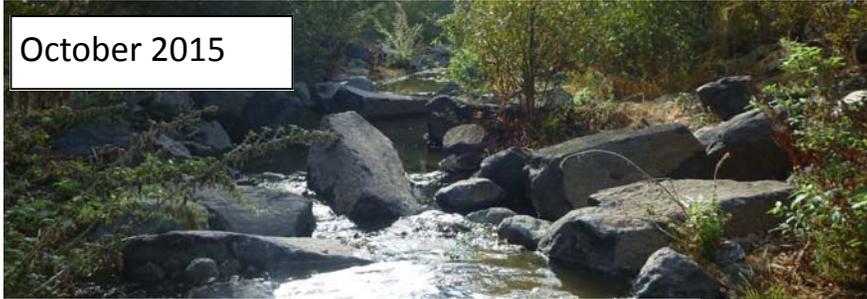
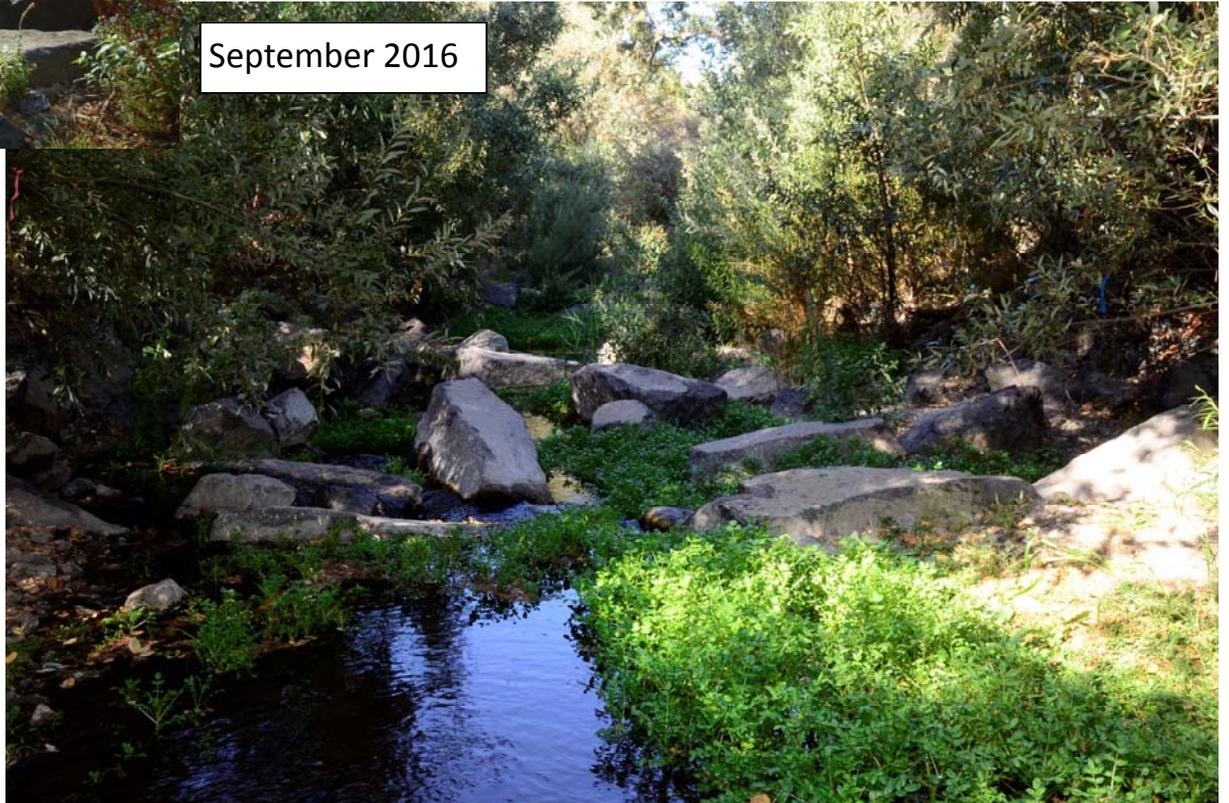
Figure 13. Photo point 7, Site 13, Years 0-3. Alum Rock Monitoring, Upper Penitencia Creek, Santa Clara County, California . Photo point 7 panoramic photographs looking downstream at rock band structure and chute 3 in the fish passage project. Refer to Figure 1 of this report for photo point locations.

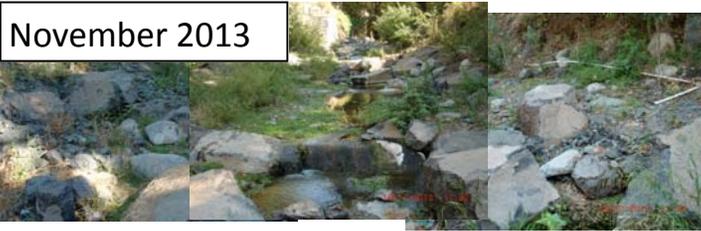
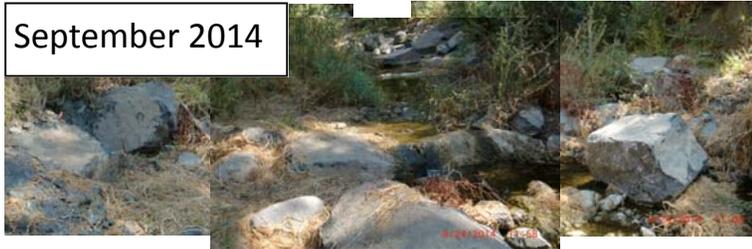
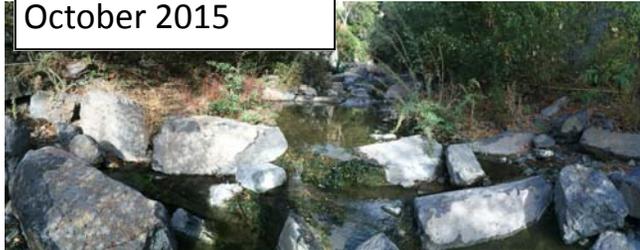
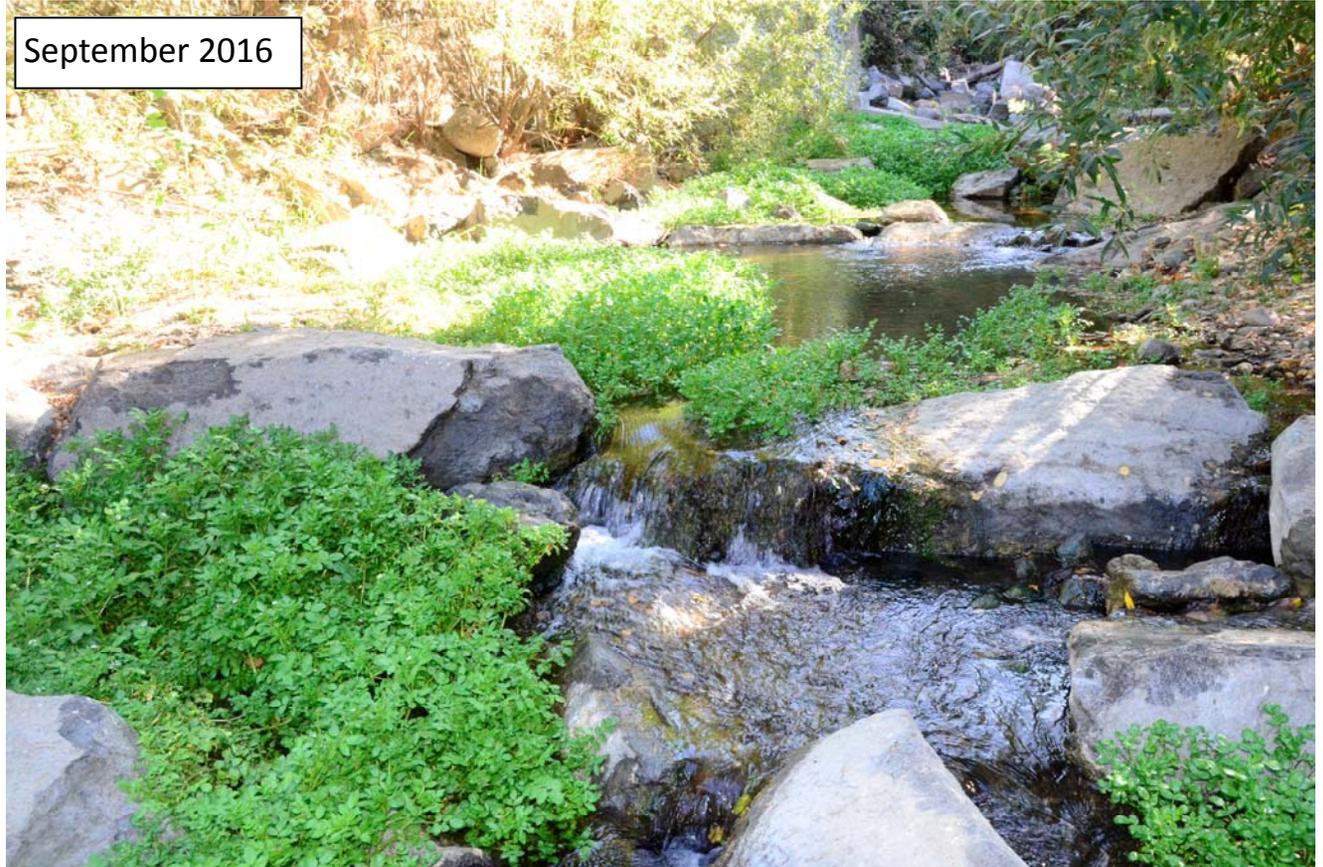
Figure 14. Photo point 8, Site 13, Years 0-3. Alum Rock Monitoring, Upper Penitencia Creek, Santa Clara County, California . Photo point 8 photographs looking upstream across rock band structure and pool 3 in the fish passage project. Refer to Figure 1 of this report for photo point locations.

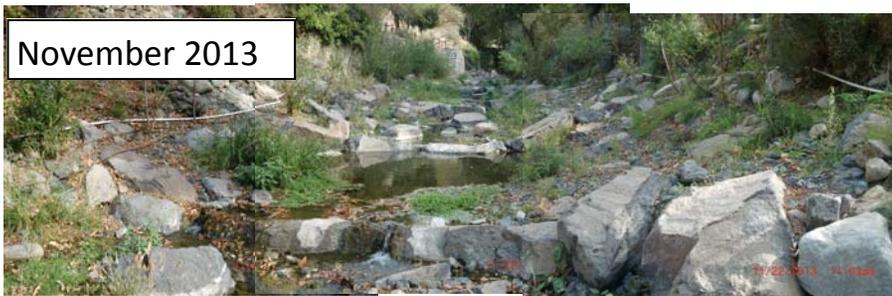
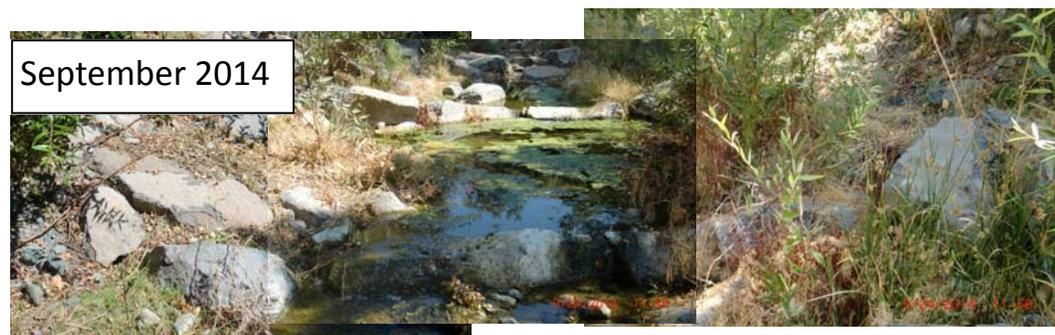
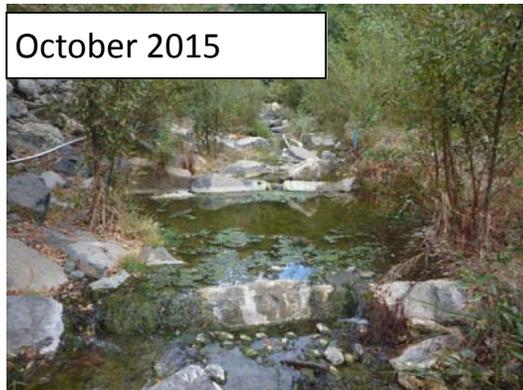
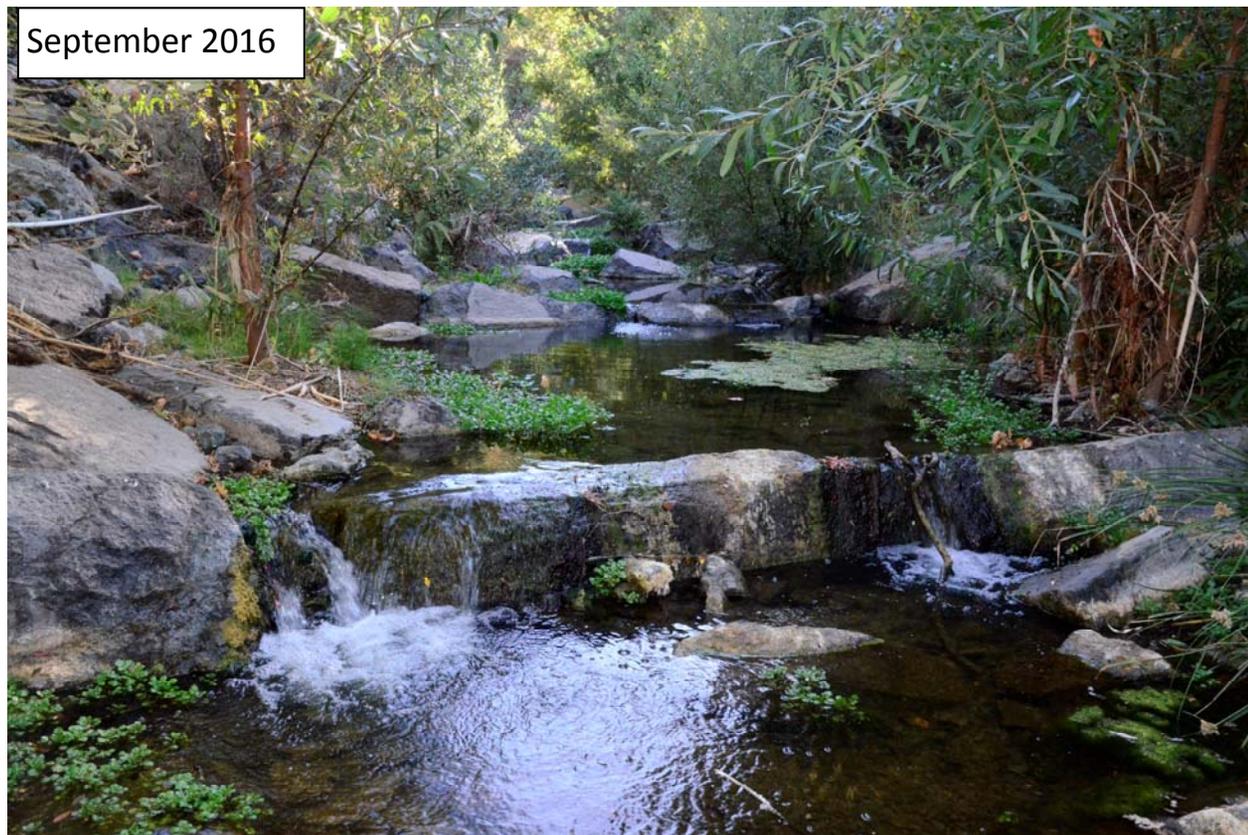
Figure 15. Photo point 9, Site 13, Years 0-3. Alum Rock Monitoring, Upper Penitencia Creek, Santa Clara County, California . Photo point 9 photographs looking upstream across rock band structure and pool 4 in the fish passage project. Refer to Figure 1 of this report for photo point locations.

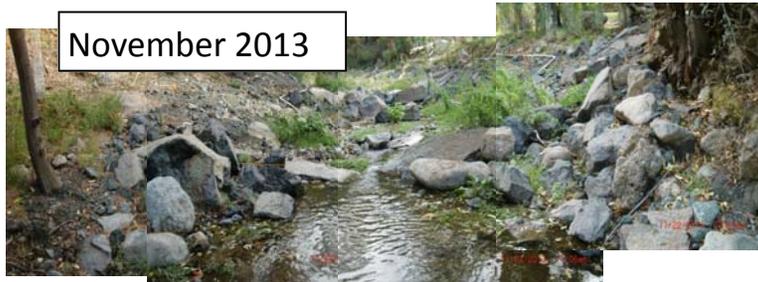
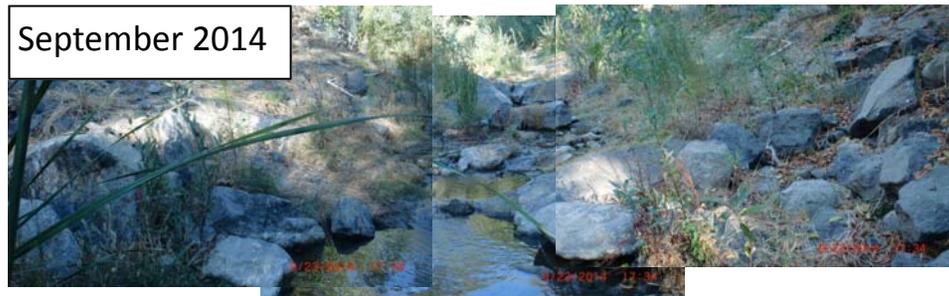
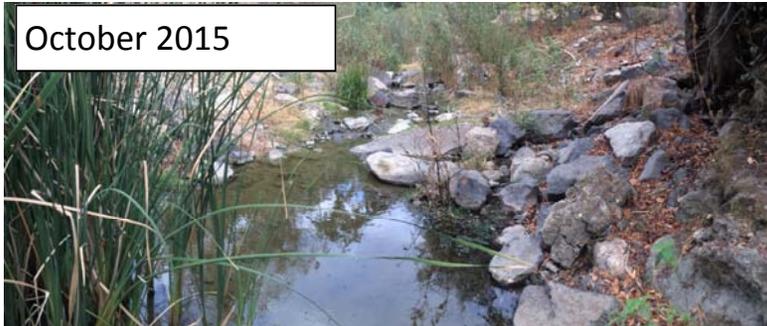
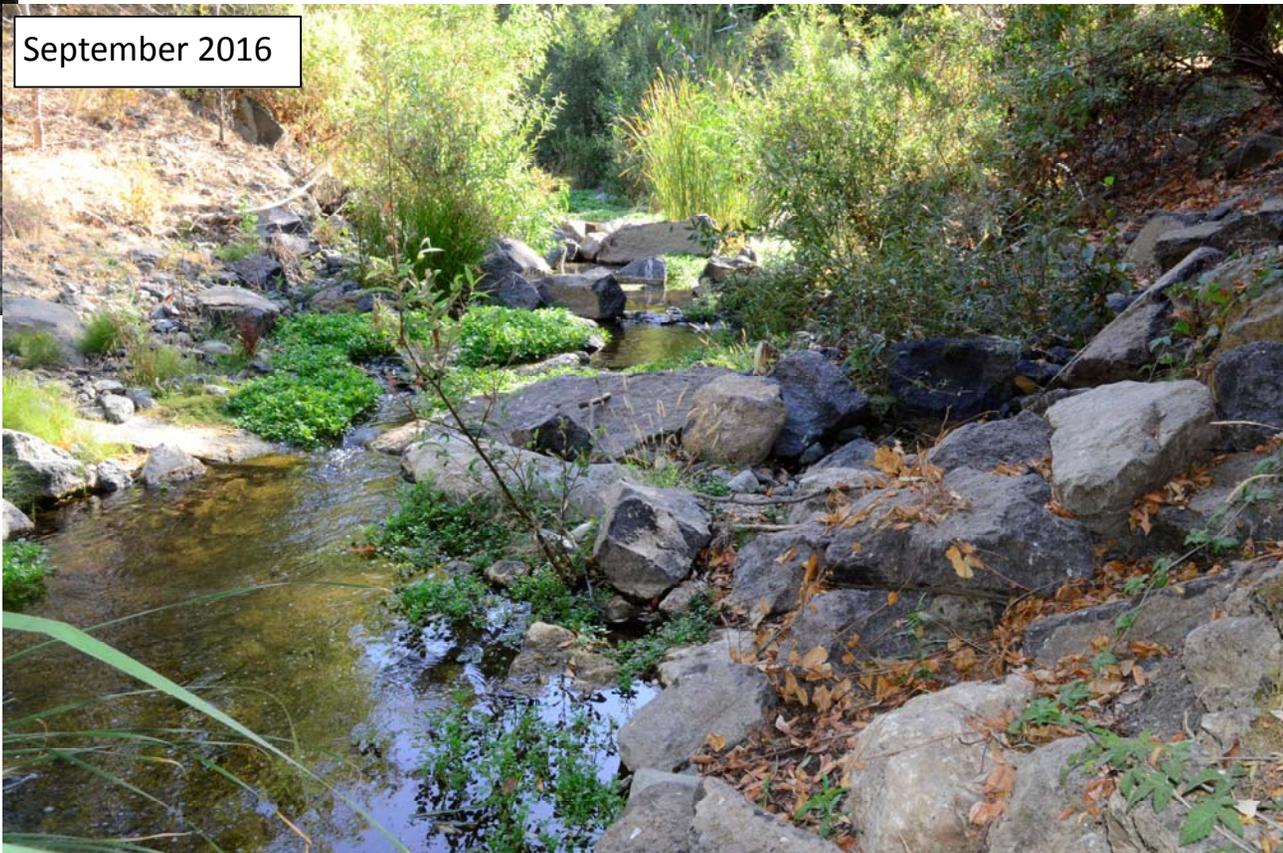
Figure 16. Photo point 10, Site 13, Years 0-3. Alum Rock Monitoring, Upper Penitencia Creek, Santa Clara County, California . Photo point 10 looking upstream from bottom of fish passage project. Refer to Figure 1 of this report for photo point locations.
