ALUM ROCK FISH PASSAGE PROJECT MITIGATION MONITORING REPORT YEAR FOUR, 2016

Santa Clara Valley Transportation Authority
3331 North First Street, Bldg. B-2
San Jose, CA 95143-1906
Contact: Ann Calnan
408.321.5976

ICF
75 E. Santa Clara Street, Suite 300
San Jose, CA 95113
Contact: Donna Maniscalco
408.216.2802

April 2017

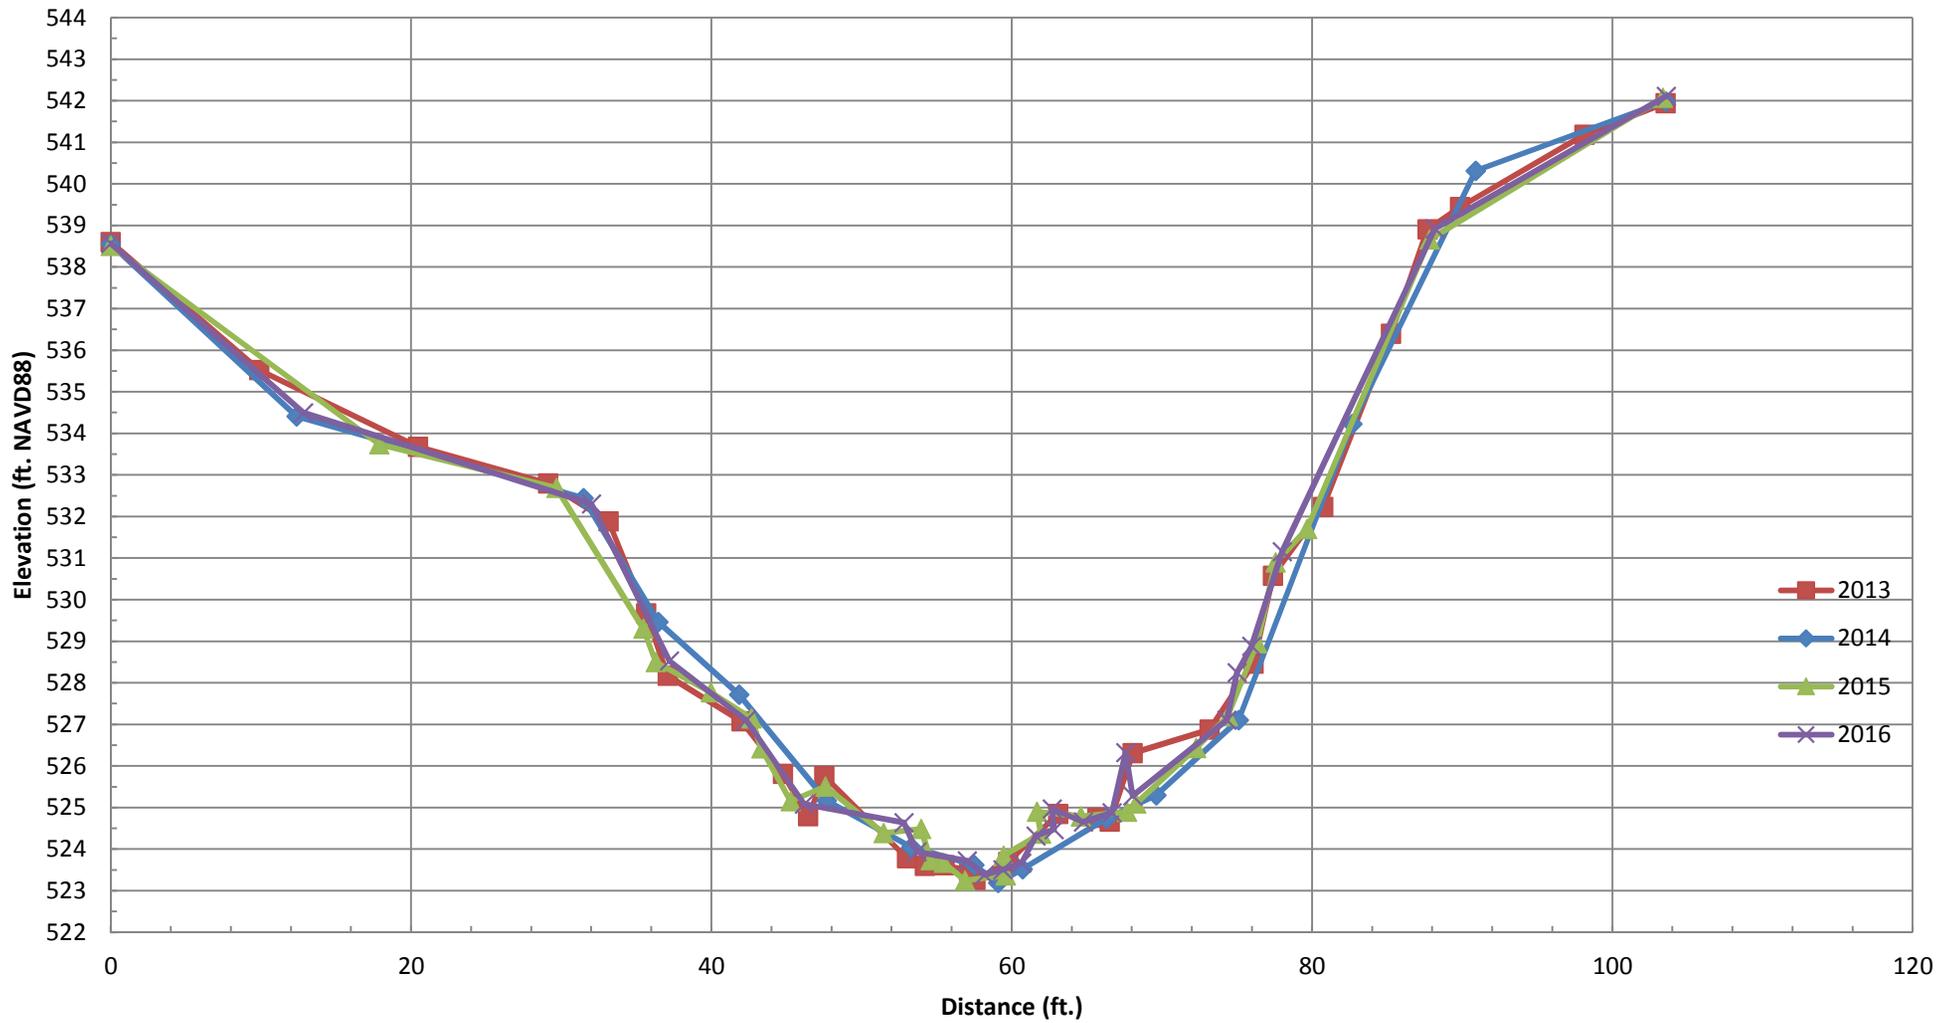
Figures 17-23 show results of the September 2016 cross sections surveys. Comparisons of these survey data to the previous years' data generally confirm visual observations – major geomorphic change, such as significant bank widening, mobilization or deposition, did not take place in the fish passage structure over WY2016, but movement of individual boulders and localized variations in bed elevations were detected. XS 1 (**Figure 17**) shows that while the channel profile is stable, the large log that shifted during high flows (**Figure 7**) is now located within the cross section. Several rocks were surveyed in the 2016 profile. Visual inspection of the photo points confirm that these rocks did not move, but are the result of a slight alignment deviation in the path of the surveyed profile. In a boulder-filled section such as this, even an alignment shift of a few inches can have this result. Slight changes in the channel bed due to the reworking of fine sediments, as observed in the visual observations and photo points, can be seen XS 2 and XS 3 (**Figure 18, Figure 19**). XS 4 (**Figure 20**) crosses through a section of channel that underwent some movement by larger boulders; visual observations confirmed that a large (~2 foot diameter) boulder shifted slightly downstream, and now sits along the right side of the profile of XS 4. Some smaller boulders along the left bank appear to have shifted as well. These are boulders that sit in the bed of the channel, and do not appear to support major structural elements. Along XS 5 (**Figure 21**), a smaller boulder may have shifted into the profile on the upper left bank, but this is a heavily vegetated area and this could not be visually confirmed. Further downstream XS 6 and 7 (**Figure 22, Figure 23**) remain largely unchanged.
