Appendix C: Walk Audit Summary

TASMAN DRIVE COMPLETE STREETS CORRIDOR STUDY WALK AUDIT SUMMARY

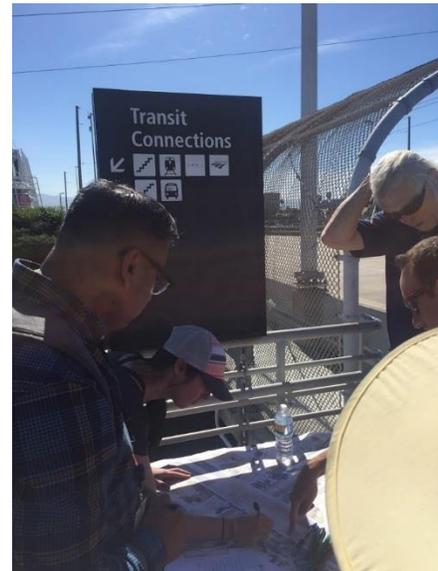
- During games at Levi's Stadium, San Tomas Aquino Creek Trail is closed near the stadium and people are directed through a well-signed detour through the neighborhoods on the south side of the stadium.

Photo 7: Group discussion and wayfinding signage at Great America Station

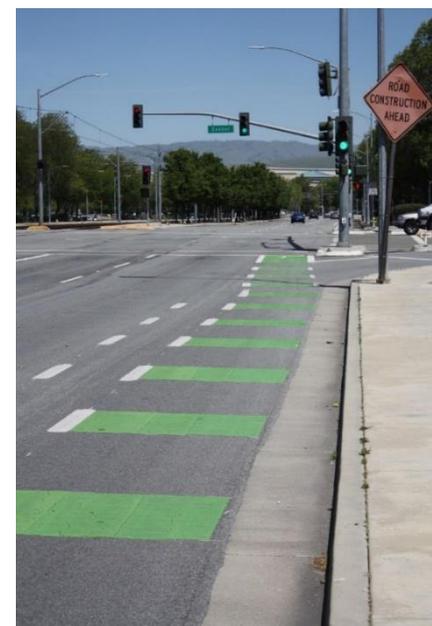
- San Jose has some of the highest quality bicycle facilities along the Tasman corridor. The bike lanes are striped with a buffer and green paint marking conflict zones on the approach to intersections along the corridor.
- Challenges such as high speed traffic and conflict areas still exist, and the City of San Jose would like to implement Class IV protected bike lanes as a low stress facility, whenever possible.
- At North 1st Street and Tasman Drive (on the north side), vehicles were parked in the bike lane in front of the Samsung building. Vehicles were also observed blocking the VTA bus stop.

Photo 9: Green lanes dashed on the approach to Zanker Road
