**Upper Penitencia Creek Improvement Project
Year 3 (2015) Monitoring Report**

Project #3518-03

May 2016

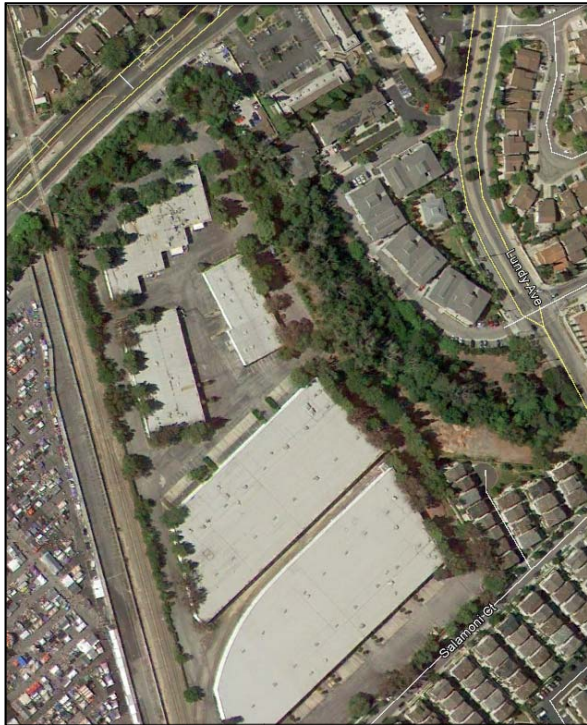
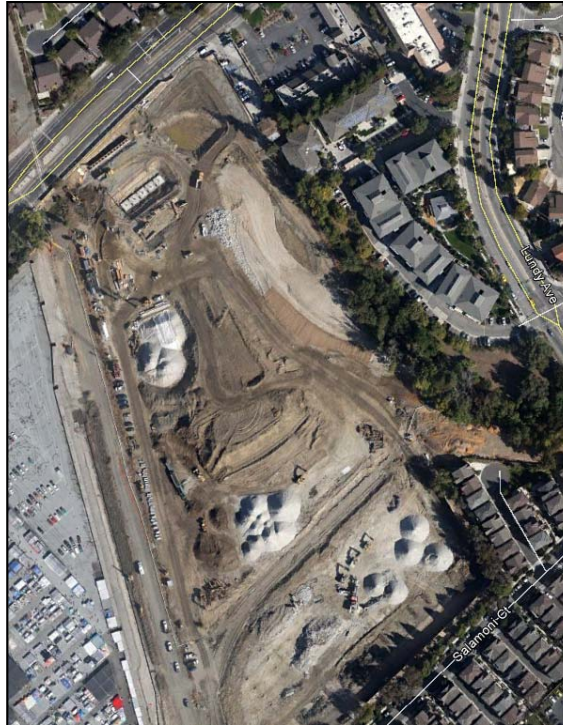
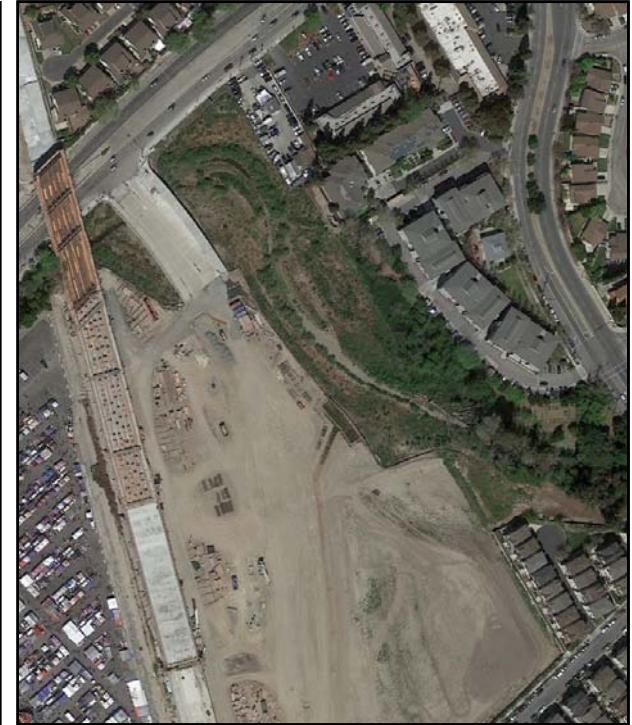
A. May 19, 2012 , Before construction

B. September 11, 2012,
Channel construction period

C. March 2015, 3 years after
channel construction.

Figure 2. Sequence of project completion, Upper Penitencia Creek, San Jose, California
Aerial photographs taken between May 2012 and March 2015 show the project before, during and after construction.

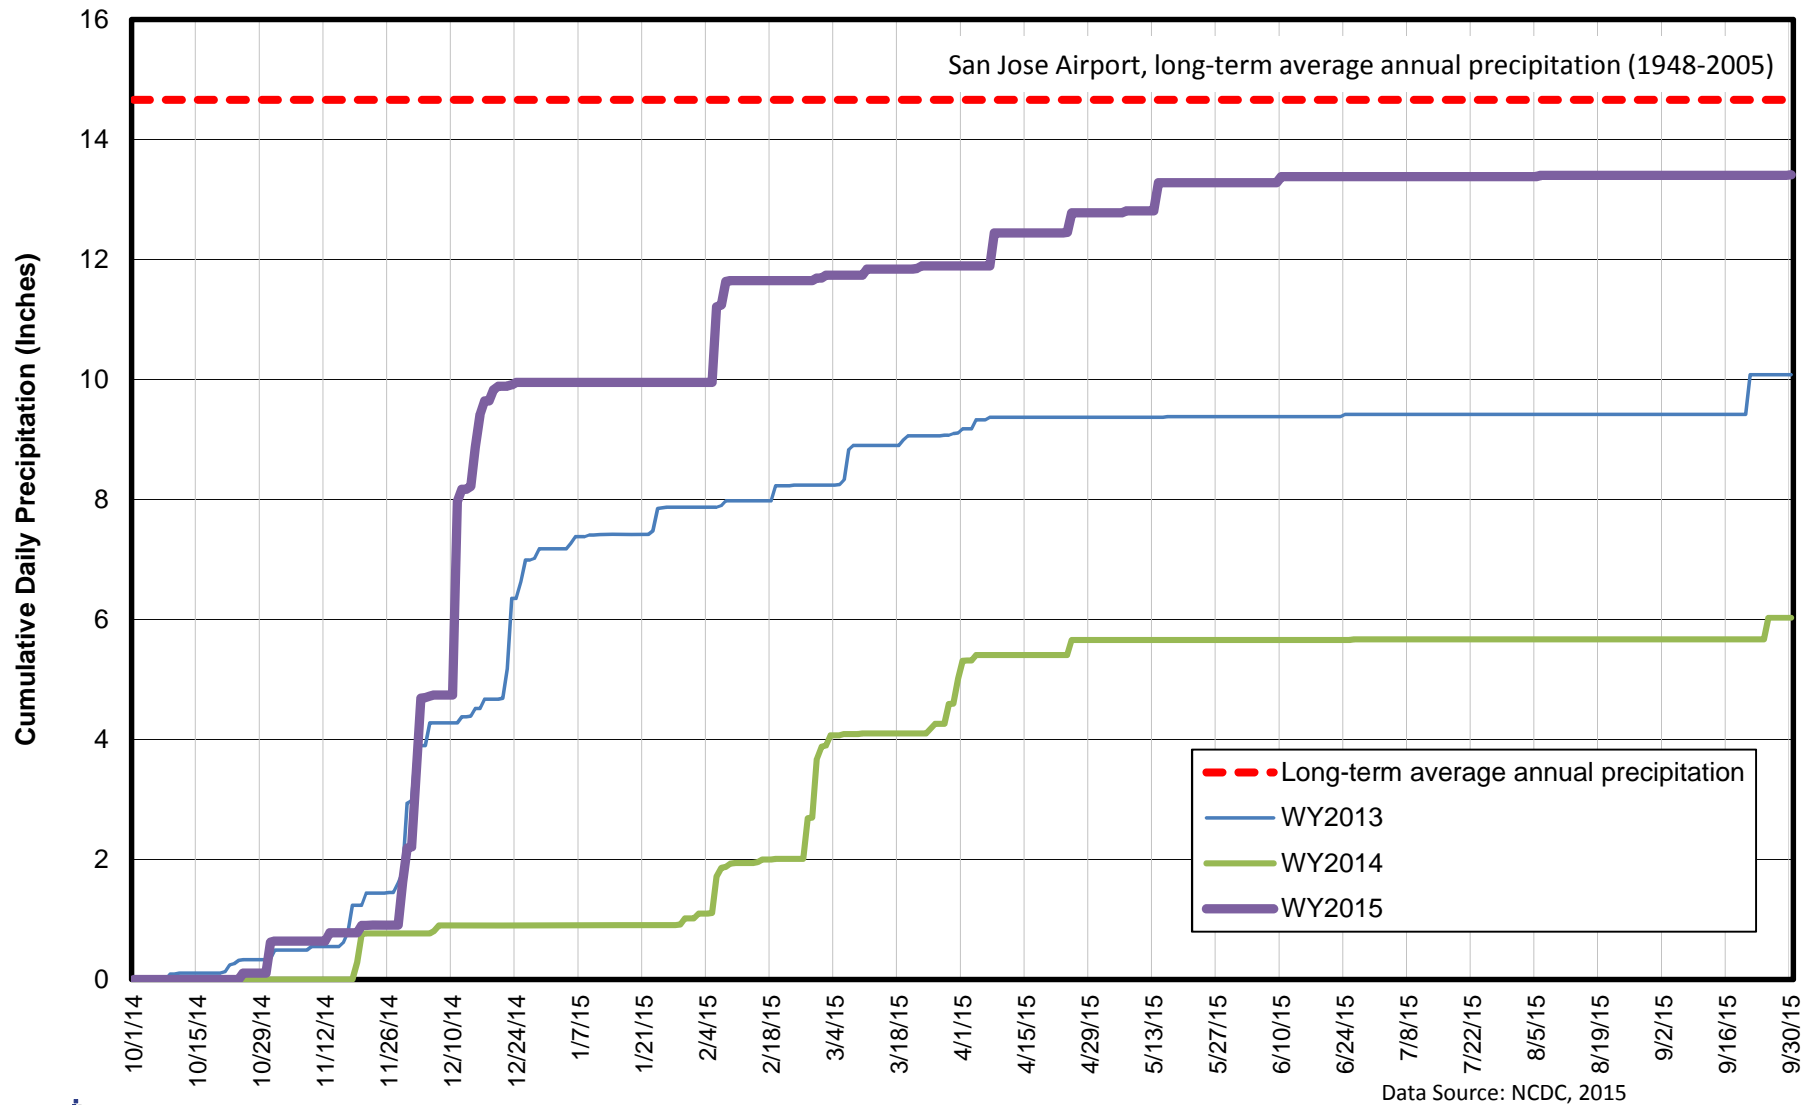
Cumulative daily rainfall for WY2015 is illustrated in **Figure 3** with an annual total precipitation of 13.41 inches as recorded at the San Jose International Airport, slightly less than the long-term average (14.7 inches) for the same station. While rainfall in WY2015 was near normal, more than 67 percent (9.04 inches) of the annual precipitation fell in only three events between November 28 and December 25, 2014. The largest daily rainfall totals were recorded on December 11, 2014 (3.23 inches), December 3, 2014 (1.28 inches), February 3, 2015 (1.26 inches), December 2, 2014 (1.20 inches), and November 29, 2014 (0.71 inches).

Figure 3. Cumulative daily precipitation, San Jose Airport, San Jose, California, water years 2013, 2014, and 2015. Total annual rainfall in all 3 years (post-construction) was below average.

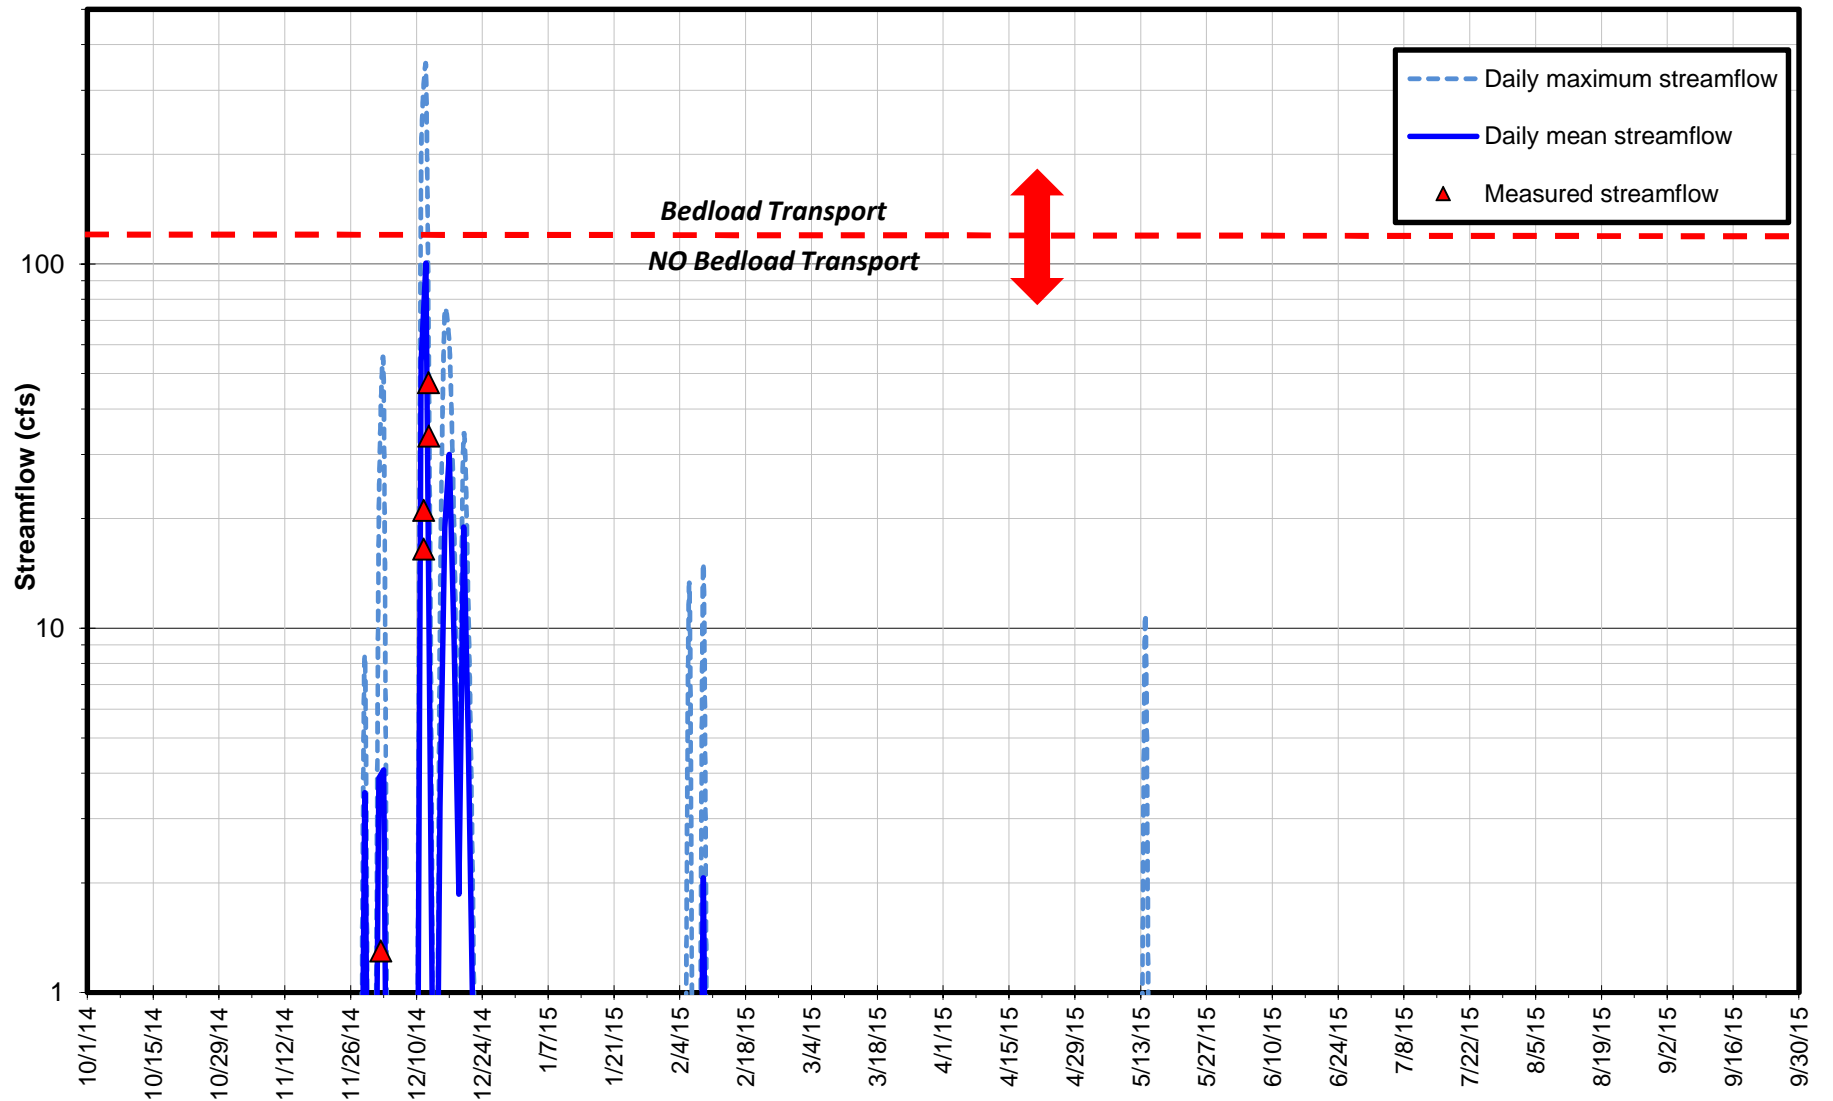
Figure 4. Daily mean and maximum streamflow, Upper Penitencia Creek above Berryessa Road, San Jose, California, water year 2015. Flow was ephemeral in WY2015 but reflected continued drought conditions. Flows that generate bedload transport are typically greater than 125 cfs at this station (as shown by the dashed red line).

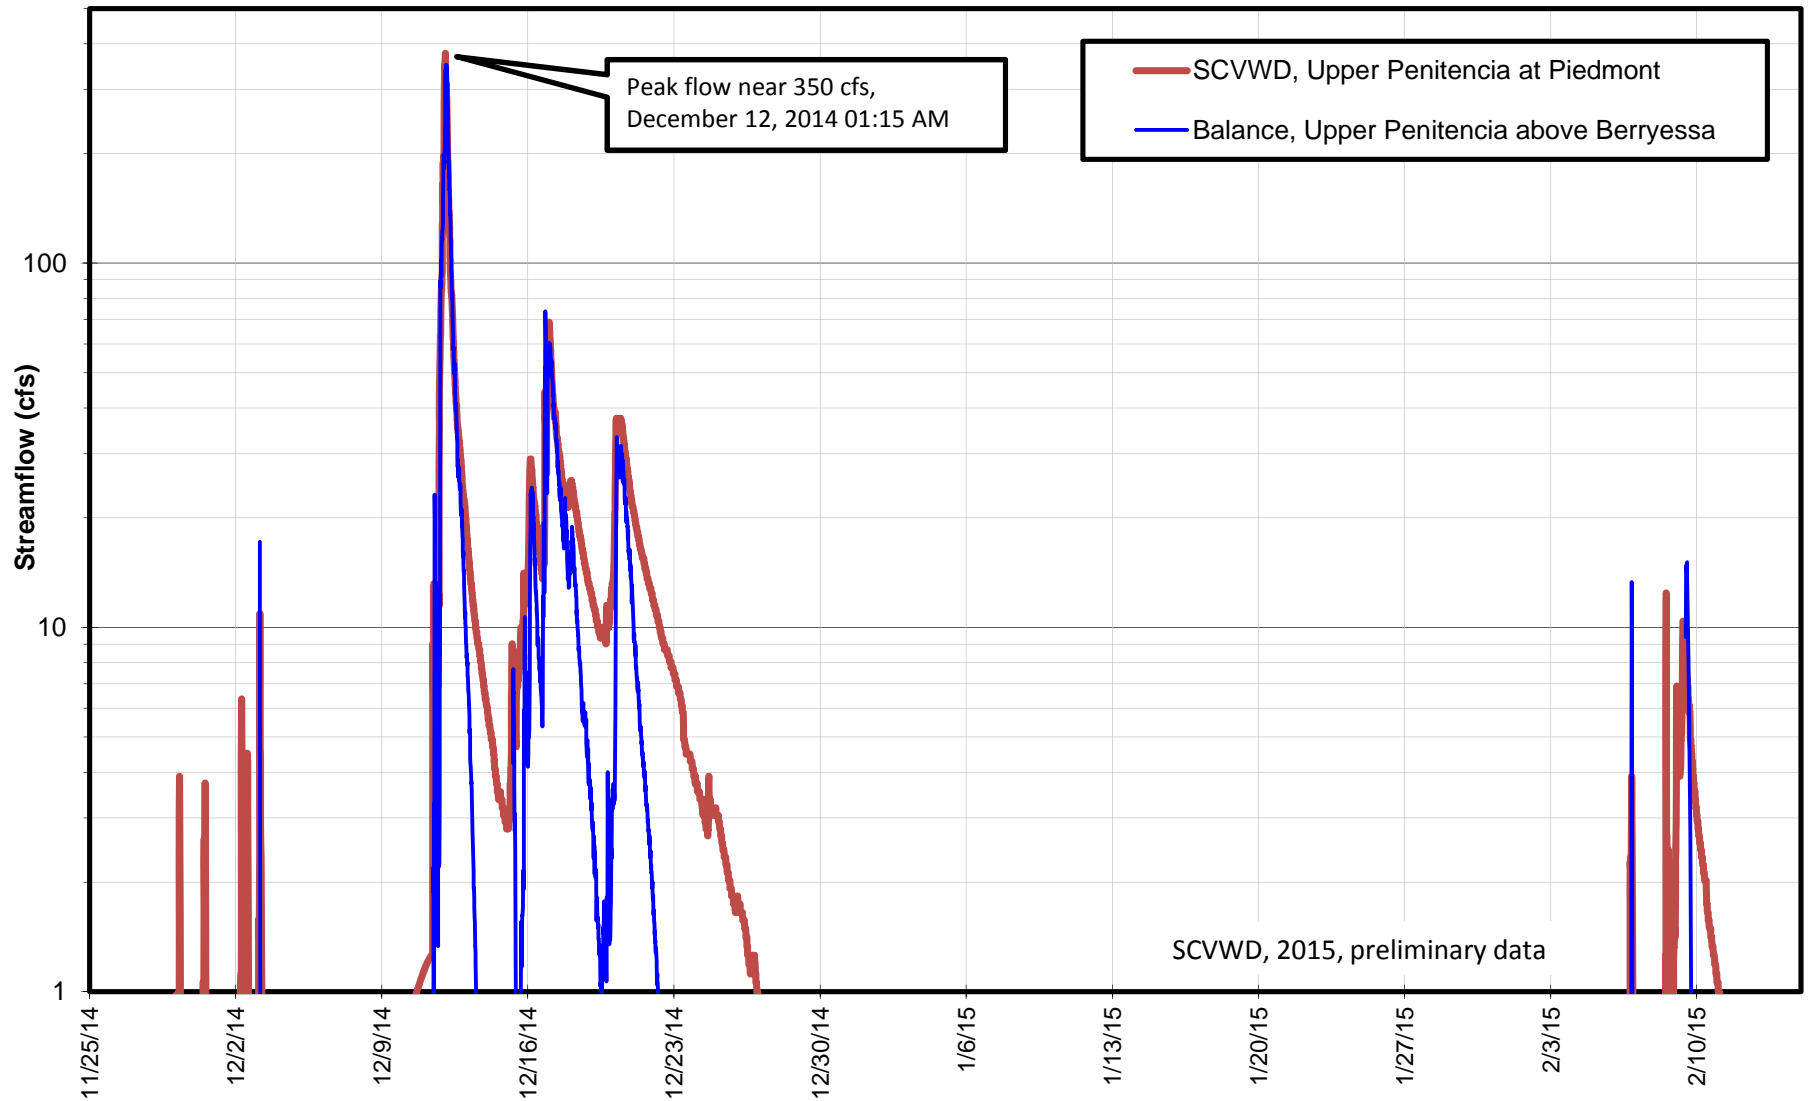
Figure 5.

A streamflow gaging station can only inform us about streamflow “at a station” or streamflow past a single point in the creek. Streamflow can change with distance downstream: a decrease as the result of infiltration (as shown in Figure 5) or an increase as a result of contributions from tributaries or stormwater outfalls. Currently, there are no additional gaging stations within or downstream of the project reach. Both infiltration and contributions from stormwater outfalls have been observed and can affect

at two locations, San Jose, California, November 25, 2014 - February 15, 2015.

The Balance gaging station is roughly 2.6 miles downstream from the SCVWD gaging station. Period shown is limited to the period of recorded flow at both gaging stations.

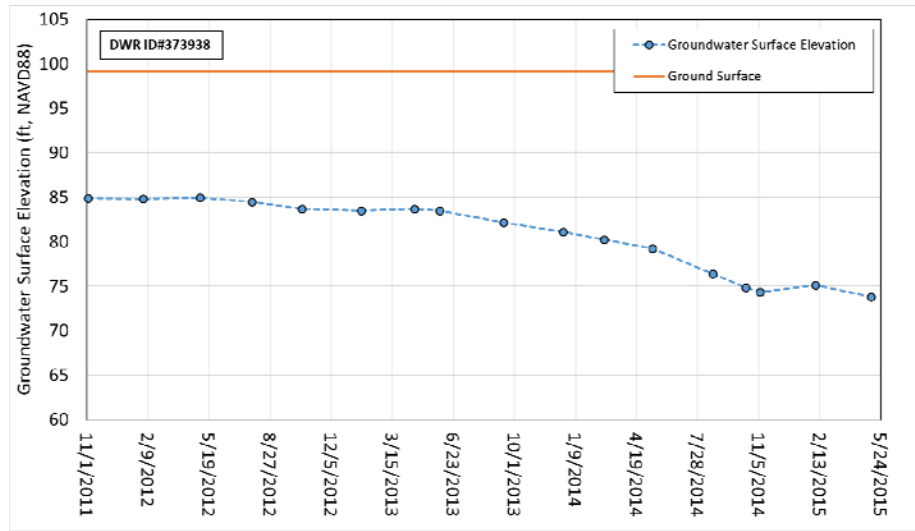
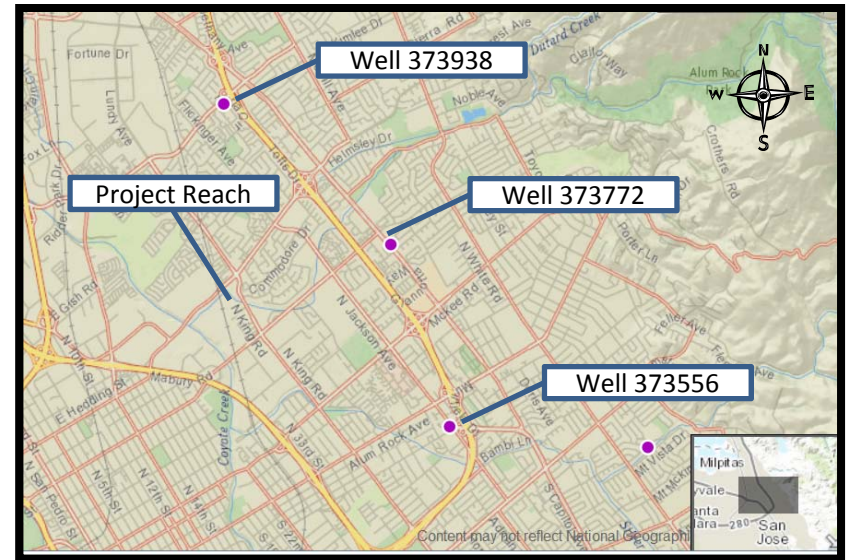
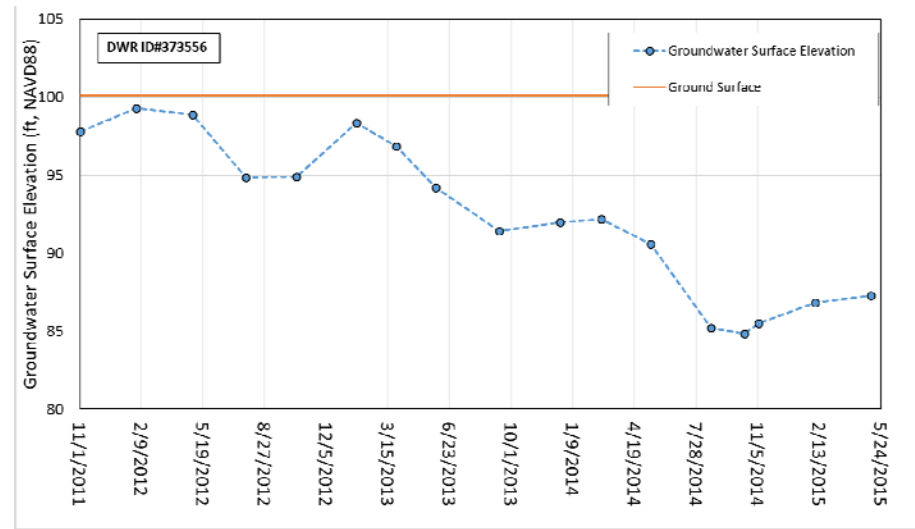
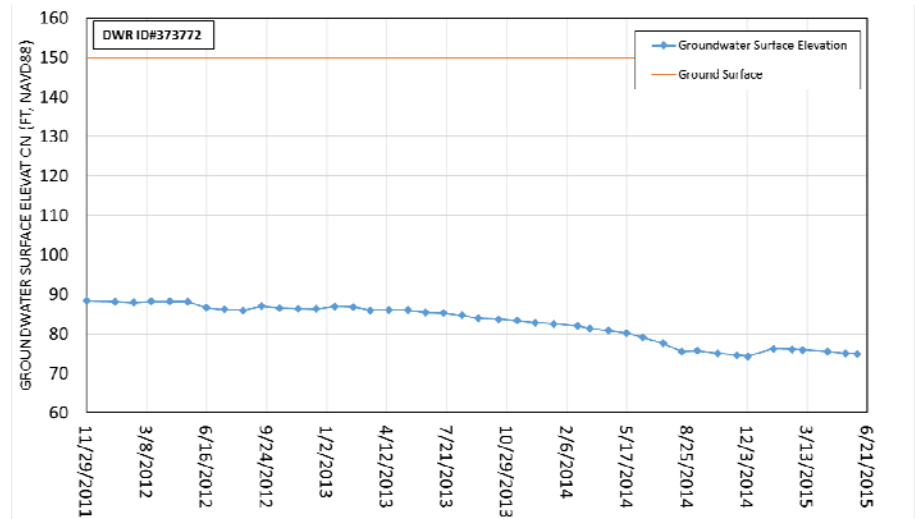
**Figure 6. Local depth to groundwater, near Penitencia Creek, 2011-2015
San Jose, California**

Data suggests local groundwater has declined between 9 and 13 feet as the result of drought conditions and groundwater pumping. As a result, this may affect the ability for the project reach to maintain continuous streamflow.

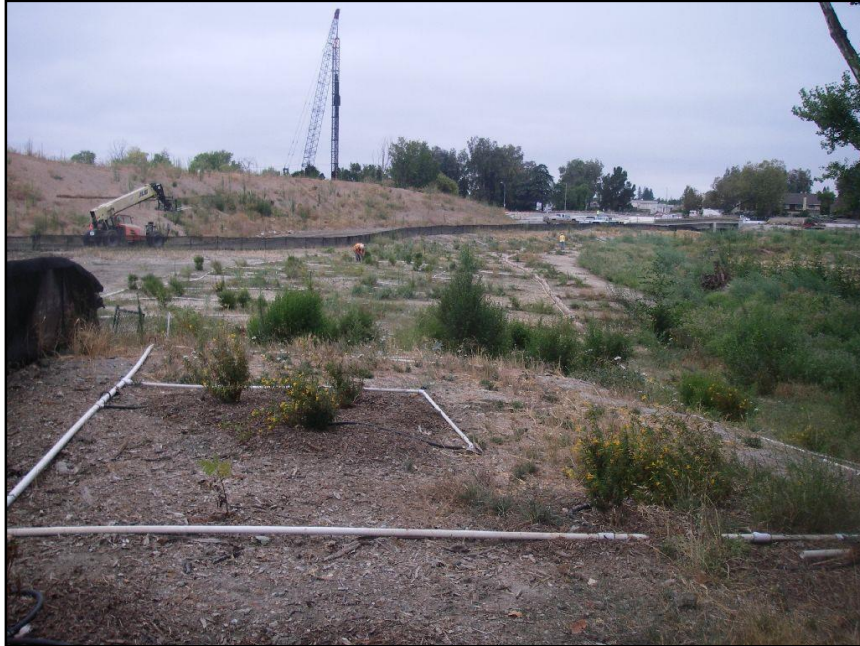
Photo 1. Photodocumentation Point 1A looking northwest at the Upper Slope Planting Zone at the eastern end of the mitigation site (August 28, 2013)

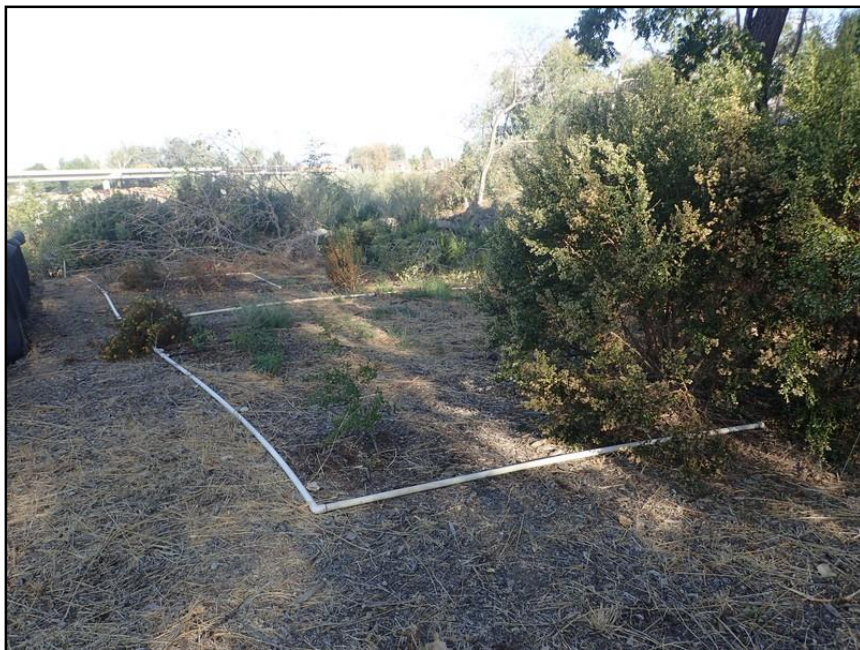
Photo 2. Photodocumentation Point 1A looking northwest at the Upper Slope Planting Zone at the eastern end of the mitigation site (September 22, 2015)

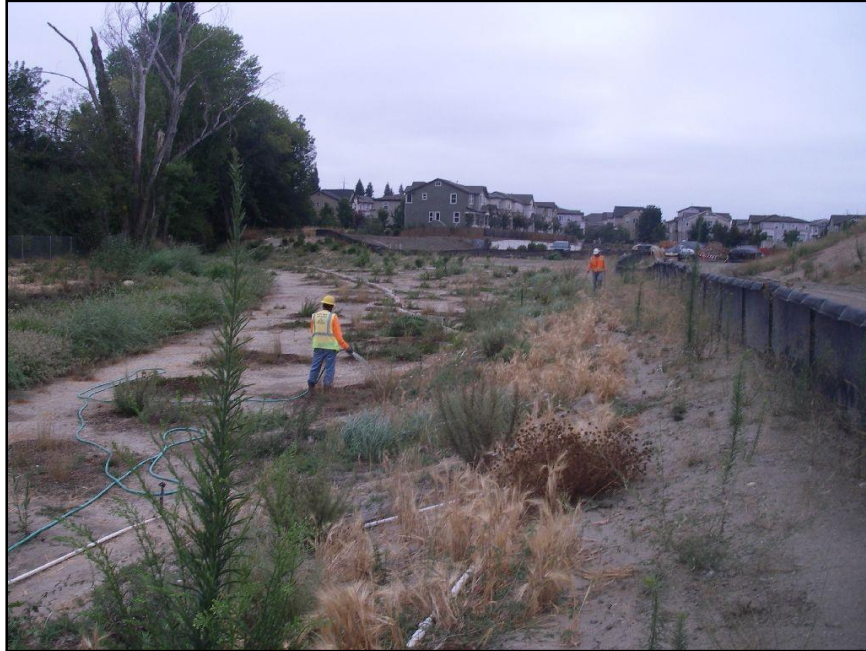
Photo 3. Photodocumentation Point 5A, looking east at the Upper Floodplain Planting Zone along the western boundary of the mitigation site (August 28, 2013)

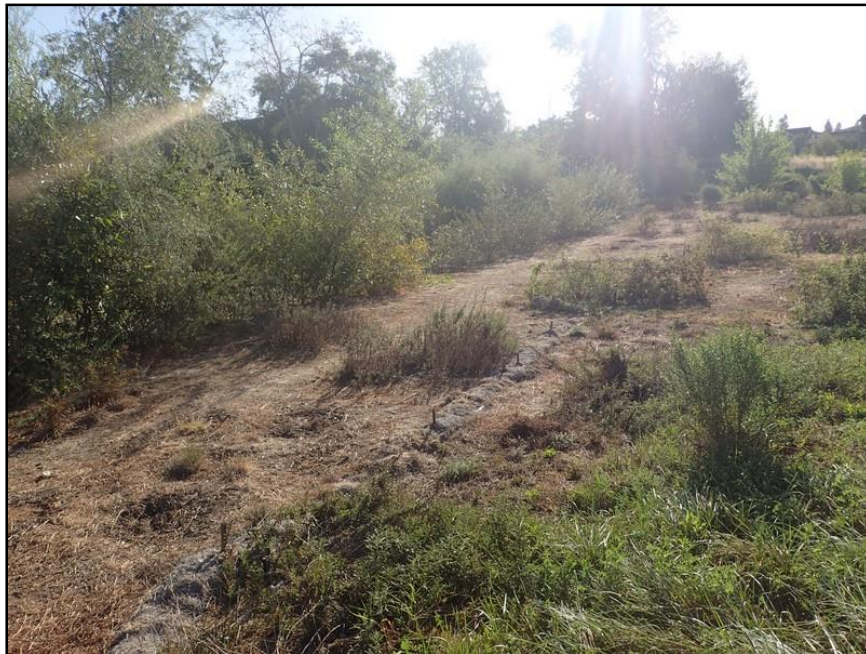
Photo 4. Photodocumentation Point 5A, looking east at the Upper Floodplain Planting Zone along the western boundary of the mitigation site (September 22, 2015)

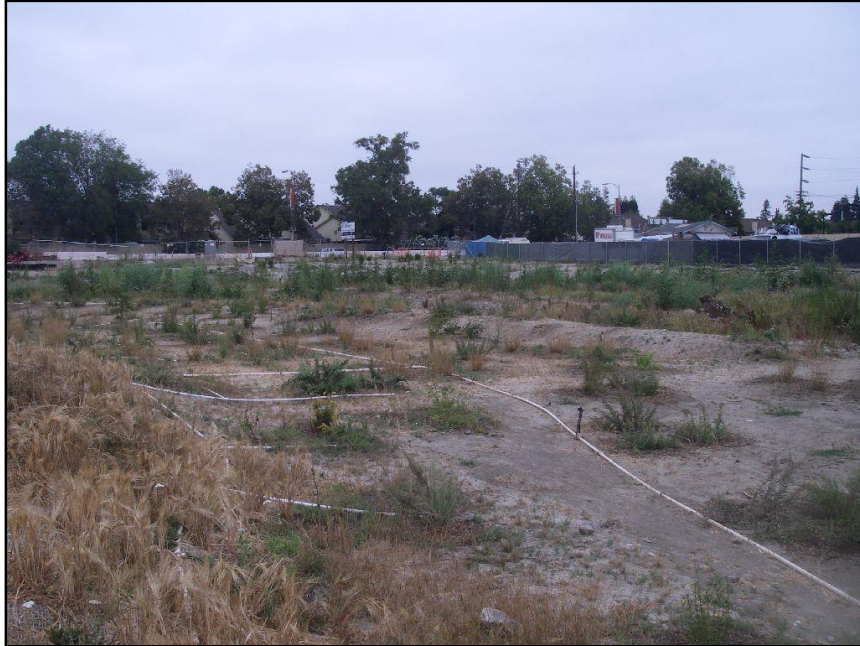
Photo 5. Photodocumentation Point 6A looking north at the Upper Streamside Planting Zone along the western boundary of the mitigation site (August 28, 2013)

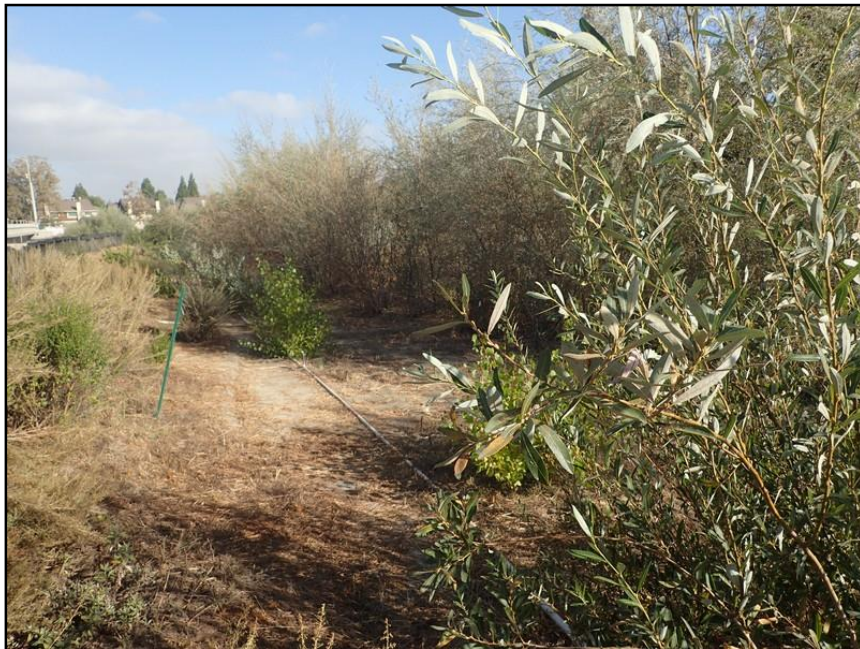
Photo 6. Photodocumentation Point 6A looking north at the Upper Streamside Planting Zone along the western boundary of the mitigation site (September 22, 2015)

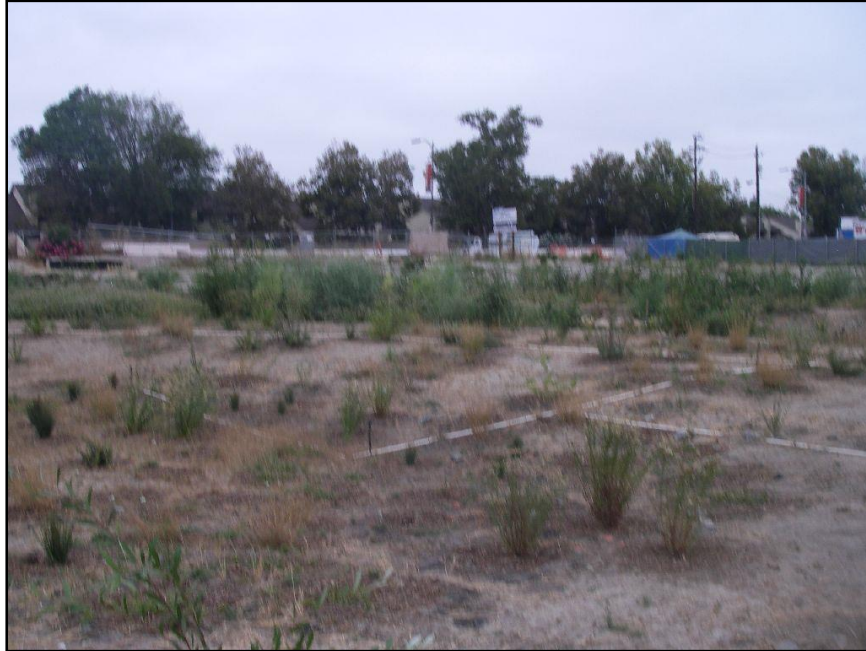
Photo 7. Photodocumentation Point 7C, looking north at the Floodplain Planting Zone in the northwestern portion of the mitigation site (August 28, 2013)

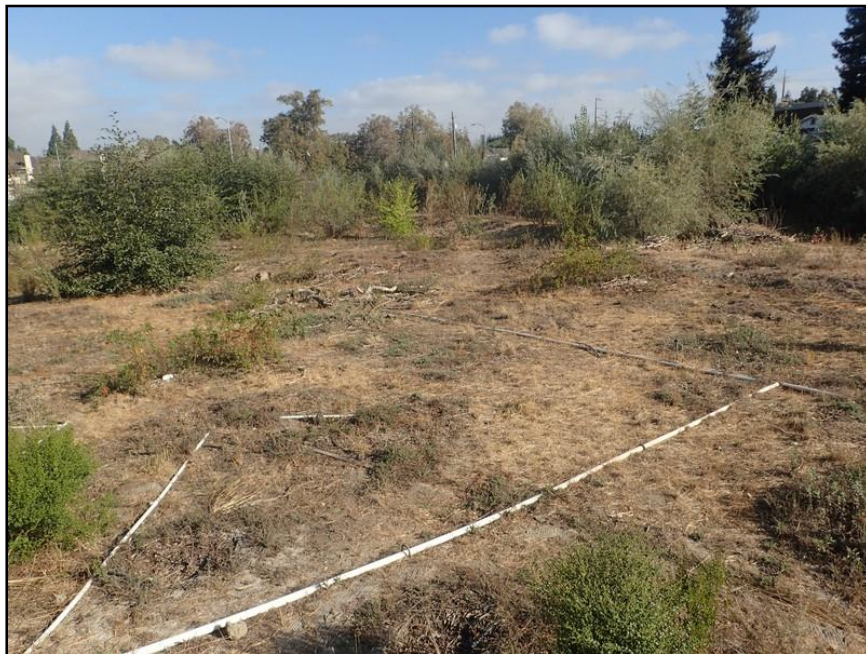
Photo 8. Photodocumentation Point 7C, looking north at the Floodplain Planting Zone in the northwestern portion of the mitigation site (September 22, 2015)

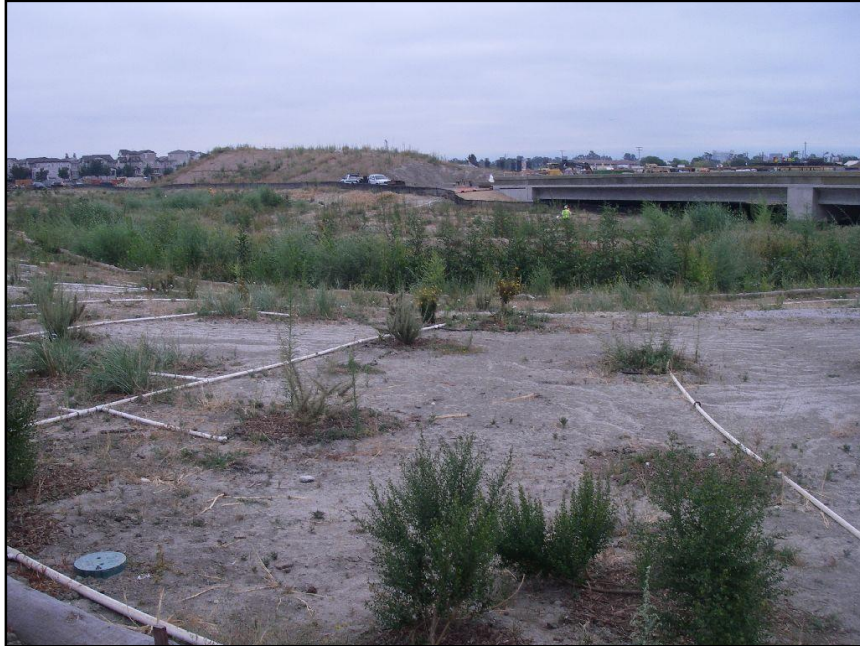
Photo 9. Photodocumentation Point 13B looking south across the Upper Slope Planting Zone to the Floodplain Planting Zone (August 28, 2013)

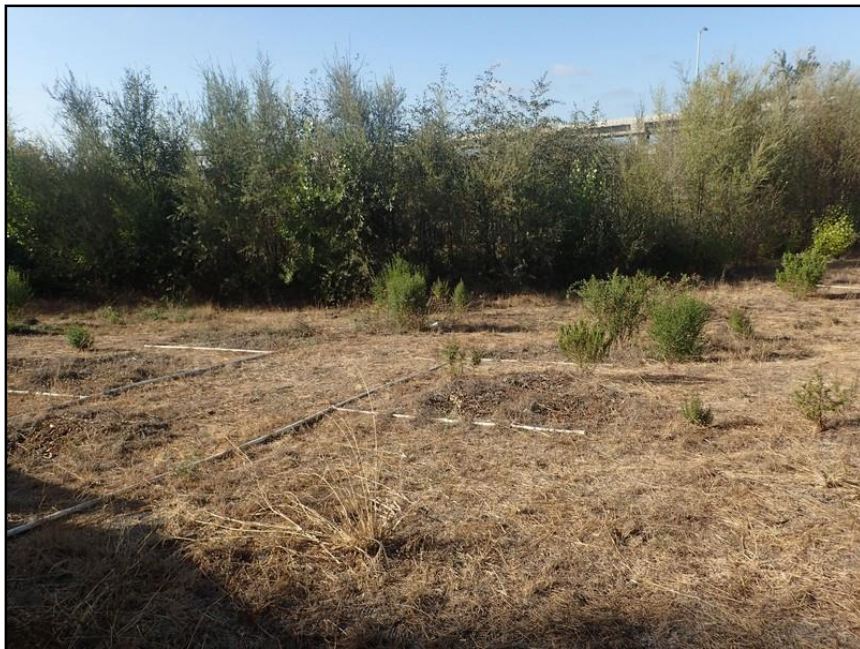
Photo 10. Photodocumentation Point 13B looking south across the Upper Slope Planting Zone to the Floodplain Planting Zone (September 22, 2015)

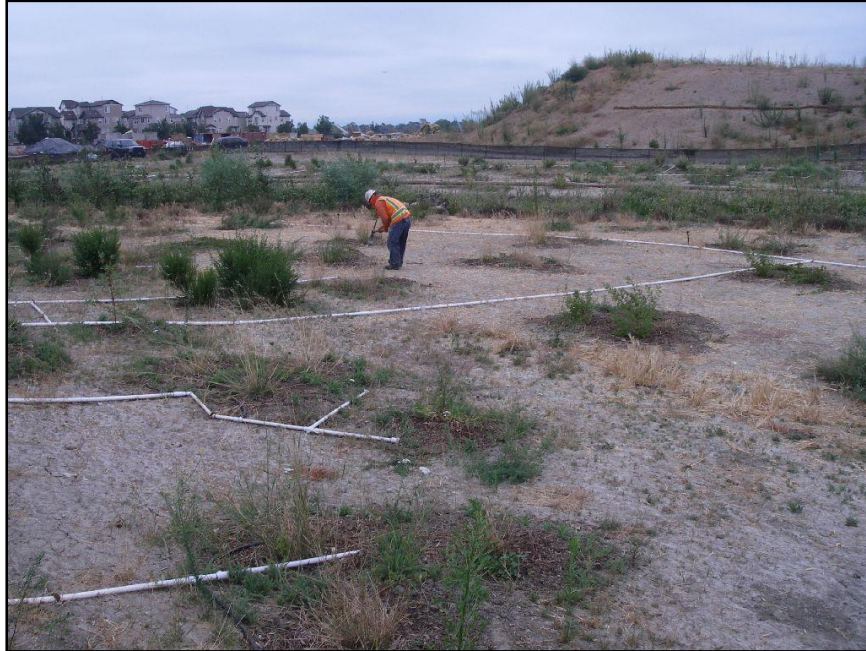
Photo 11. Photodocumentation Point 18B, looking south at the Floodplain Planting Zone (August 28, 2013)

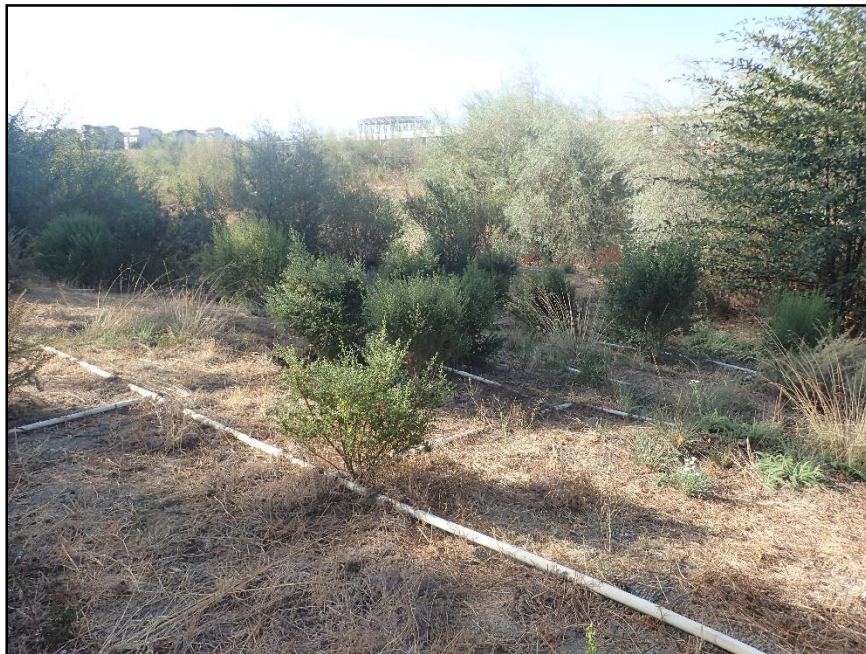
Photo 12. Photodocumentation Point 18B, looking south at the Floodplain Planting Zone (September 22, 2015)
