ALUM ROCK FISH PASSAGE PROJECT MITIGATION MONITORING REPORT YEAR TWO, 2014

Santa Clara Valley Transportation Authority
3331 North First Street Bldg. B-2
San Jose, CA 95143-1906
Contact: Ann Calnan
408.321.5976

ICF International
75 E. Santa Clara Street, Suite 300
San Jose, CA 95113
Contact: Donna Maniscalco
408.216.2802

March 2015

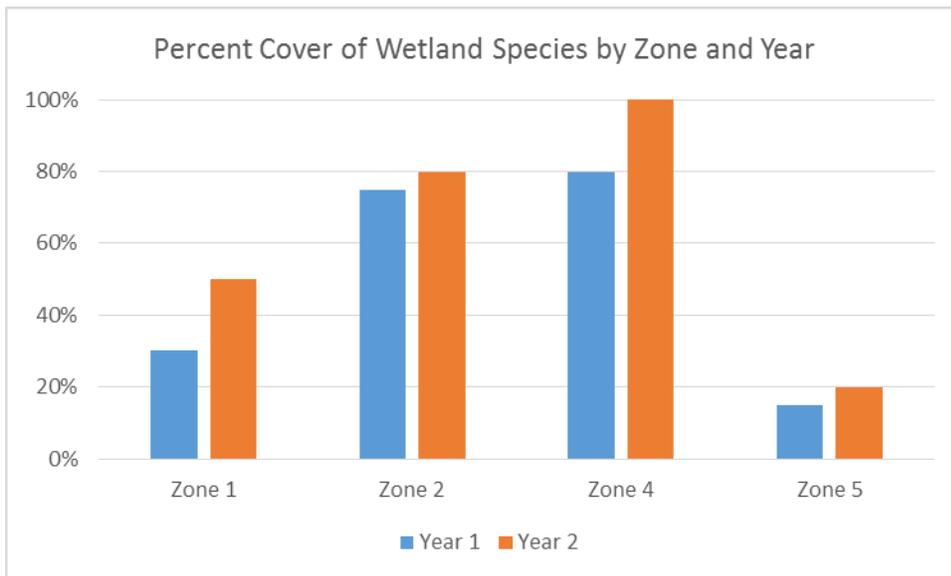
Figure 6. Percent Cover of Wetland Species by Zone and Year

| Zone | Year 1 | | Year 2 | |
|---|---|---|---|---|
| Average | 50% | Yes | 63% | Yes |

Note: For Year 2, the success criterion for Objective 1 is a minimum of 35% aerial cover of native facultative and wetter species within the re-established scrub/shrub and emergent floodplain area.

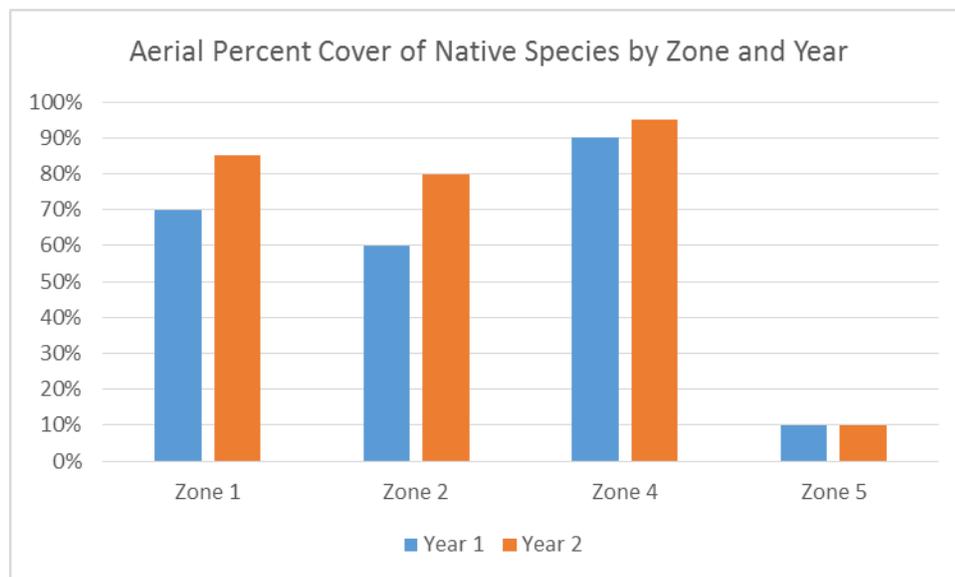
Figure 7. Percent Cover of Native Species by Zone and Year

| Aerial Percent Cover of Native Species Zone | Year 1 | | Year 2 | |
|---|---|---|---|---|
| Average | 58% | Yes | 68% | Yes |

Note: For Year 2, the success criterion for Objective 2 is a minimum of 25% aerial cover of all native species within the riparian and restored upland area.

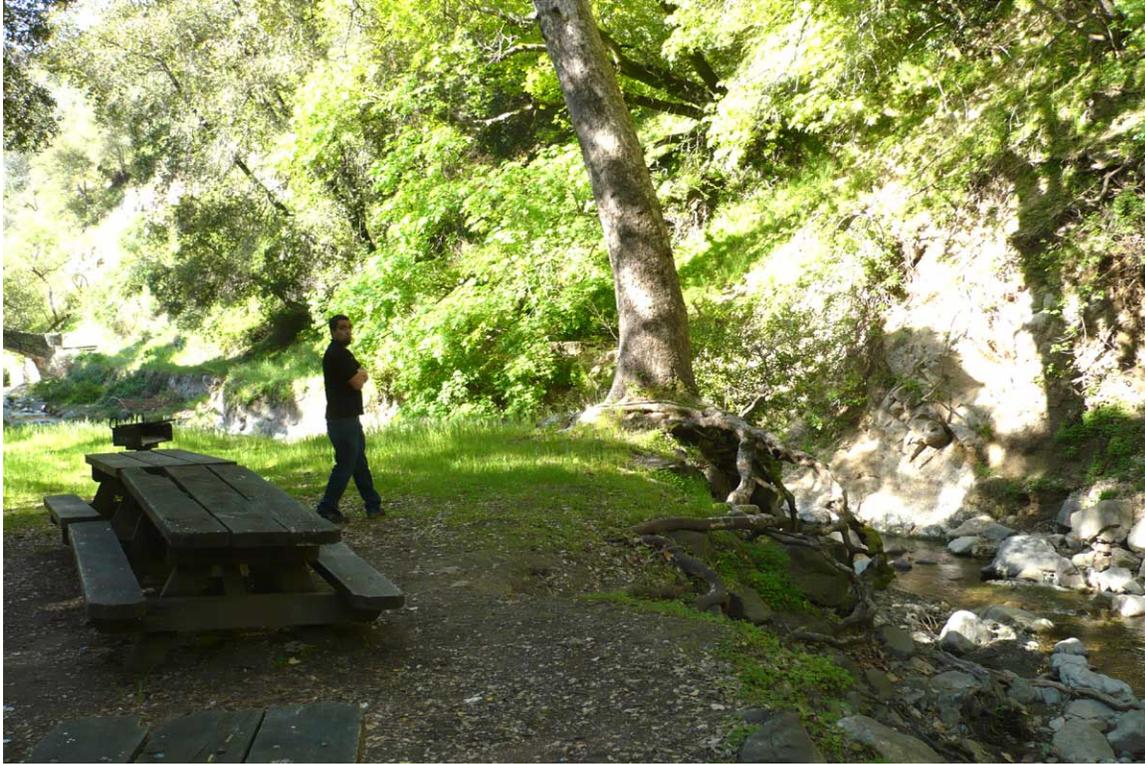
Project 11: Mature Sycamore Tree and Picnic Area

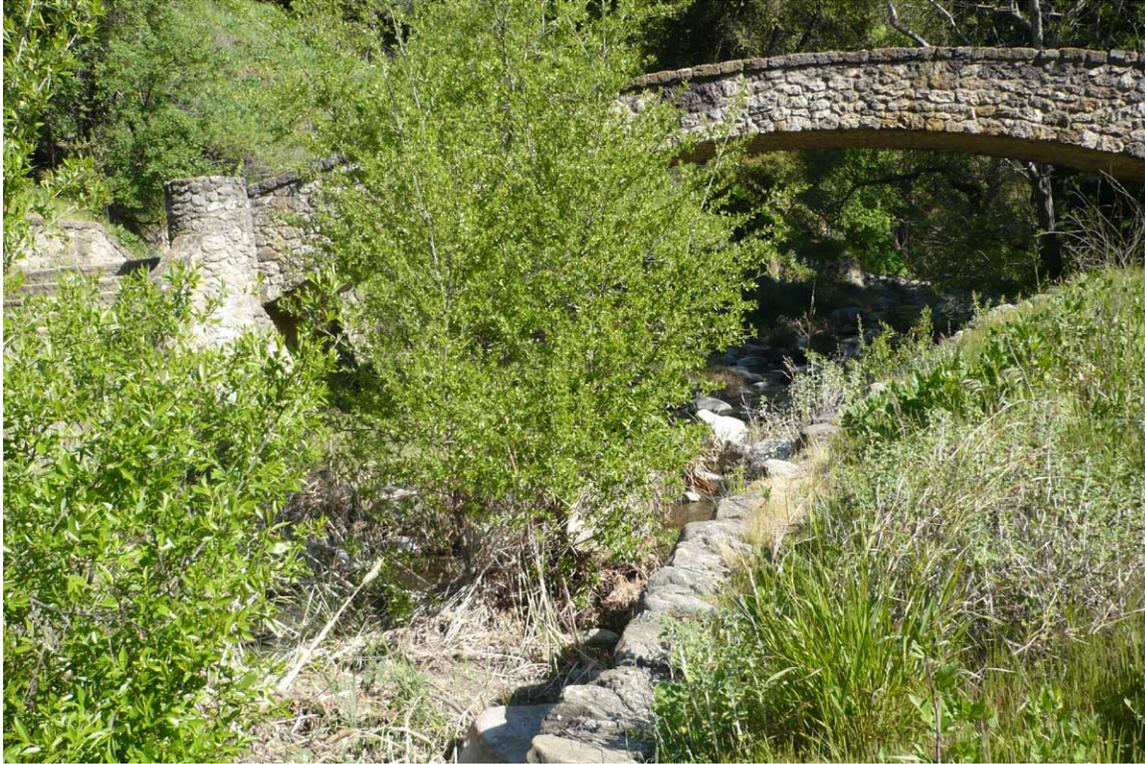
Project 3 and 10: Rock Wall Looking Upstream

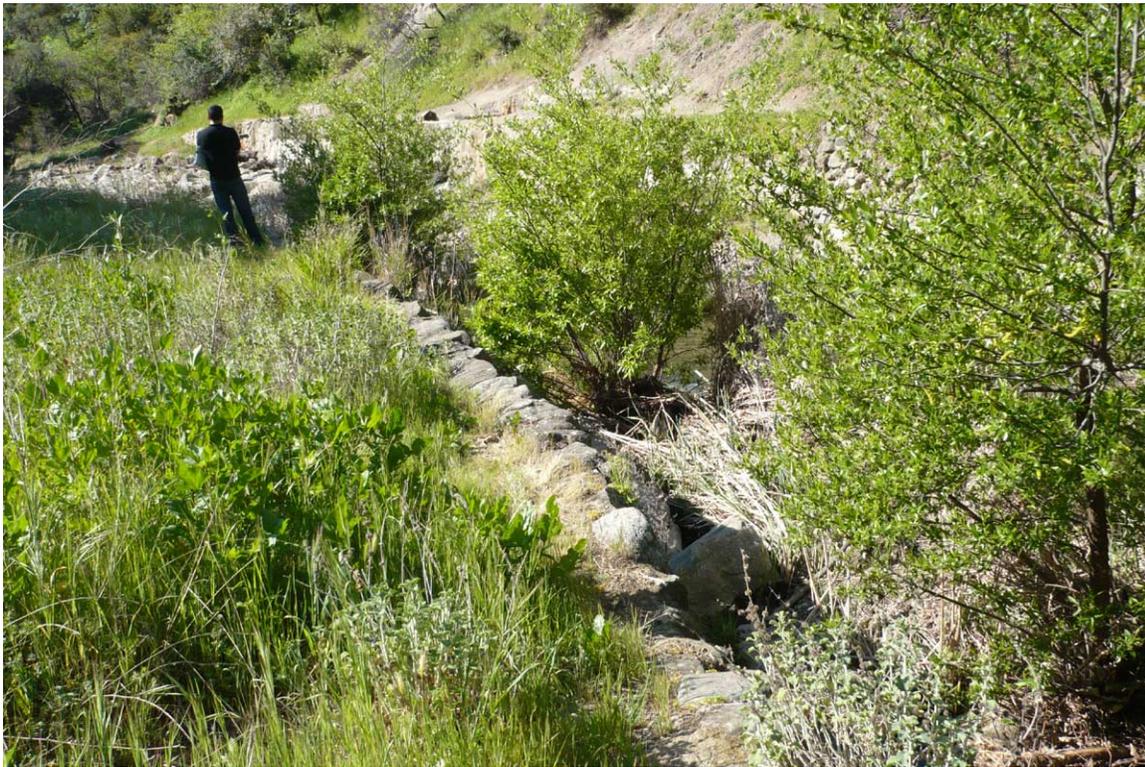
Project 3 and 10: Rock Wall Looking Downstream

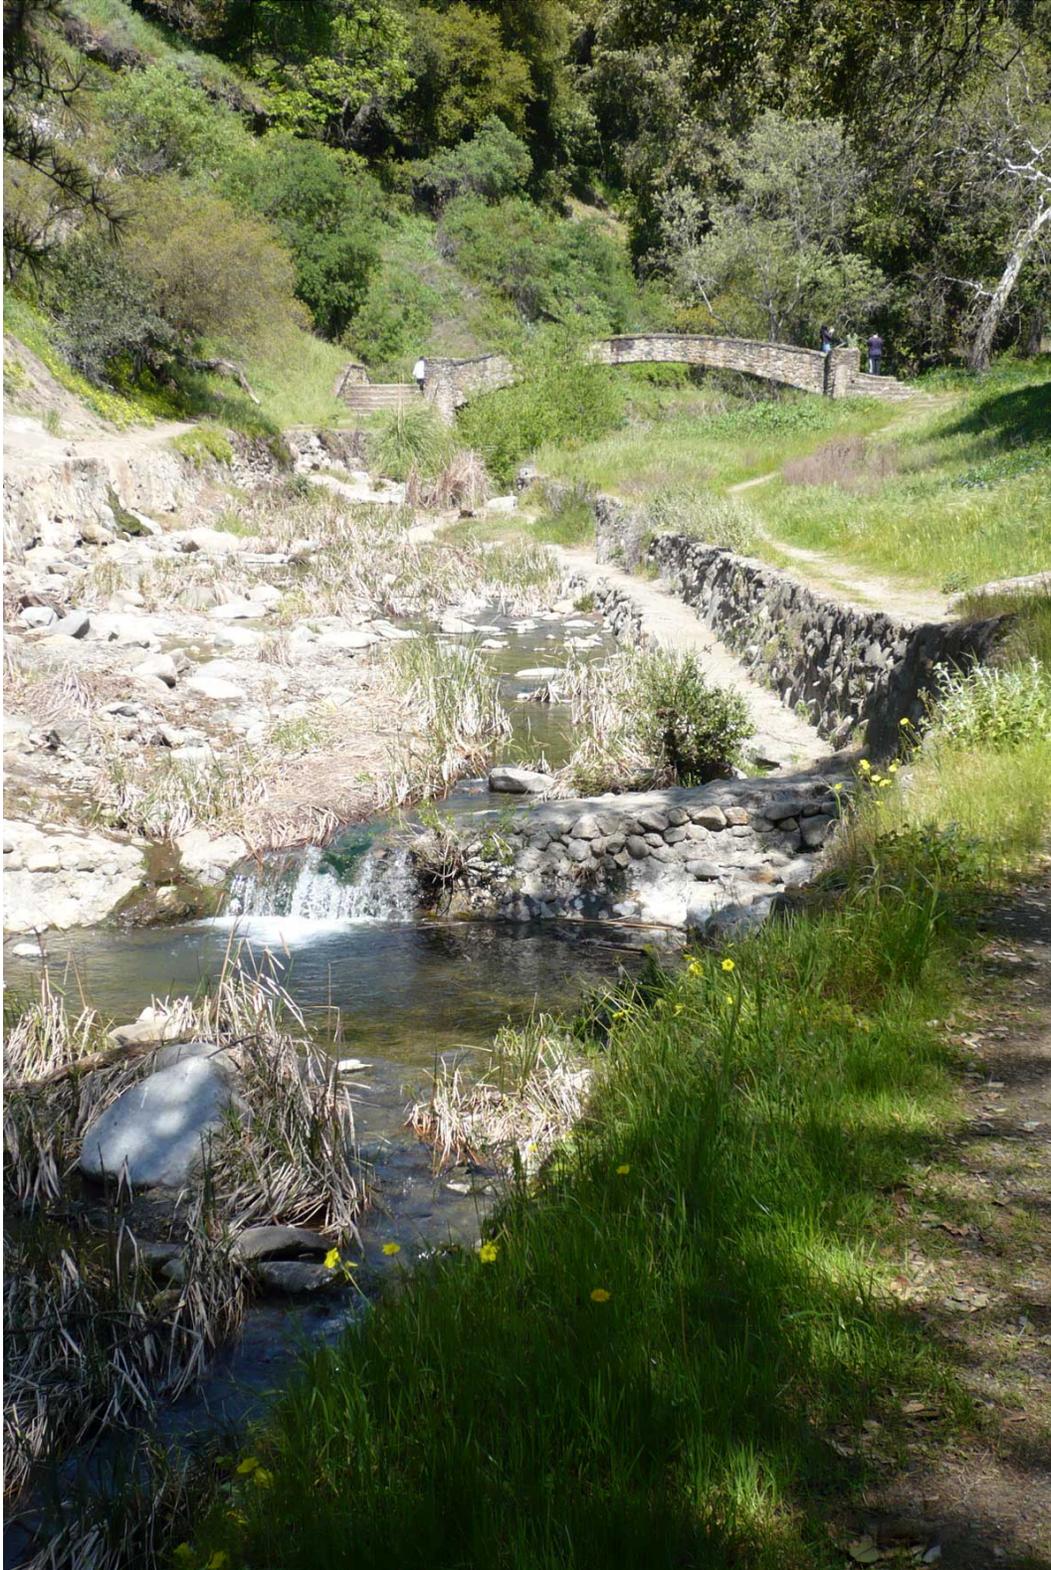
Project 3 and 10: Overview of Floodplain Re-establishment Area

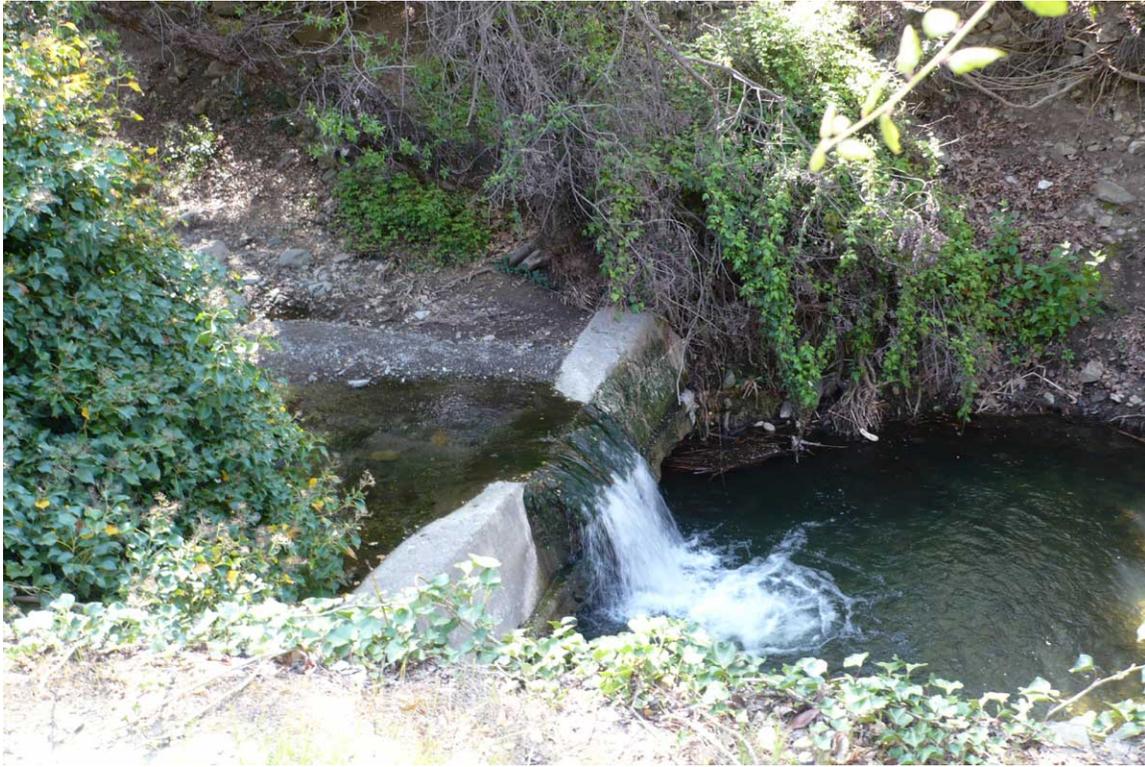
Project 5 and 13/CEMAR: Weir Area, Plunge Pool

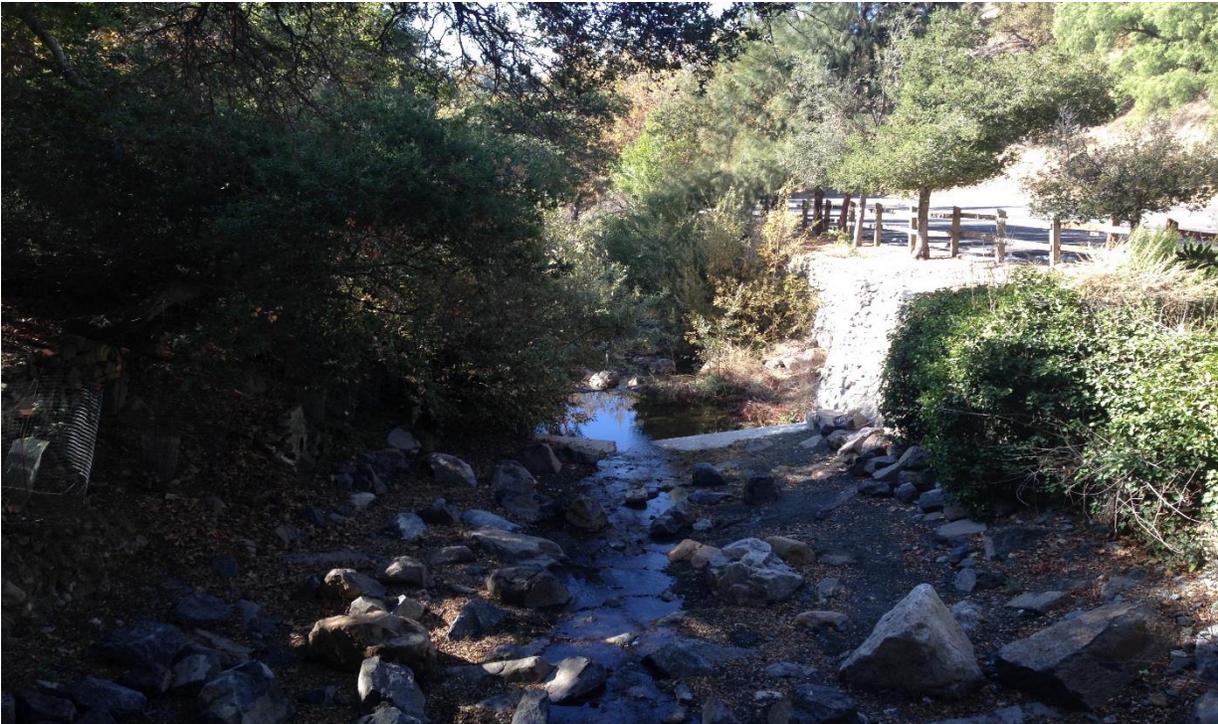
Photo 1. Looking west from YSI Bridge (Zones 1 and 2)

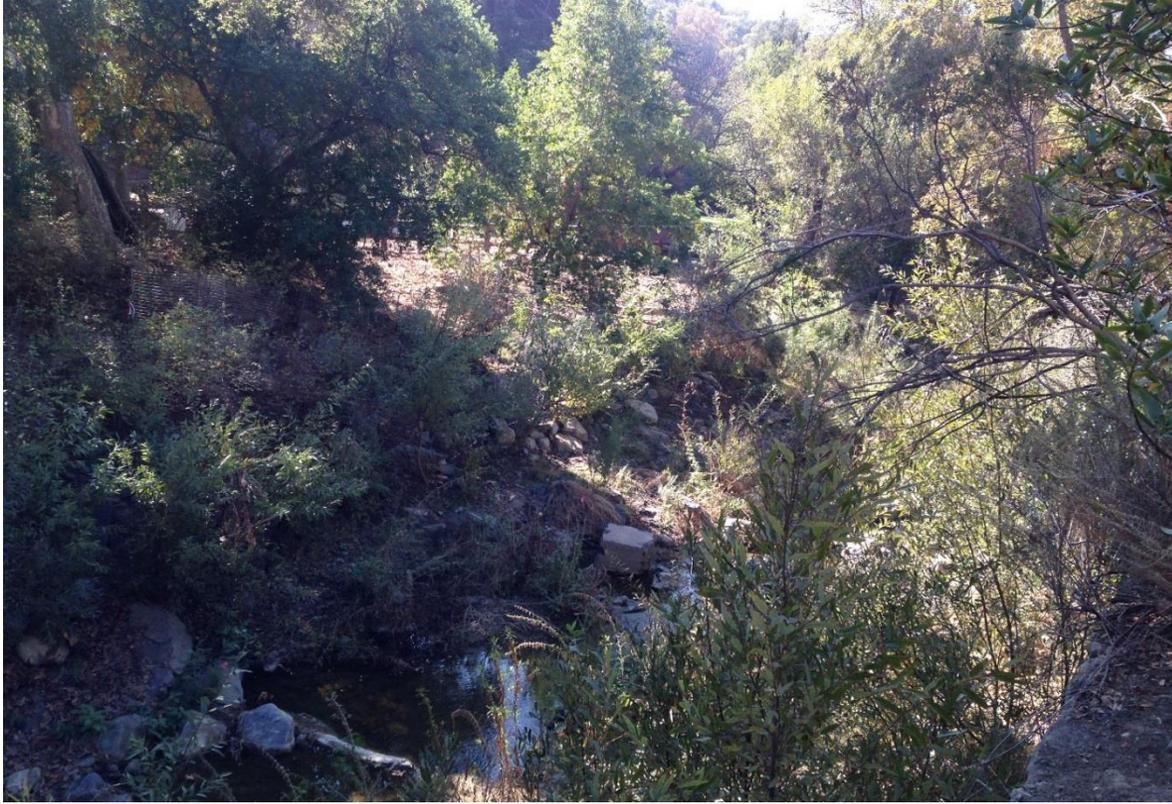
Photo 2. Looking southwest from north bank (Zones 1 and 2)

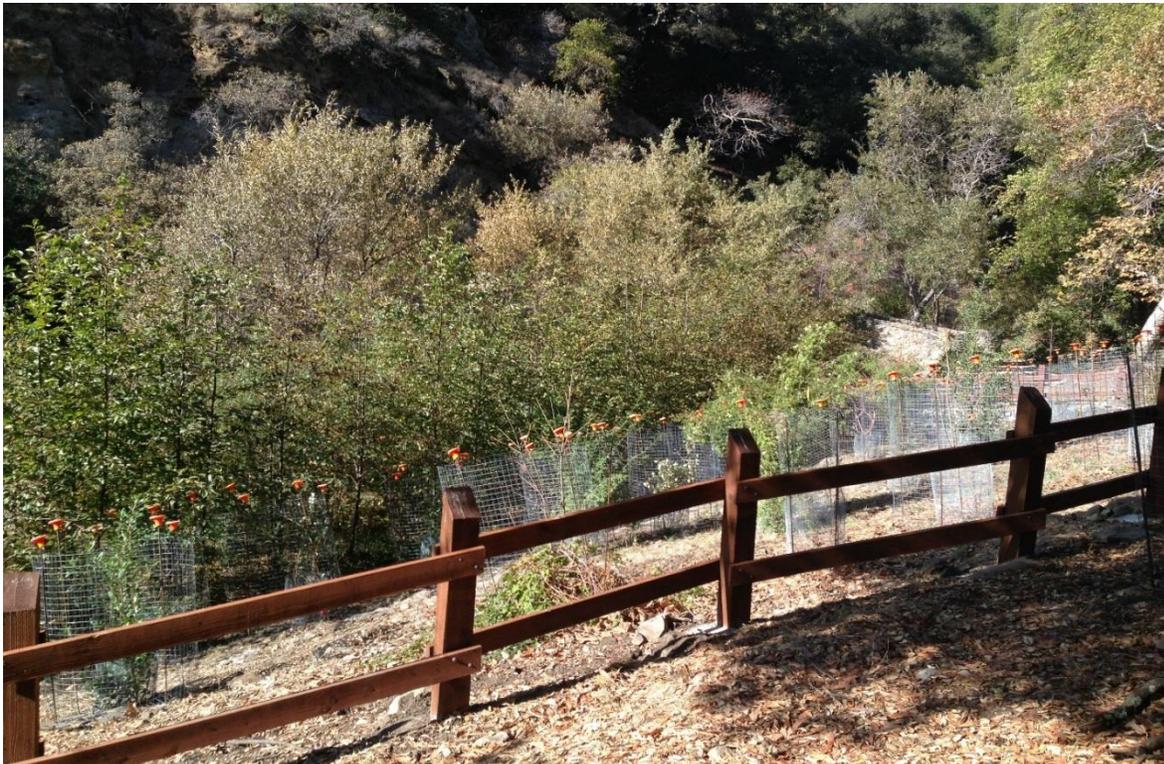
Photo 3. Looking northeast to floodplain from pedestrian path (Zones 4 and 5).

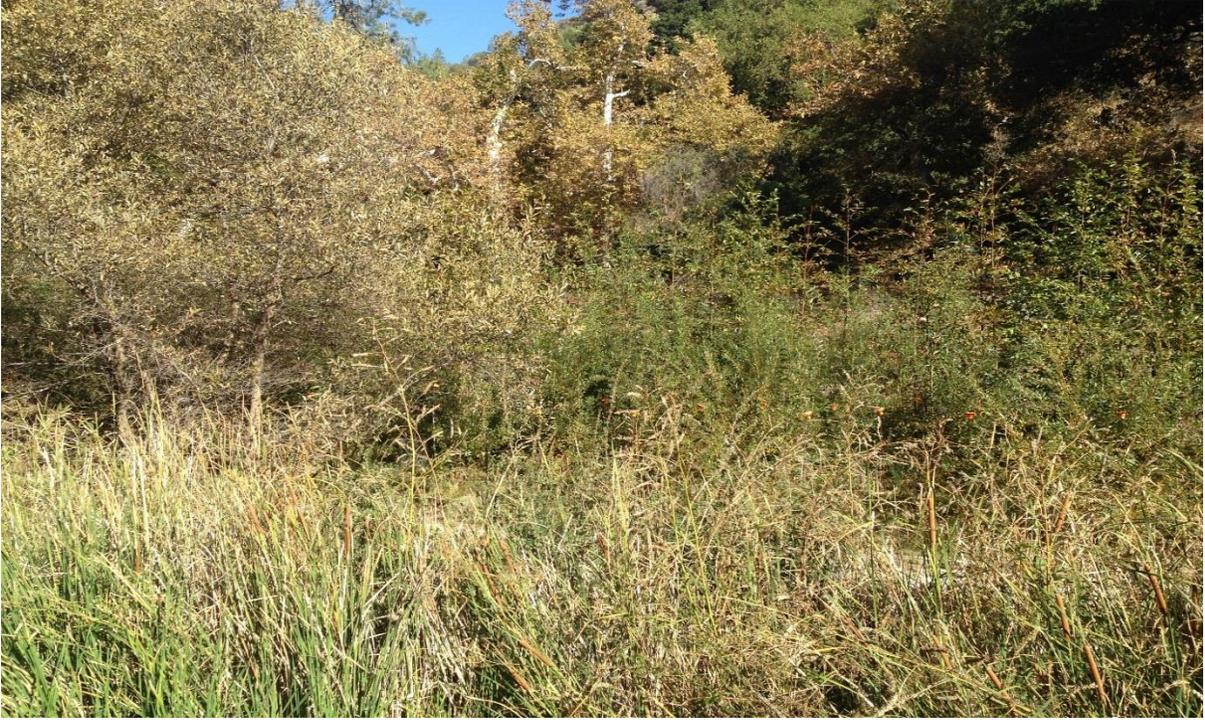
Photo 4. Looking south at Zone 4 from north bank of creek.

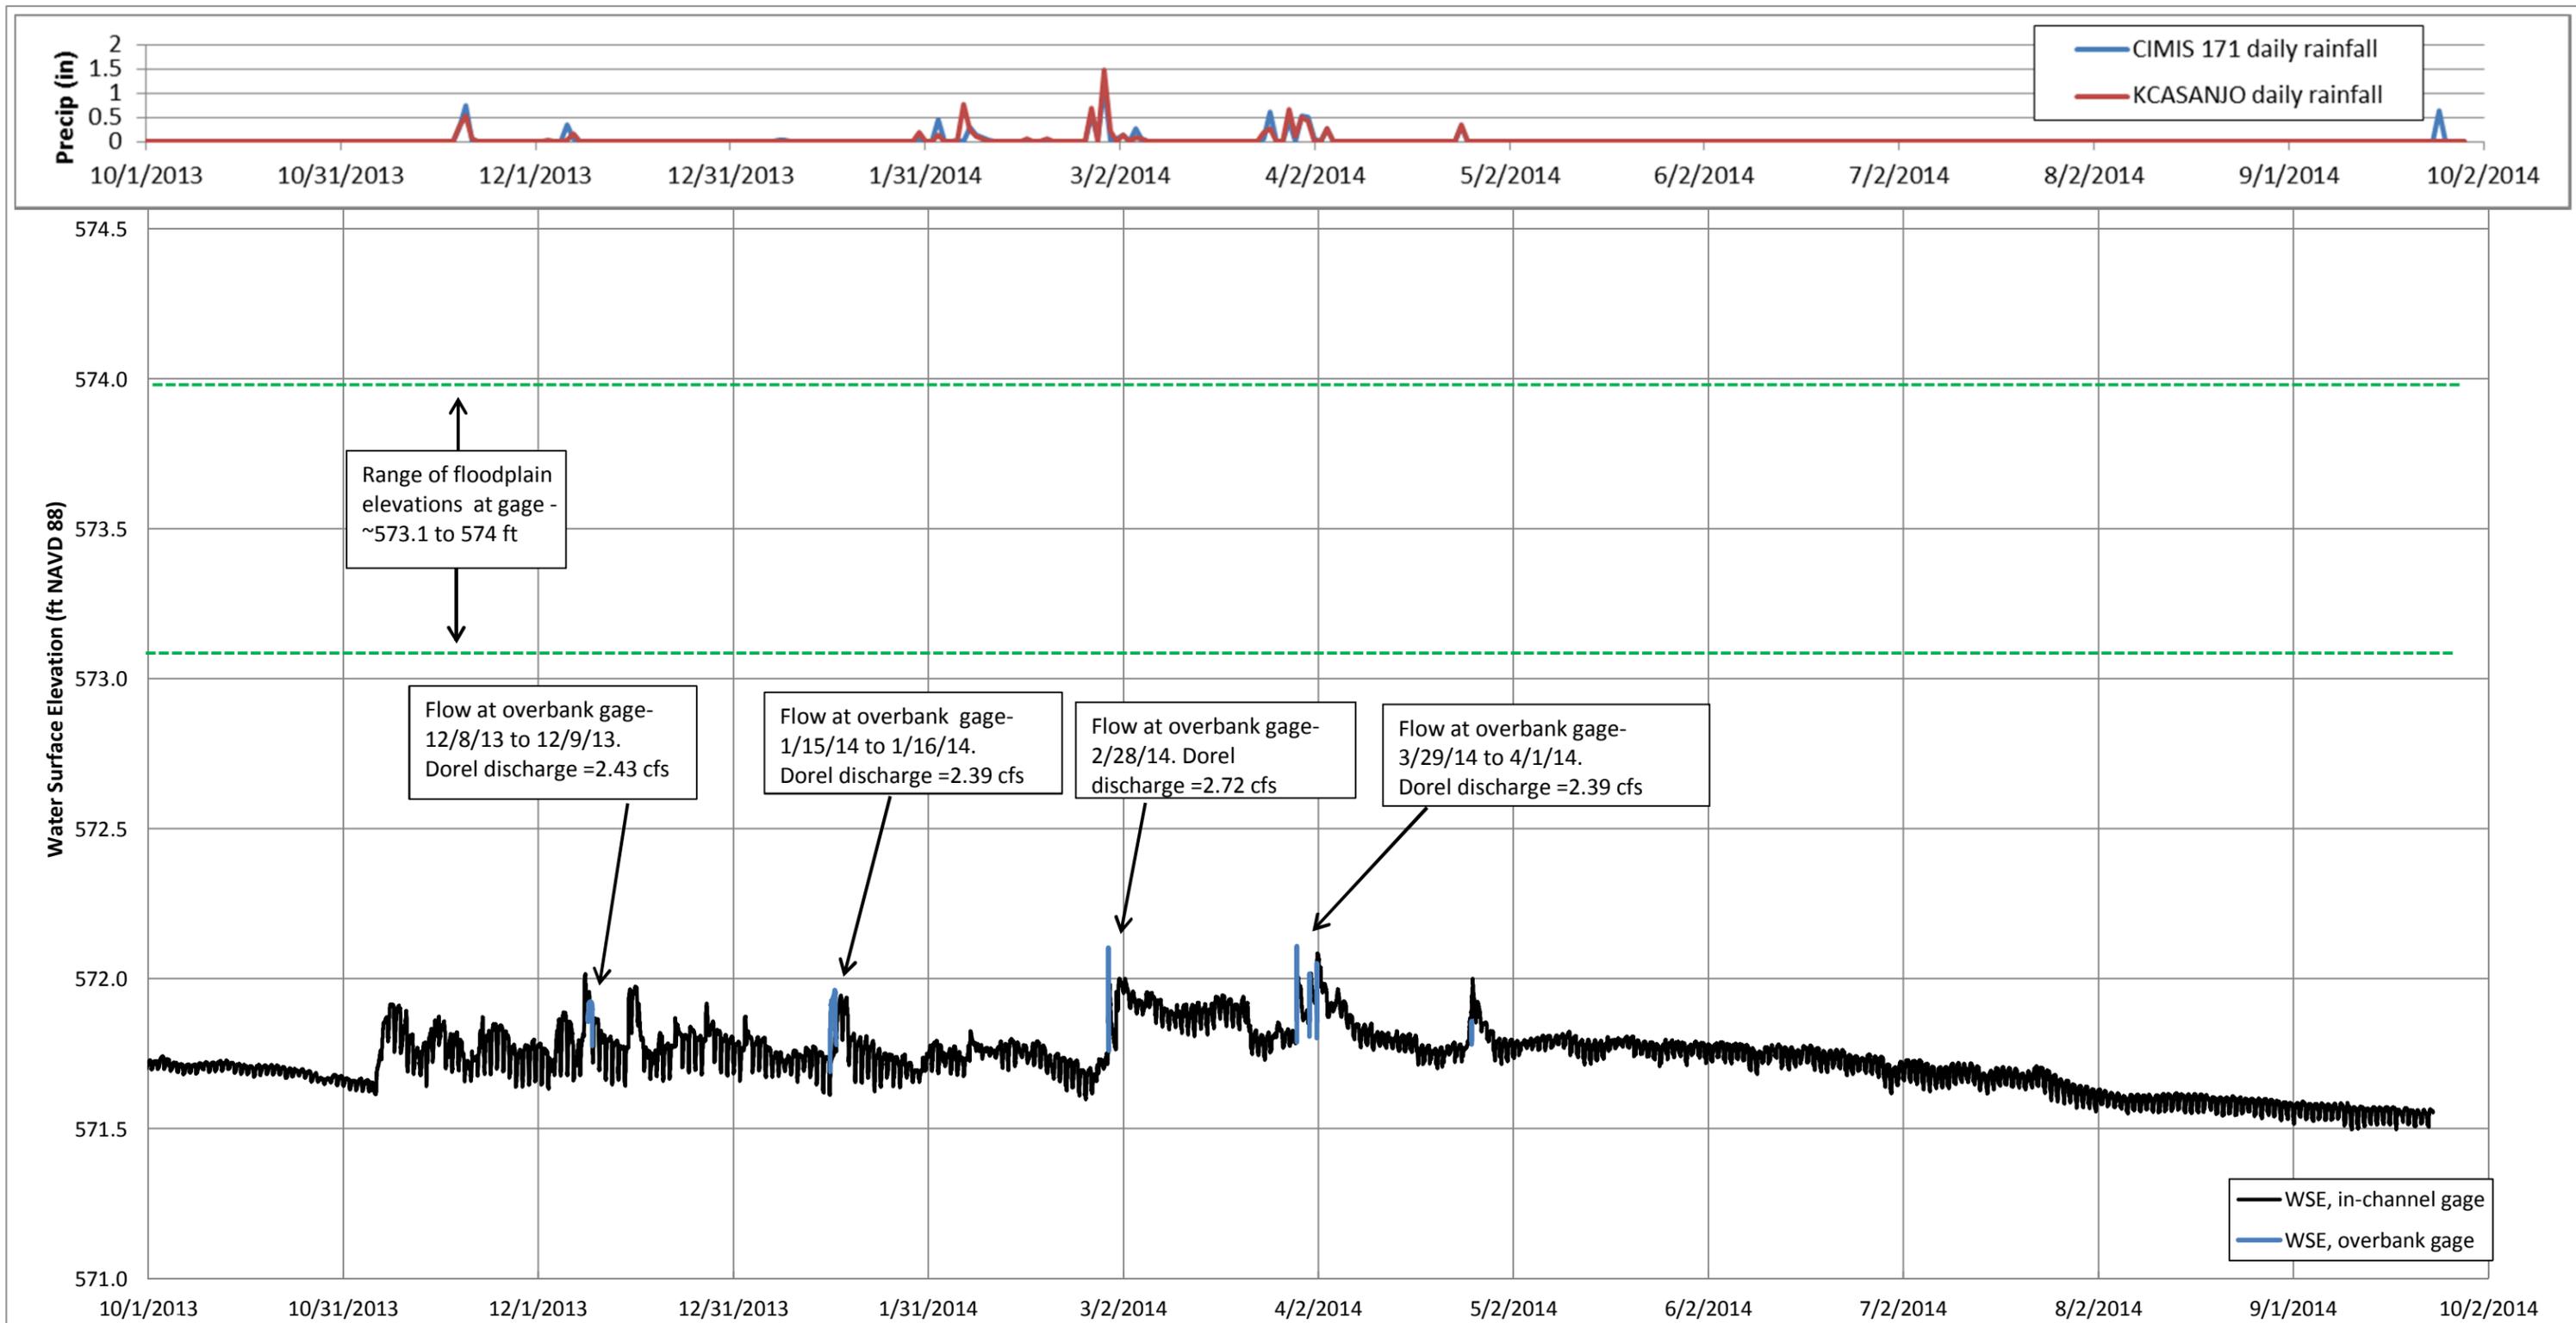
Figure 6.

Figure 6 shows the Alum Rock in-channel stage data converted to elevation in feet NAVD 88, from which displays the flow in the context of the elevation of the floodplain. Superimposed on this plot are portions of the flow record from the overbank gage. Due to the extremely dry year, this gage was out of the water for most of the year. Data recorded during these times were removed, and the peaks that represent inundation of the overbank gage are displayed in blue. Peaks at this gage do not necessarily represent inundation of the floodplain.

WY2014 was an exceptionally dry year, and runoff in the project area was primarily characterized as short-duration events (sometimes flow was elevated for as little as one hour). As a result, Balance staff were not able to be on site when the overbank gage was inundated and could not calibrate the logging pressure transducer record to the staff plate readings at the overbank gage. To tie in the gage to floodplain elevation, the elevation of the overbank peaks was matched to those recorded at the in-channel gage. The upper and lower extent of floodplain elevations adjacent to the gage are plotted with green dashed lines (**Figure 6**). This shows that while runoff events sometimes produced flow at the overbank gage, the floodplain, which is one to two feet above this gage, was not inundated this water year. We will endeavor to calibrate the overbank gage in the coming water year monitoring, and expect that the future years' data at the overbank gage will be calibrated to the staff plate and the project datum (NAVD 88).

Alum Rock water surface elevations measured within the channel and on the floodplain, Alum Rock monitoring, Santa Clara County, California. In-channel water surface elevation (WSE) is calculated from surveys of the staff plate at the upstream datalogger. Floodplain WSE is approximated by adjusting flow records to match flooding peaks in the in-channel record. Floodplain flow records are only plotted during times of inundation. According to stage-discharge records for the SCVWD Dorel gage, a flow of approximately 2.4 cfs is needed to see a response at the overbank gage. When scaled for watershed size, Dorel discharge can be used to estimate Alum Rock discharge, a necessity because WY14 was dry and no field observations occurred while the floodplain staff plate was submerged. Efforts will be made to calibrate the floodplain staff during WY15.

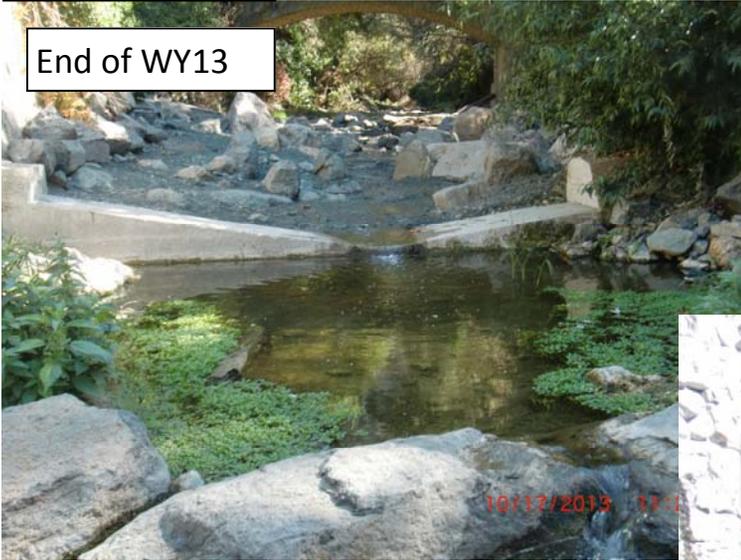
Figure 9.

Visual inspections and photo point comparisons (**Figures 7-16**) of Project Site 13 show that the fish passage seems to be functioning as intended. Little to no erosion of the bed or construction elements was observed, and the structure was in good condition. Many fingerling fish were observed in pools throughout the reach. Bed substrates were of gravel to cobble size, with finer silts observed downstream. Some thin layers of “crunchy” bed materials were noticed on the bed at the top of reach about 50 feet downstream of the bridge; these may be mineral deposits from the flowing water that formed into hardened layers. However, because they were thin and not extensive, they are unlikely to have an effect on bed conditions. Thick algal mats were growing in some pools, and riparian vegetation growth was generally vigorous from the edges of the channel to the toe of the steepened slopes.

Photo point 3 photographs looking upstream across pool 1 at the modified concrete grade control structure and pedestrian bridge in the fish passage project. WY13 photo taken November 2013. WY14 photo taken September 2014. Refer to Figure 1 of this report for photo point locations. Upper Penitencia Creek, Alum Rock Park, Santa Clara County, California.

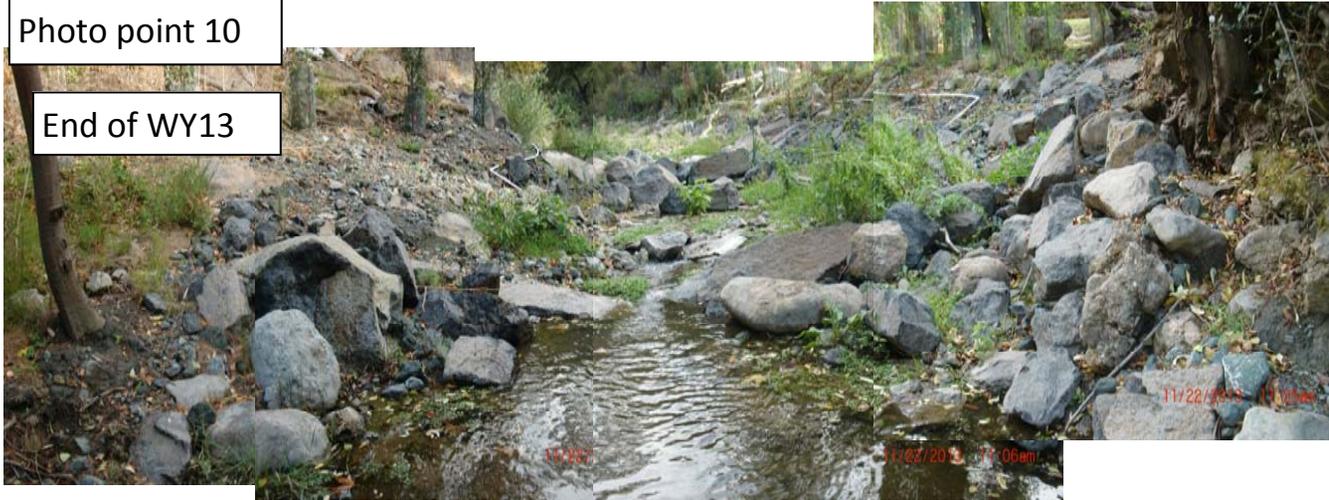
Figure 16.

Photo point 10 looking upstream from bottom of fish passage project. WY13 photo taken November 2013. WY14 photo taken September 2014. Refer to Figure 1 of this report for photo point locations. Upper Penitencia Creek, Alum Rock Park, Santa Clara County, California.

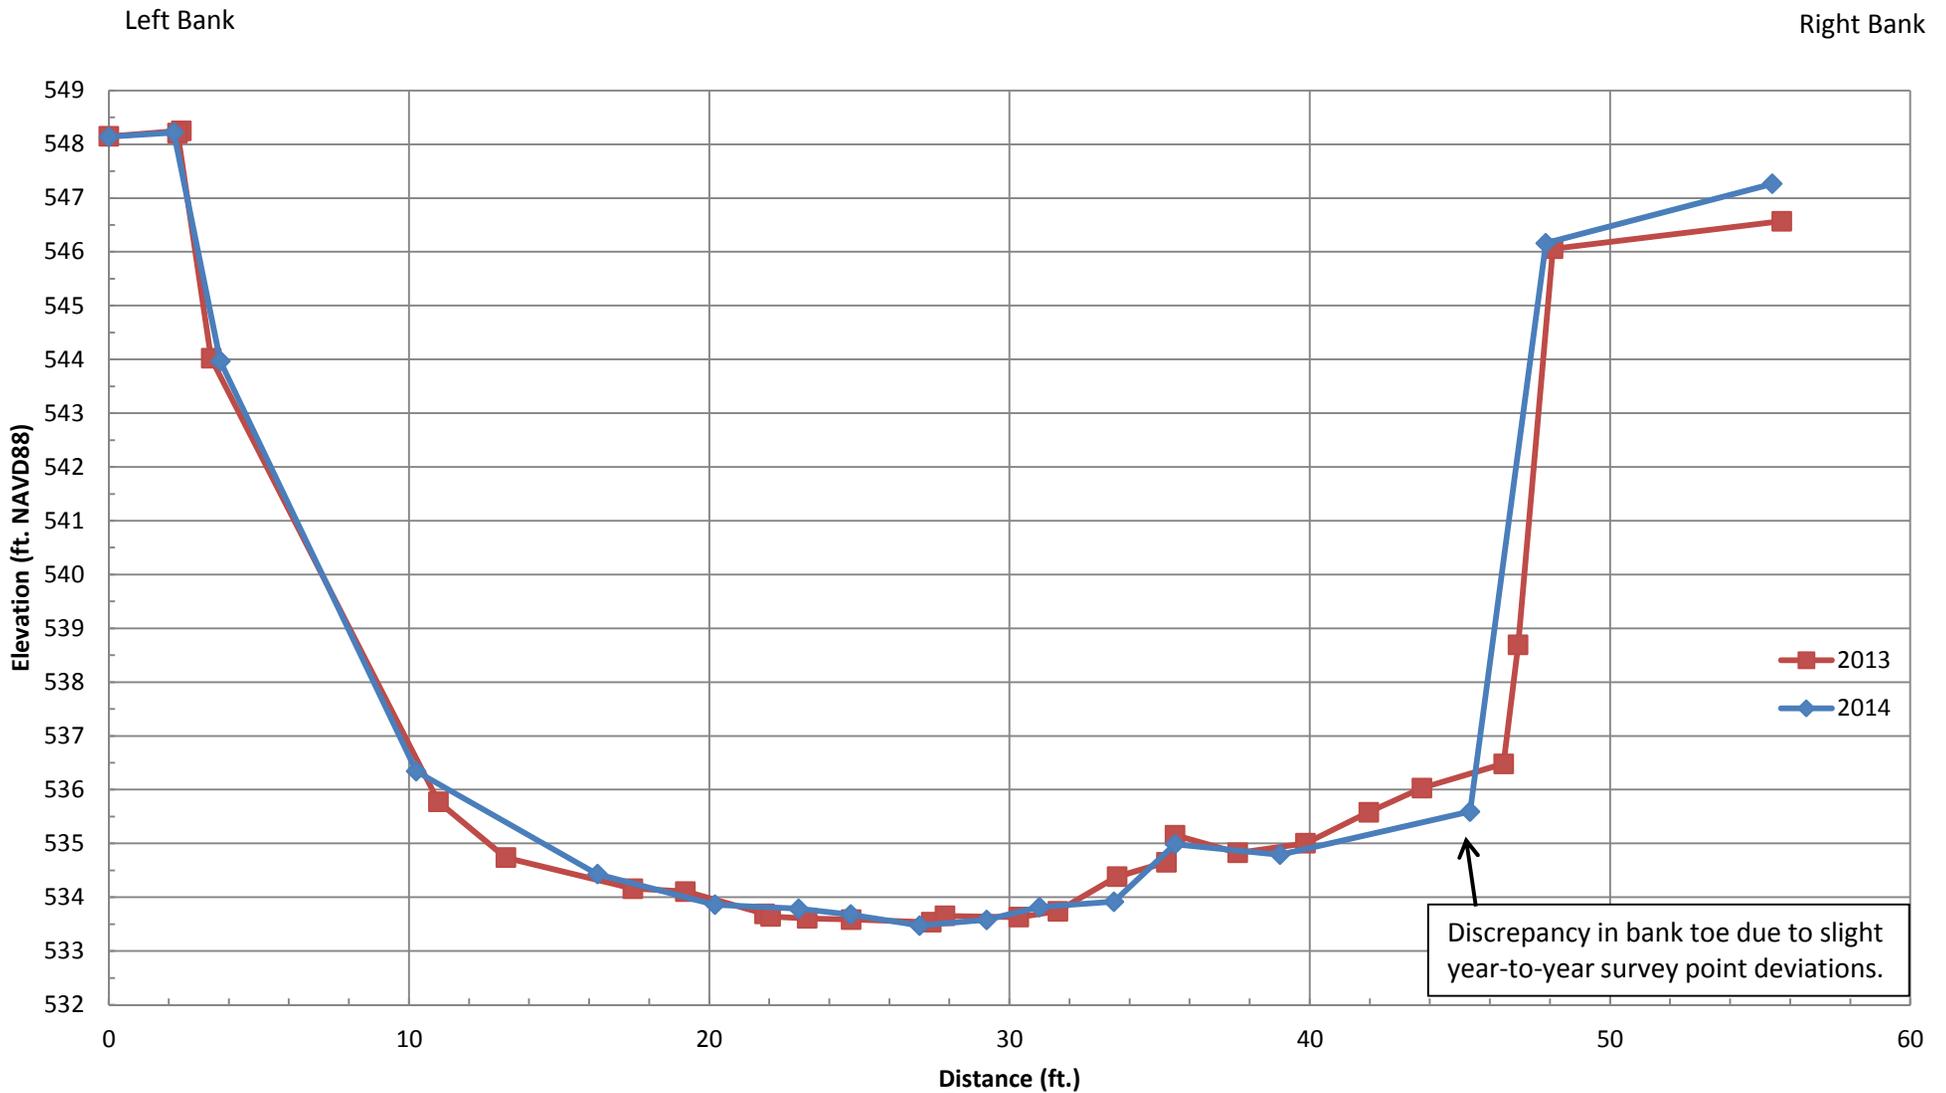
Figure 17 . Cross section 1, Alum Rock WY14 monitoring, Santa Clara County, California.

Figures 17-23 show the results of the September 2014 cross sections surveys. Comparisons of September 2014 survey data to baseline survey data generally confirm the results of the visual observations – little geomorphic change took place in the fish passage over WY2014. This result was expected due to the lack of high flow conditions. The general shape of the surveys shows no evidence of bank widening, downcutting, or aggradation. Some details of the channel bed vary from year to year, for example, XS 2 and XS 4 show such variations. However, based on visual assessment of the cross sections, it is believed this is due to inconsistencies with which rocks and boulders were included in the bed survey, rather than to geomorphic change.

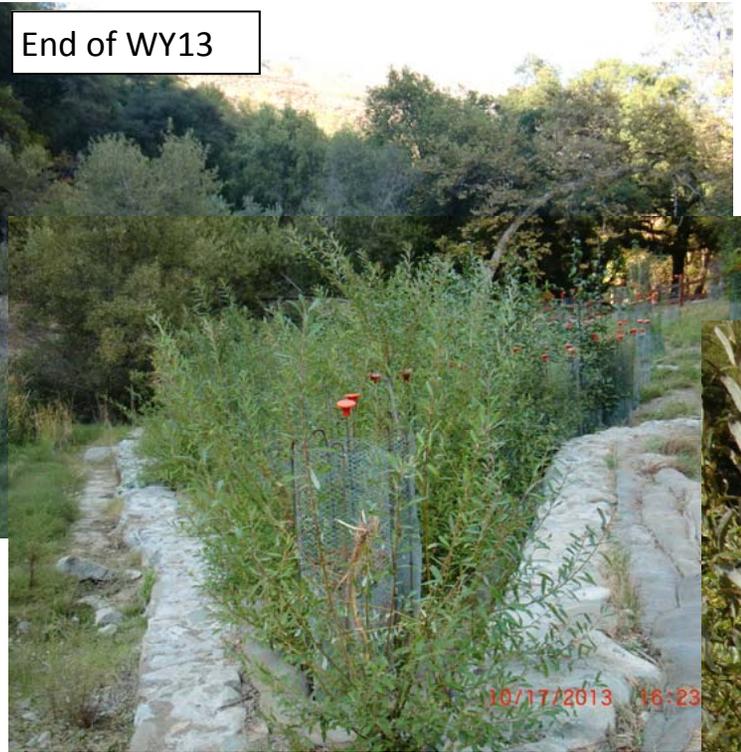
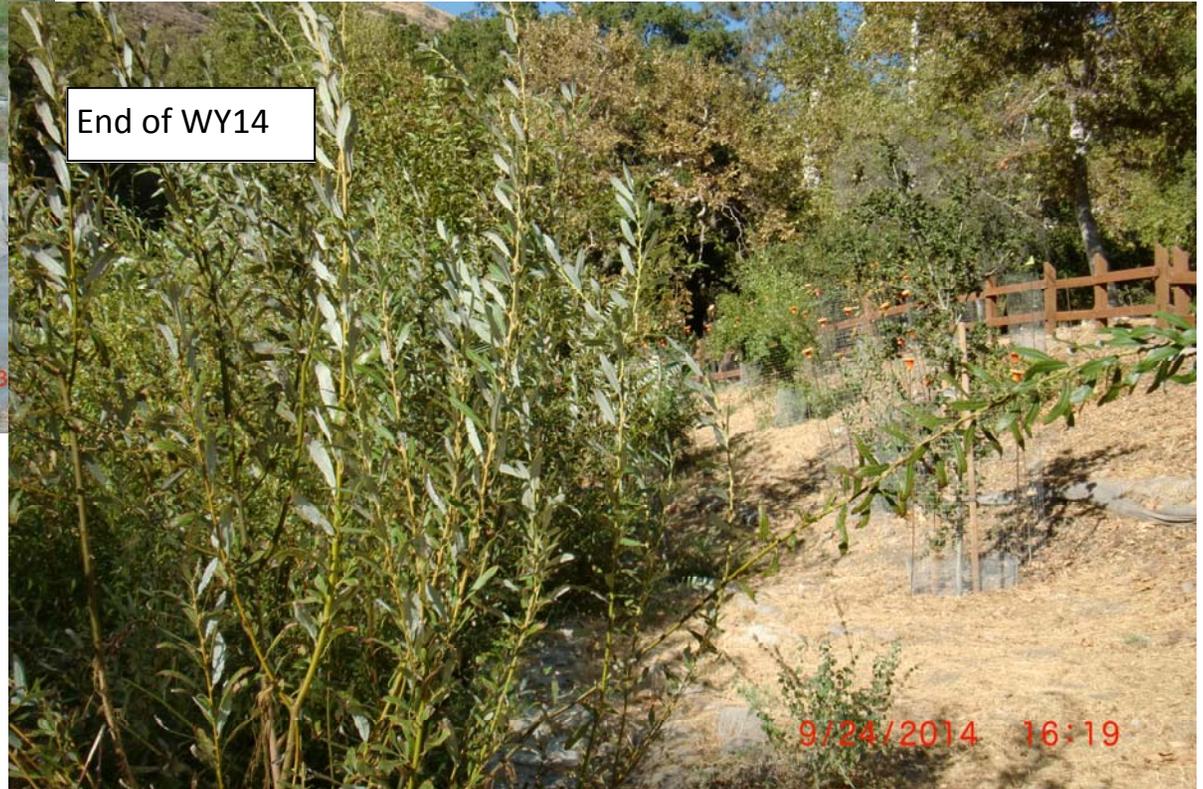
Figure 25.

Visual assessment of geomorphic change on the floodplain was marked by vigorous growth of alders and willows, as is evident in the photo points (**Figures 25-30**). No other significant geomorphic changes were observed. The connections from the main channel to the constructed floodplain have not changed significantly, other than an increase in the vegetation growing around them. The thickness of this vegetation may have the capacity to divert most of the high flows away from the floodplain, protecting it from erosion, but may strongly divert flows into the opposite bank, increasing the potential for erosion. Such flow patterns and bank changes will be assessed visually during and/or following high flows in the upcoming water years.

Photo point 11 looking upstream at Site 10 floodplain toward foot bridge. WY13 photo taken October 2013. WY14 photo taken September 2014. Refer to Figure 2 of this report for photo point locations. Upper Penitencia Creek, Alum Rock Park, Santa Clara County, California.

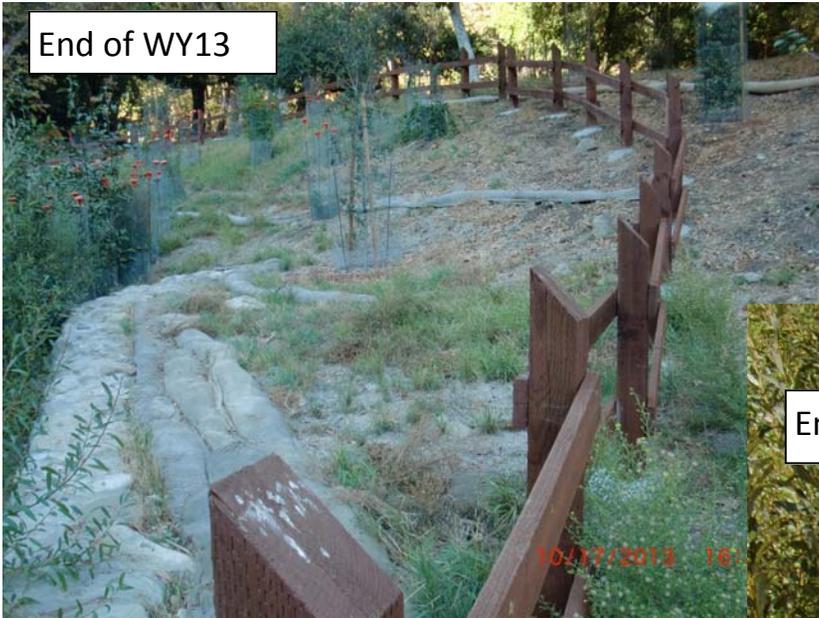
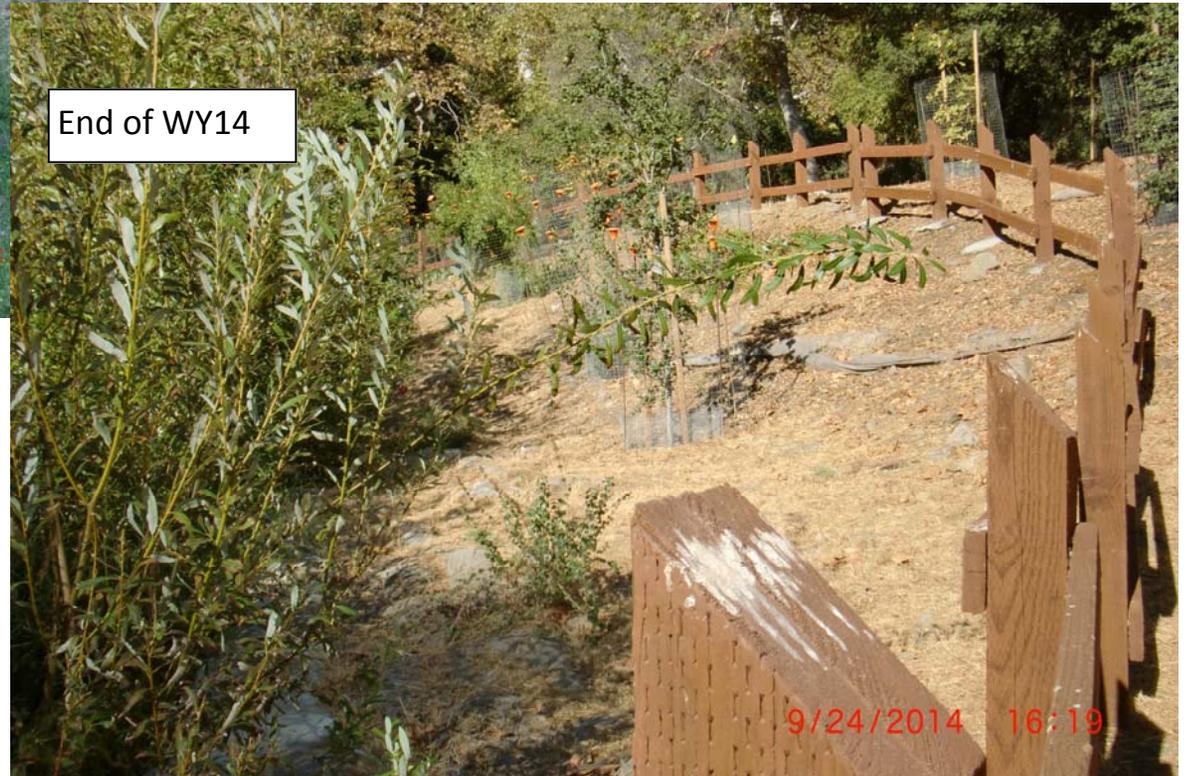
Figure 26.

Photo point 12 looking upslope at the downstream edge of the Site 10 floodplain. WY13 photo taken October 2013. WY14 photo taken September 2014. Refer to Figure 2 of this report for photo point locations. Upper Penitencia Creek, Alum Rock Park, Santa Clara County, California.
