ALUM ROCK FISH PASSAGE PROJECT MITIGATION MONITORING REPORT YEAR TWO, 2014

Santa Clara Valley Transportation Authority
3331 North First Street Bldg. B-2
San Jose, CA 95143-1906
Contact: Ann Calnan
408.321.5976

ICF International
75 E. Santa Clara Street, Suite 300
San Jose, CA 95113
Contact: Donna Maniscalco
408.216.2802

March 2015

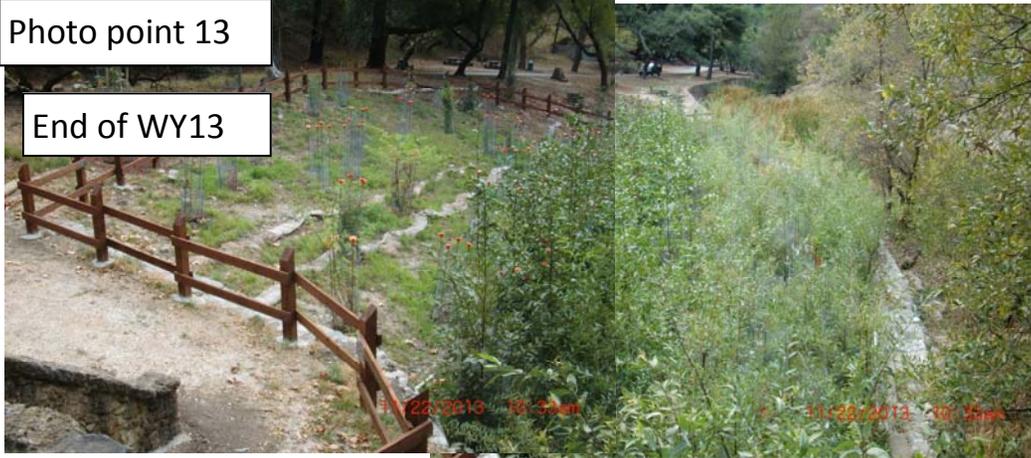
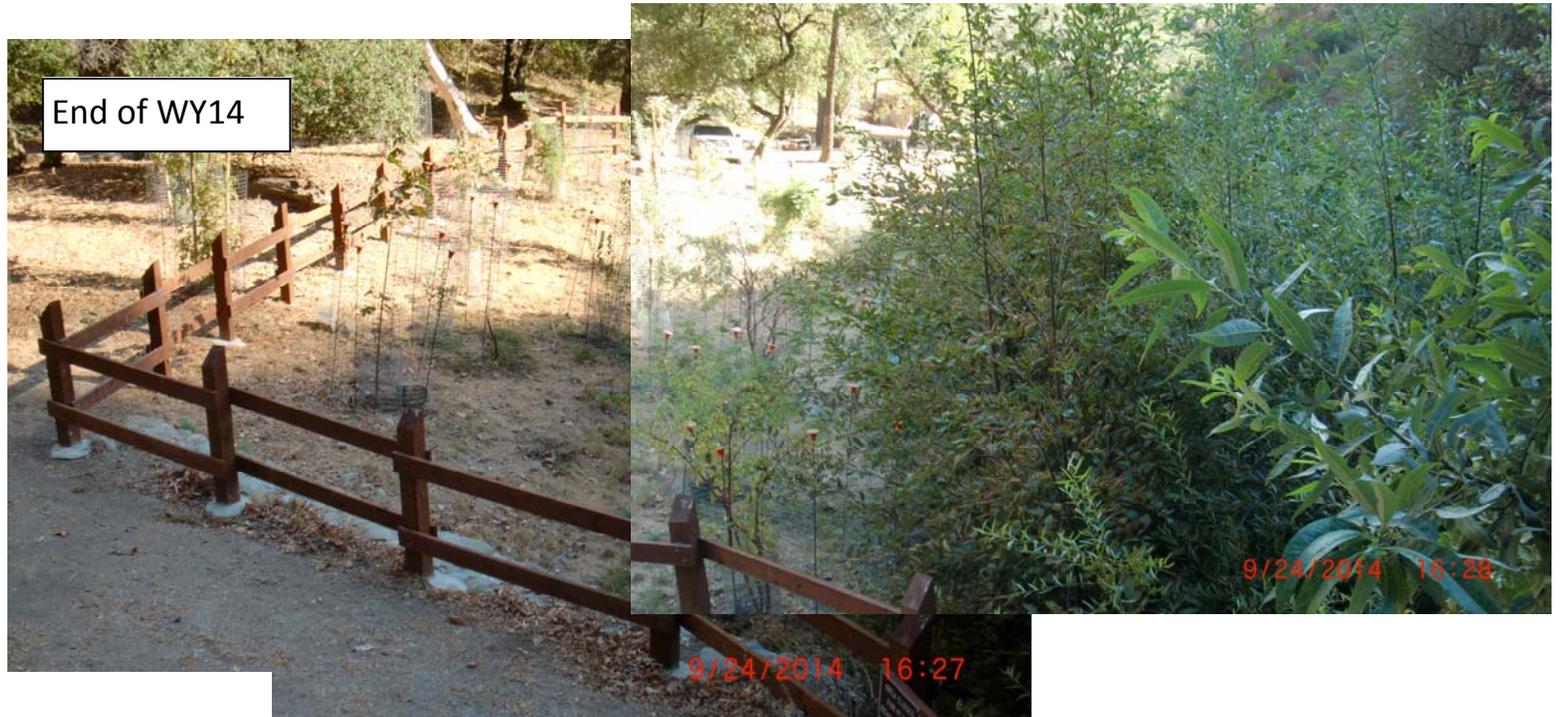
Figure 27.

Visual assessment of geomorphic change on the floodplain was marked by vigorous growth of alders and willows, as is evident in the photo points (**Figures 25-30**). No other significant geomorphic changes were observed. The connections from the main channel to the constructed floodplain have not changed significantly, other than an increase in the vegetation growing around them. The thickness of this vegetation may have the capacity to divert most of the high flows away from the floodplain, protecting it from erosion, but may strongly divert flows into the opposite bank, increasing the potential for erosion. Such flow patterns and bank changes will be assessed visually during and/or following high flows in the upcoming water years.

Photo point 13 looking downstream from foot bridge at Site 10 floodplain. WY13 photo taken November 2013. WY14 photo taken September 2014. Refer to Figure 2 of this report for photo point locations. Upper Penitencia Creek, Alum Rock Park, Santa Clara County, California.

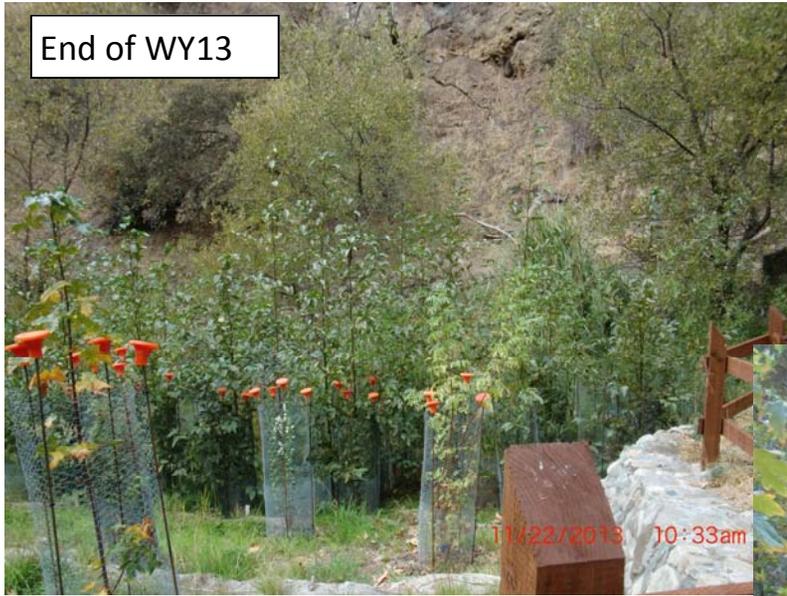
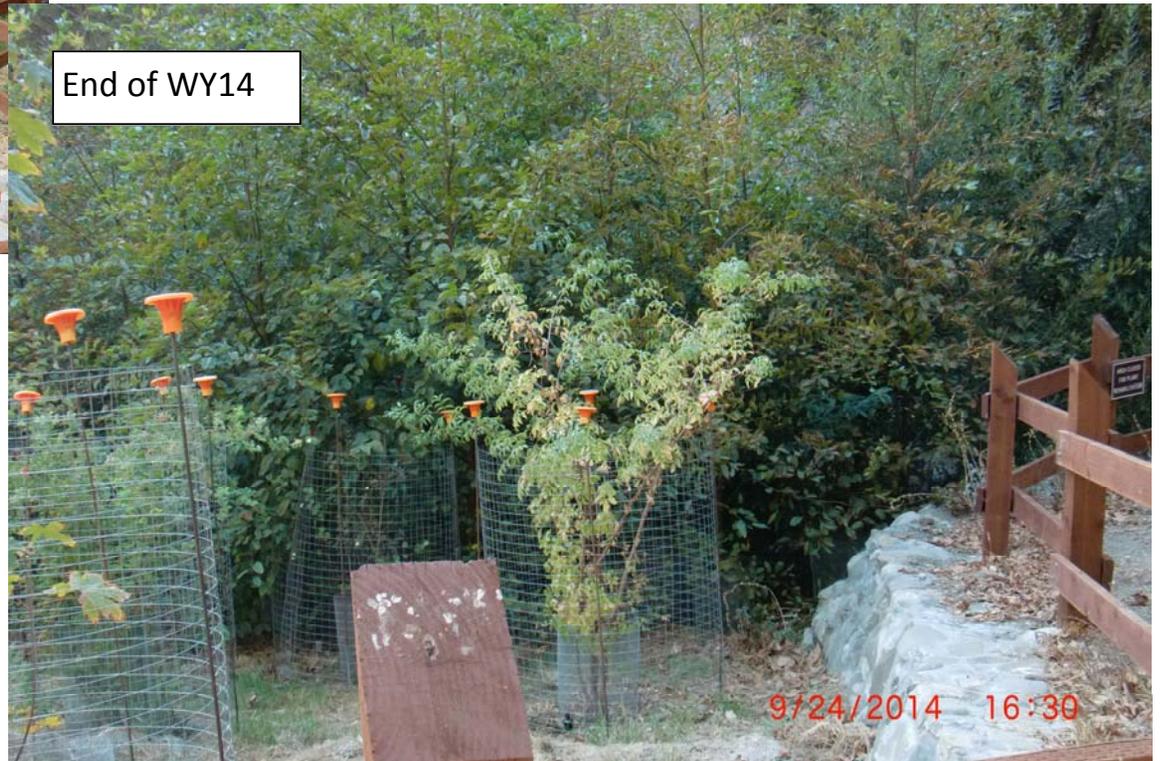
Figure 28.

Photo point 14 looking from upslope across XS 101 at Site 10 floodplain. WY13 photo taken November 2013. WY14 photo taken September 2014. Refer to Figure 2 of this report for photo point locations. Upper Penitencia Creek, Alum Rock Park, Santa Clara County, California.

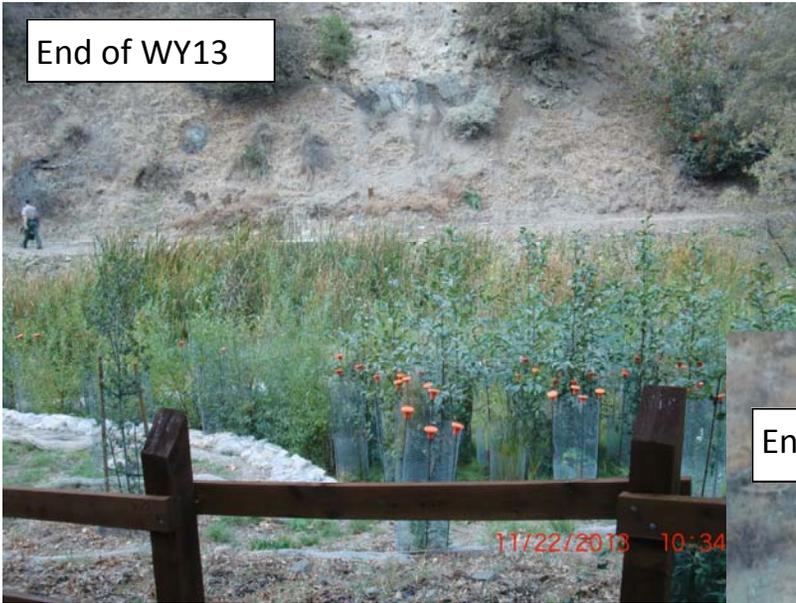
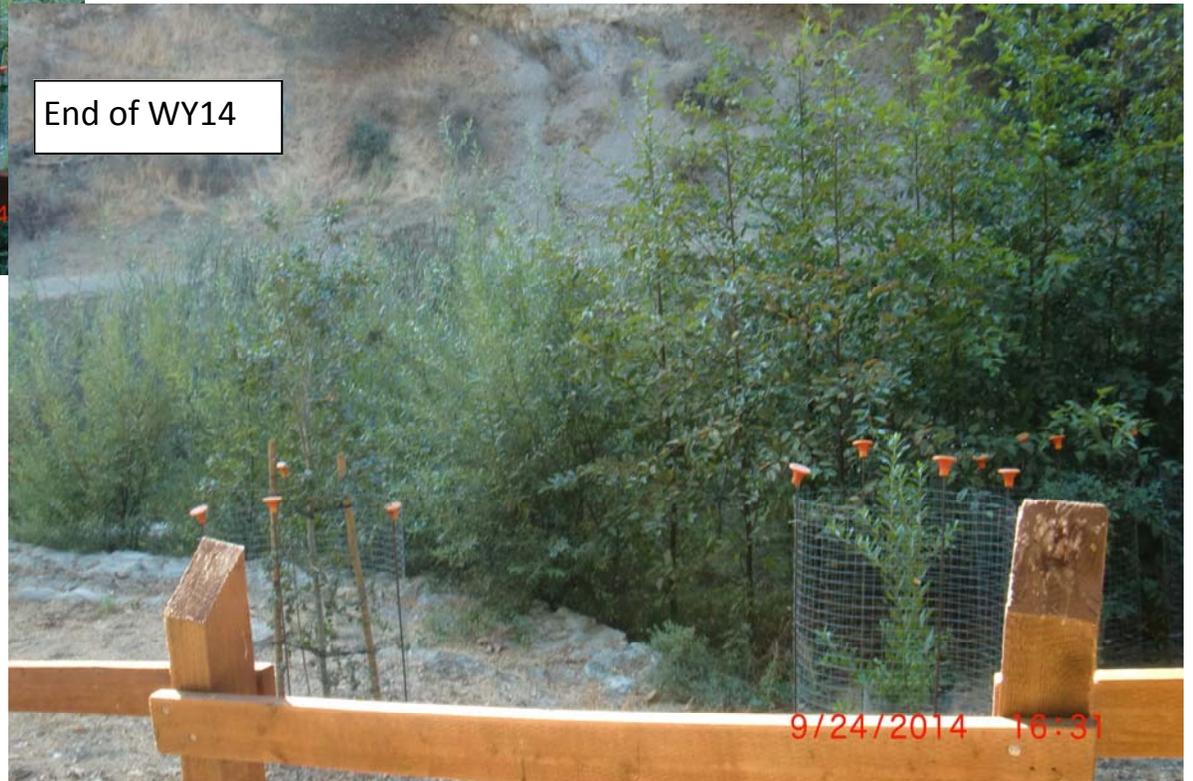
Figure 29.

Photo point 15 looking from upslope across XS 102 at Site 10 floodplain. WY13 photo taken November 2013. WY14 photo taken September 2014. Refer to Figure 2 of this report for photo point locations. Upper Penitencia Creek, Alum Rock Park, Santa Clara County, California.

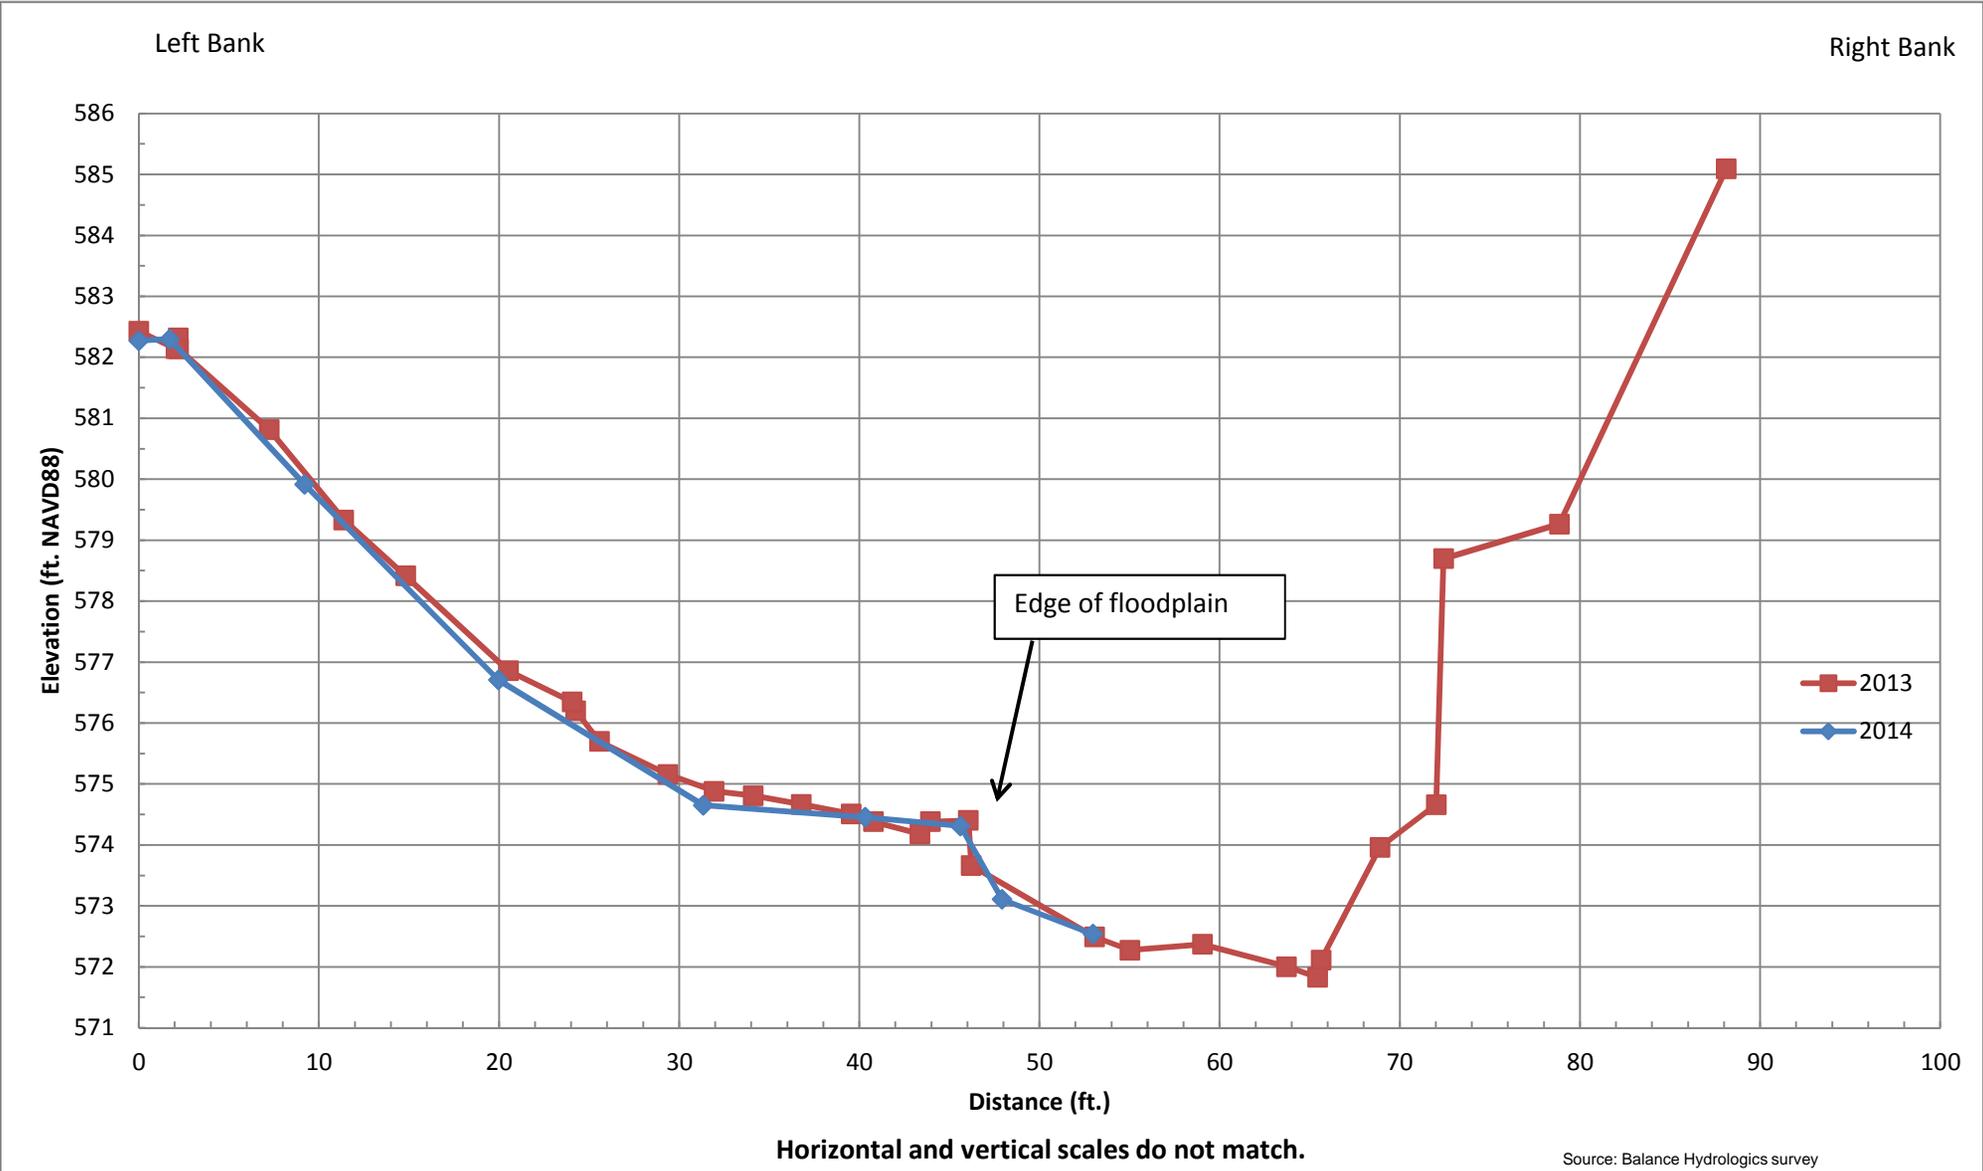
Figure 31 . Cross section 101, Alum Rock WY14 monitoring, Santa Clara County, California.

Figures 31-32 show the results of the September 2014 cross sections surveys. Comparisons of the September 2014 survey to the baseline survey generally confirm the results of the visual observations: little geomorphic change took place in the floodplain over WY2014. This result was expected due to the lack of high flow conditions. The comparison of the surveyed cross sections shows no evidence of channel widening, downcutting, or aggradation. Some of the details of the channel bed vary from year to year, but these changes are relatively minor. The floodplain is included in the survey of XS 101. We did not survey the right channel bank or channel thalweg during the September 2014 surveys. XS 102 shows

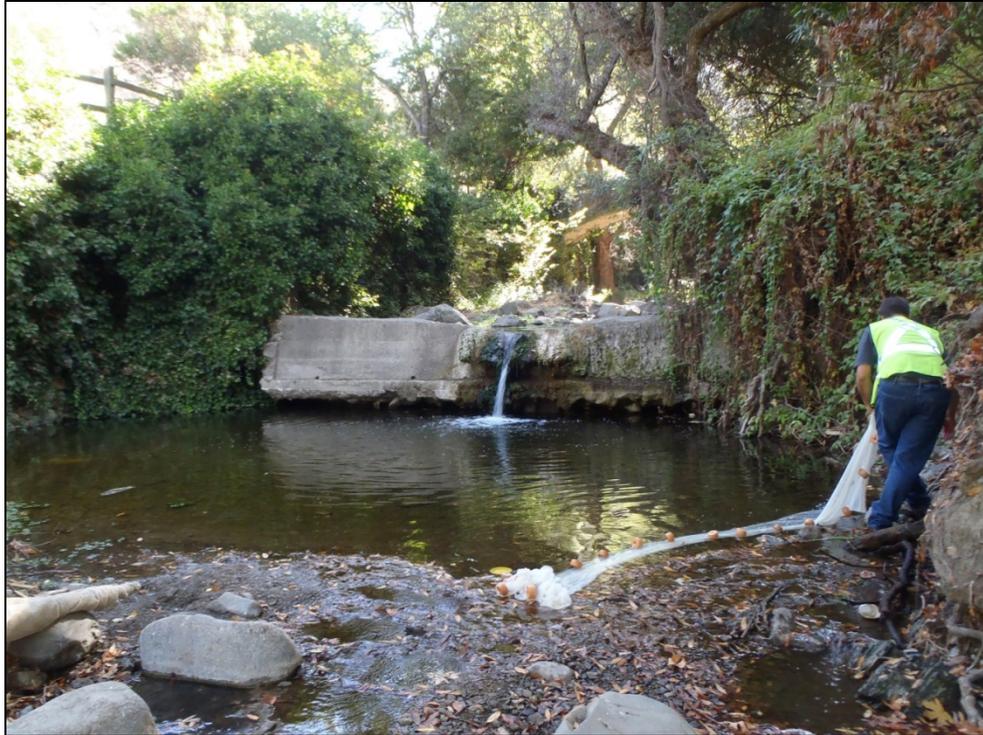
Fish passage in the Project reach was improved by modifying a 4.5-ft high concrete weir (crest of weir to normal pool surface) to allow passage by steelhead (Figure 1, Figure 2) and constructing a 225-ft long roughened channel. Project monitoring is required to “assess the biological performance of the fish passage improvement Project and evaluate the ability of the site to pass steelhead” (National Marine Fisheries Service [NMFS] 2012). To meet this goal, a 5-year Fisheries Monitoring Plan (Plan) was developed by H. T. Harvey & Associates (HTH), approved by NMFS, and implemented beginning in September 2013 (HTH 2013a; 2014). The Plan includes habitat typing and electrofishing surveys to document: 1) the fish species occupying the Project reach, and 2) the habitat associations in reaches within and upstream of the Project reach. During Year 2 monitoring, HTH fish ecologists documented all fish species that were encountered with special focus on CCC steelhead. Both CCC steelhead and resident rainbow trout have been documented in Upper Penitencia Creek and upstream of the Project area (Leidy et al. 2005; Leicester 2011; Leicester and Smith 2012; HTH 2013b). Because CCC steelhead likely exhibit variable life history strategies, rainbow trout observed in the Project reach were assumed to be steelhead and are referred to as such in this report. Other monitoring components performed by others and not summarized herein include vegetation monitoring and streambed hydrological monitoring, all of which when combined, will improve understanding of the evolving habitat conditions and species use in the restored channel.

Figure 1. Concrete Weir Prior to Modification, 8 August 2012 (Looking Upstream)

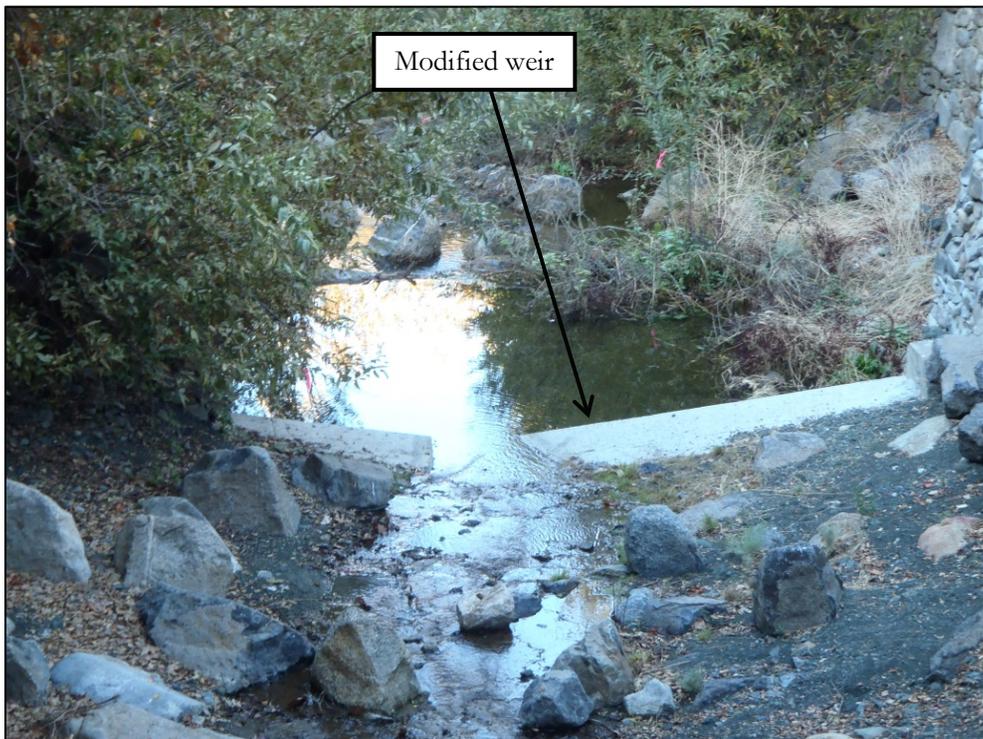
Figure 2. Modified Concrete Weir, 5 November 2014 (Looking Downstream)
