ALUM ROCK FISH PASSAGE PROJECT MITIGATION MONITORING REPORT YEAR THREE, 2015

Santa Clara Valley Transportation Authority
3331 North First Street, Bldg. B-2
San Jose, CA 95143-1906
Contact: Ann Calnan
408.321.5976

ICF International
75 E. Santa Clara Street, Suite 300
San Jose, CA 95113
Contact: Donna Maniscalco
408.216.2802

April 2016

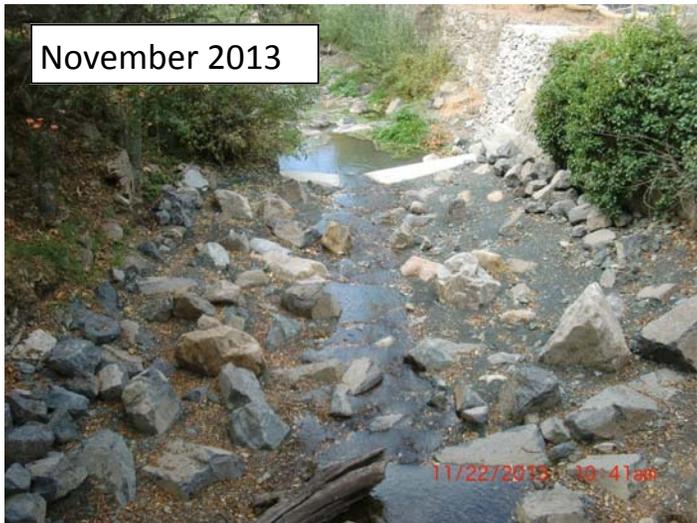
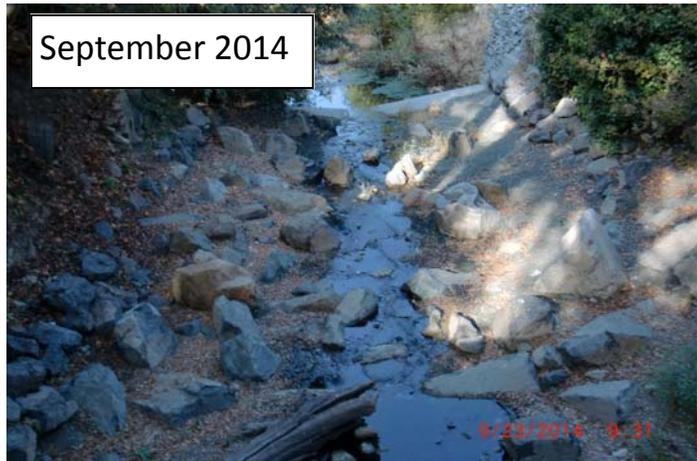
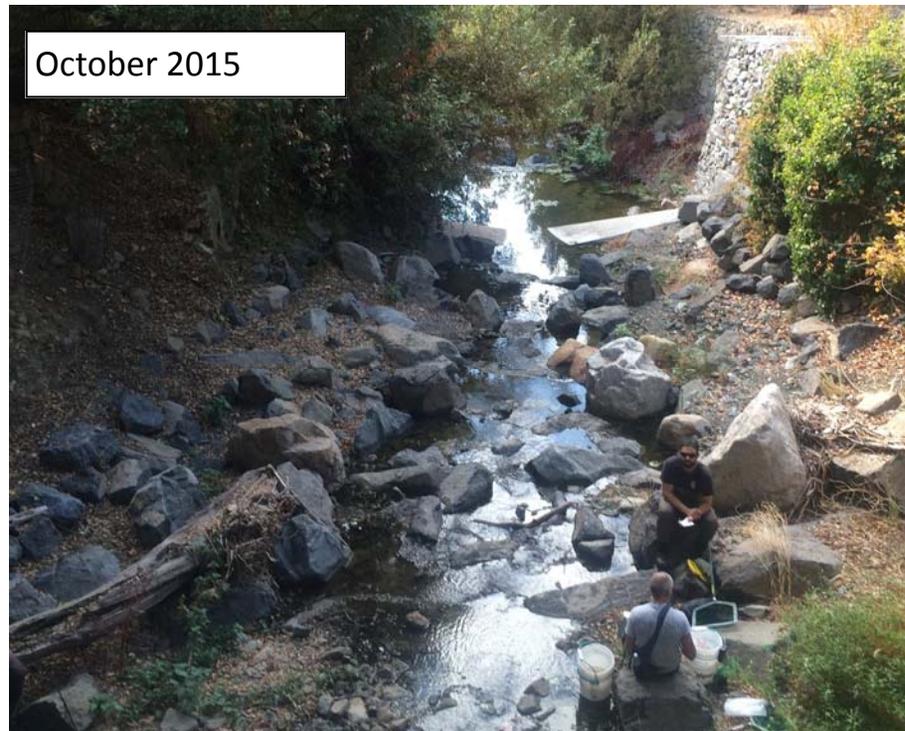
Figure 7.

The flows of December 2014 did move large wood in the channel. Photo point 1 (**Figure 7**) shows that a large log has shifted a few feet up the bank. Similarly-sized woody material may be transported into the project site during future flows, providing additional habitat.

Photo point 1, Site 13, Years 0-2. Alum Rock Monitoring, Upper Penitencia Creek, Santa Clara County, California . Photo point 1 photographs taken from pedestrian bridge, looking downstream at the first rock band structure and chute of the fish passage project. Note the large log that has moved up the left bank. Refer to Figure 1 of this report for photo point locations.

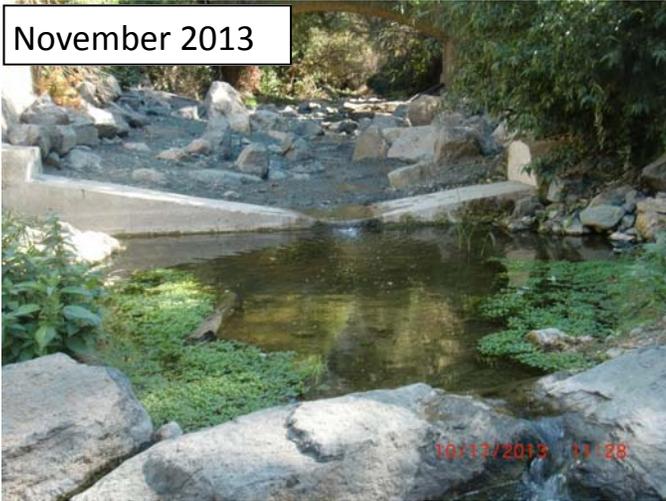
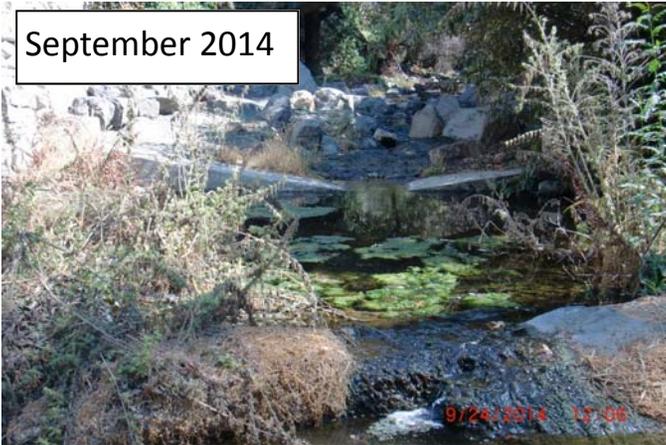
Figure 8.

Photo point 2, Site 13, Years 0-2. Alum Rock Monitoring, Upper Penitencia Creek, Santa Clara County, California . Photo point 2 photographs looking upstream to bridge below first rock band structure and chute of the fish passage project. Note the scour of gravels in the pools and along the banks, Refer to Figure 1 of this report for photo point locations.

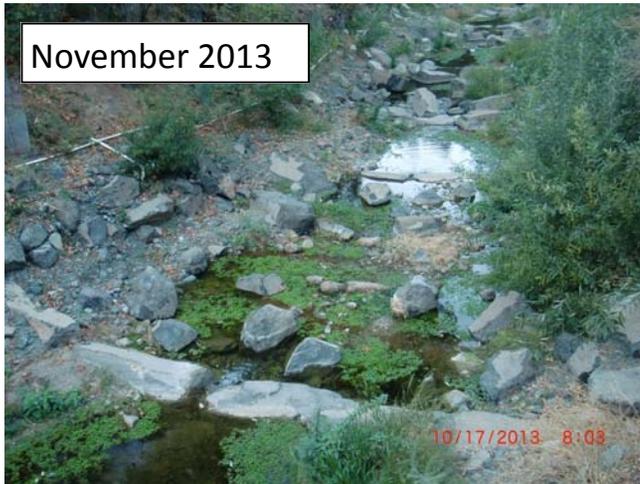
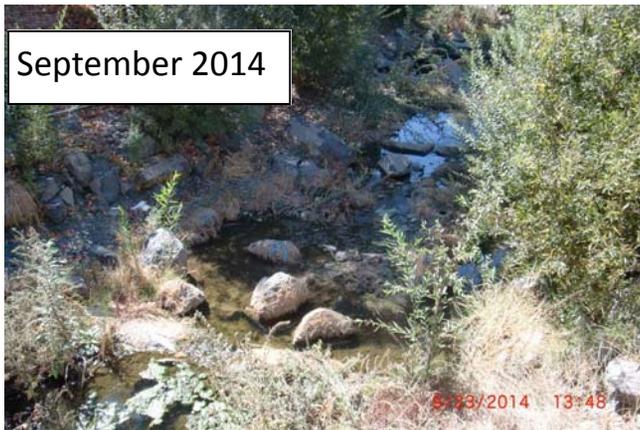
Photo point 3, Site 13, Years 0-2. Alum Rock Monitoring, Upper Penitencia Creek, Santa Clara County, California . Photo point 3 photographs looking upstream across pool 1 at the modified concrete grade control structure and pedestrian bridge in the fish passage project. Refer to Figure 1 of this report for photo point locations.

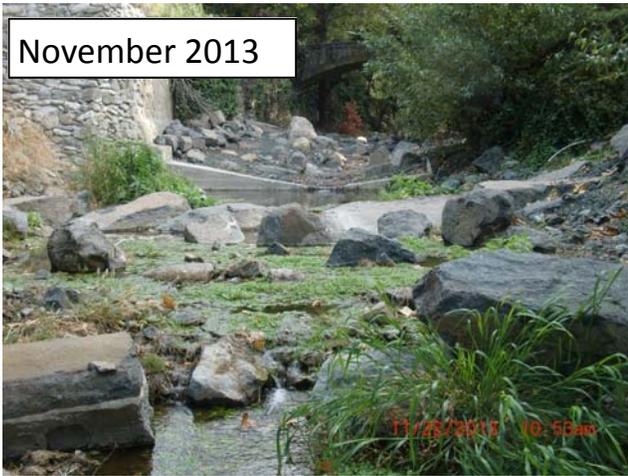
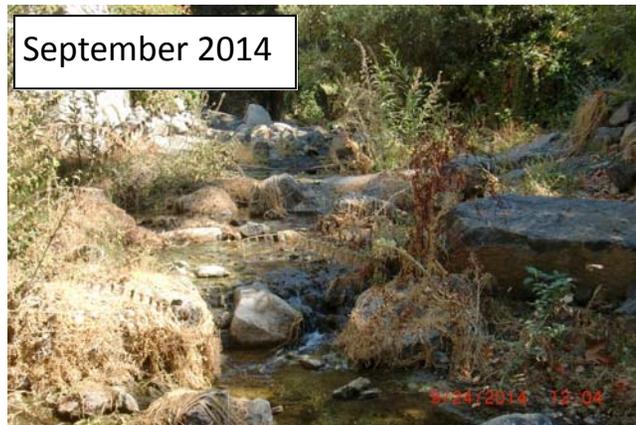
Figure 10. Photo point 4, Site 13, Years 0-2. Alum Rock Monitoring, Upper Penitencia Creek, Santa Clara County, California . Photo point 4 photographs taken on right bank from top of the modified concrete grade control structure wall looking downstream across chute 2 along the fish passage project. Refer to Figure 1 of this report for photo point locations.

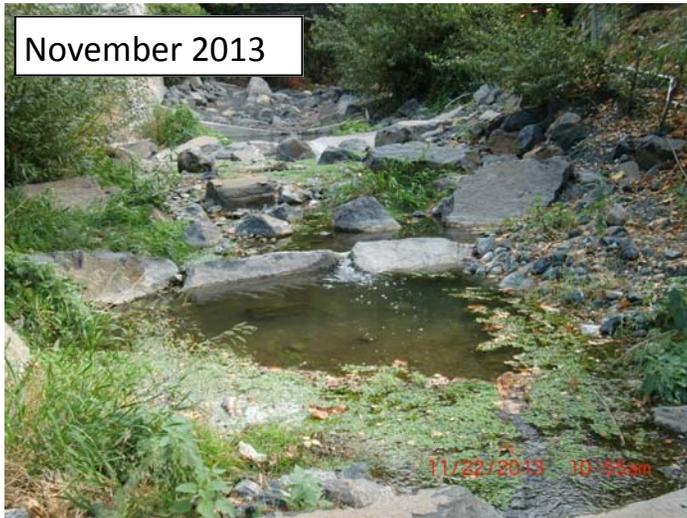
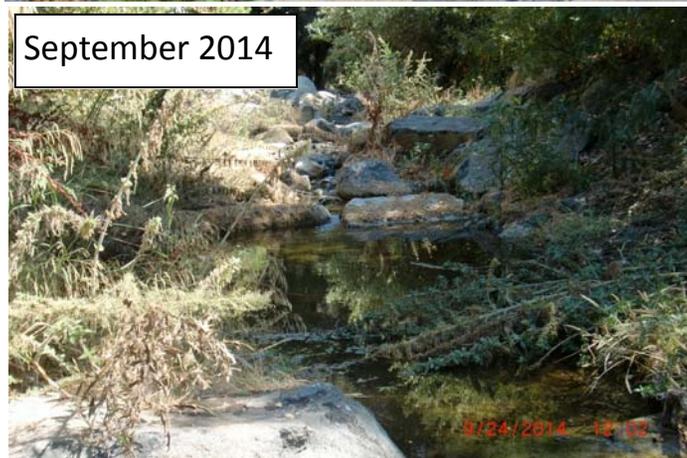
Figure 11. Photo point 5, Site 13, Years 0-2. Alum Rock Monitoring, Upper Penitencia Creek, Santa Clara County, California . Photo point 5 photographs looking upstream across chute 2 to modified concrete grade control structure and bridge in the fish passage project. Note the scour of vegetation and algal mats. Refer to Figure 1 of this report for photo point locations.

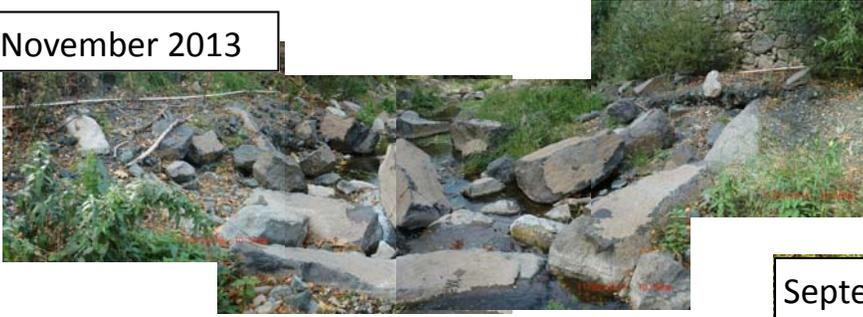
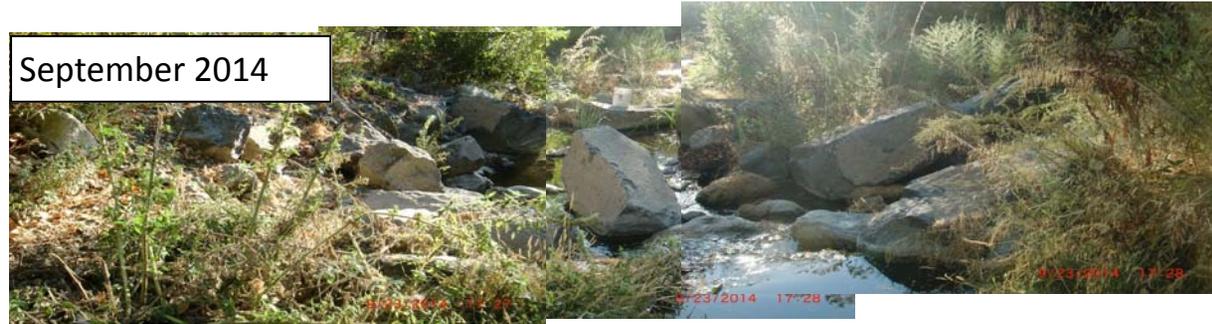
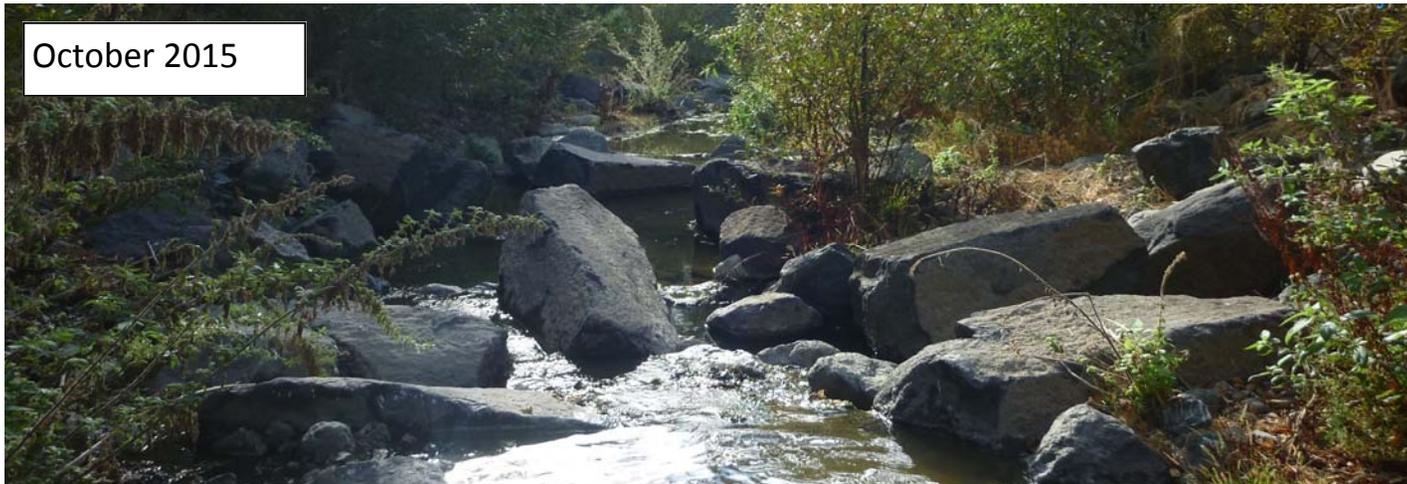
Figure 12. Photo point 6, Site 13, Years 0-2. Alum Rock Monitoring, Upper Penitencia Creek, Santa Clara County, California . Photo point 6 photographs looking upstream across pool 2 and chute 2 in the fish passage project. Refer to Figure 1 of this report for photo point locations.

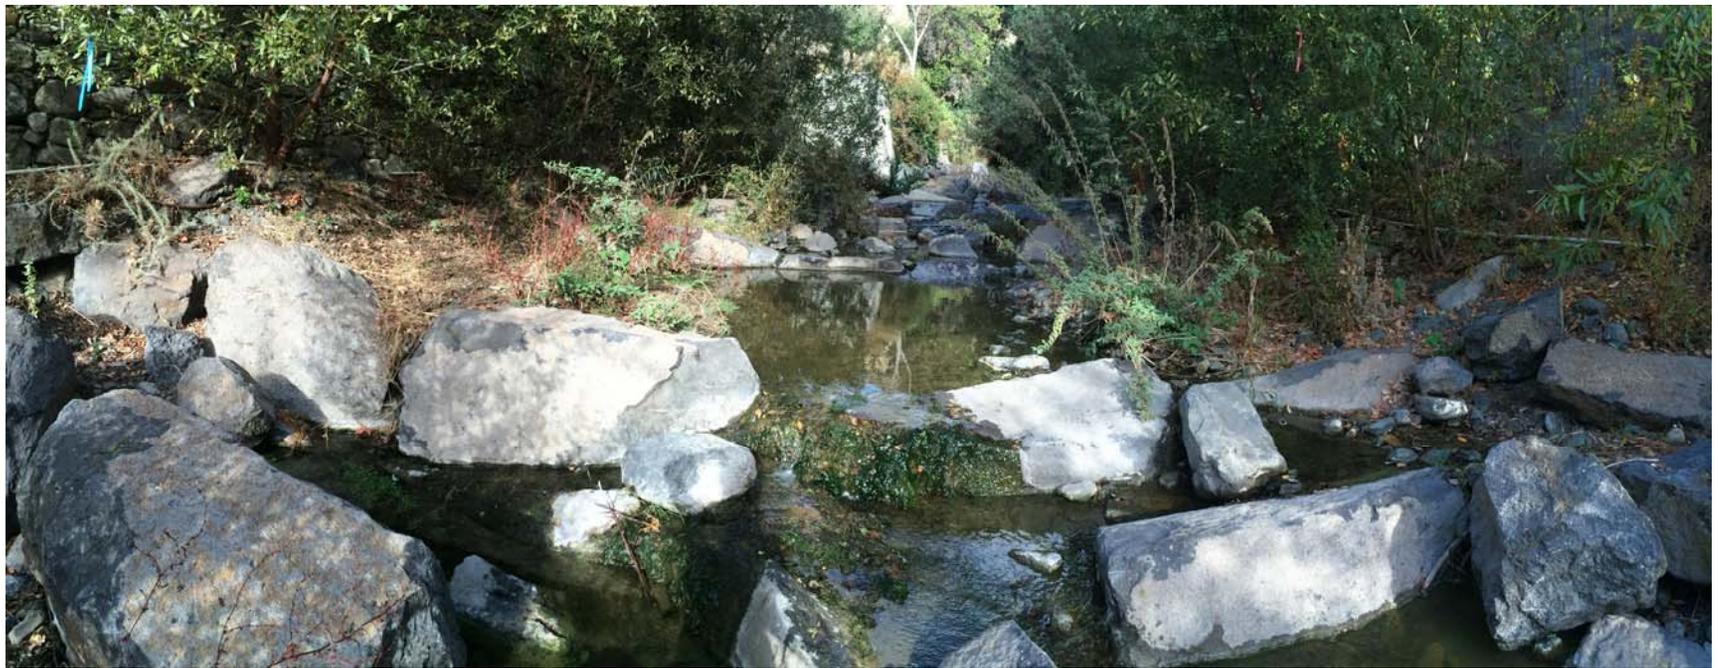
Figure 13.

Photo point 7, Site 13, Years 0-2. Alum Rock Monitoring, Upper Penitencia Creek, Santa Clara County, California . Photo point 7 panoramic photographs looking downstream at rock band structure and chute 3 in the fish passage project. Note forming erosion line on right bank downstream of rock band. Refer to Figure 1 of this report for photo point locations.

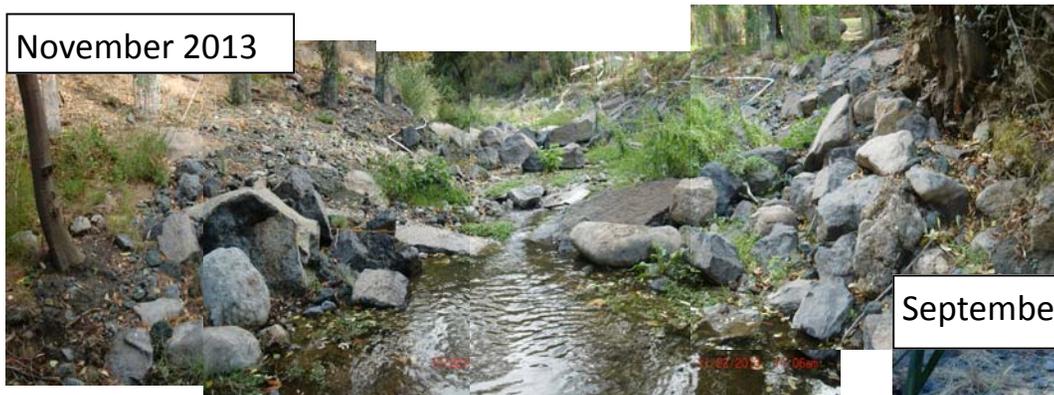
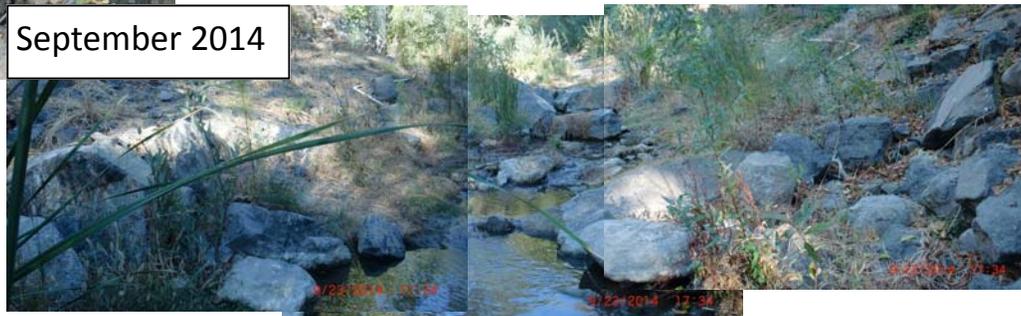
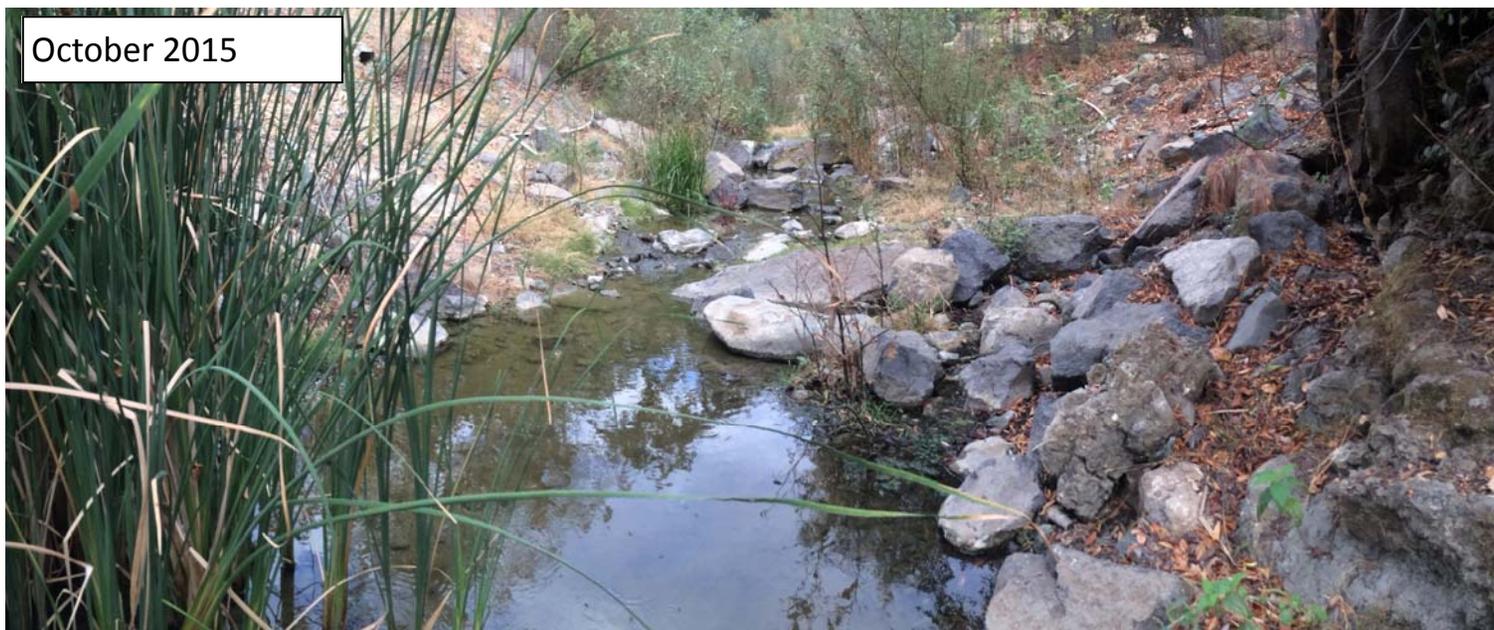
Figure 15.

Photo point 9, Site 13, Years 0-2. Alum Rock Monitoring, Upper Penitencia Creek, Santa Clara County, California . Photo point 9 photographs looking upstream across rock band structure and pool 4 in the fish passage project. Refer to Figure 1 of this report for photo point locations.

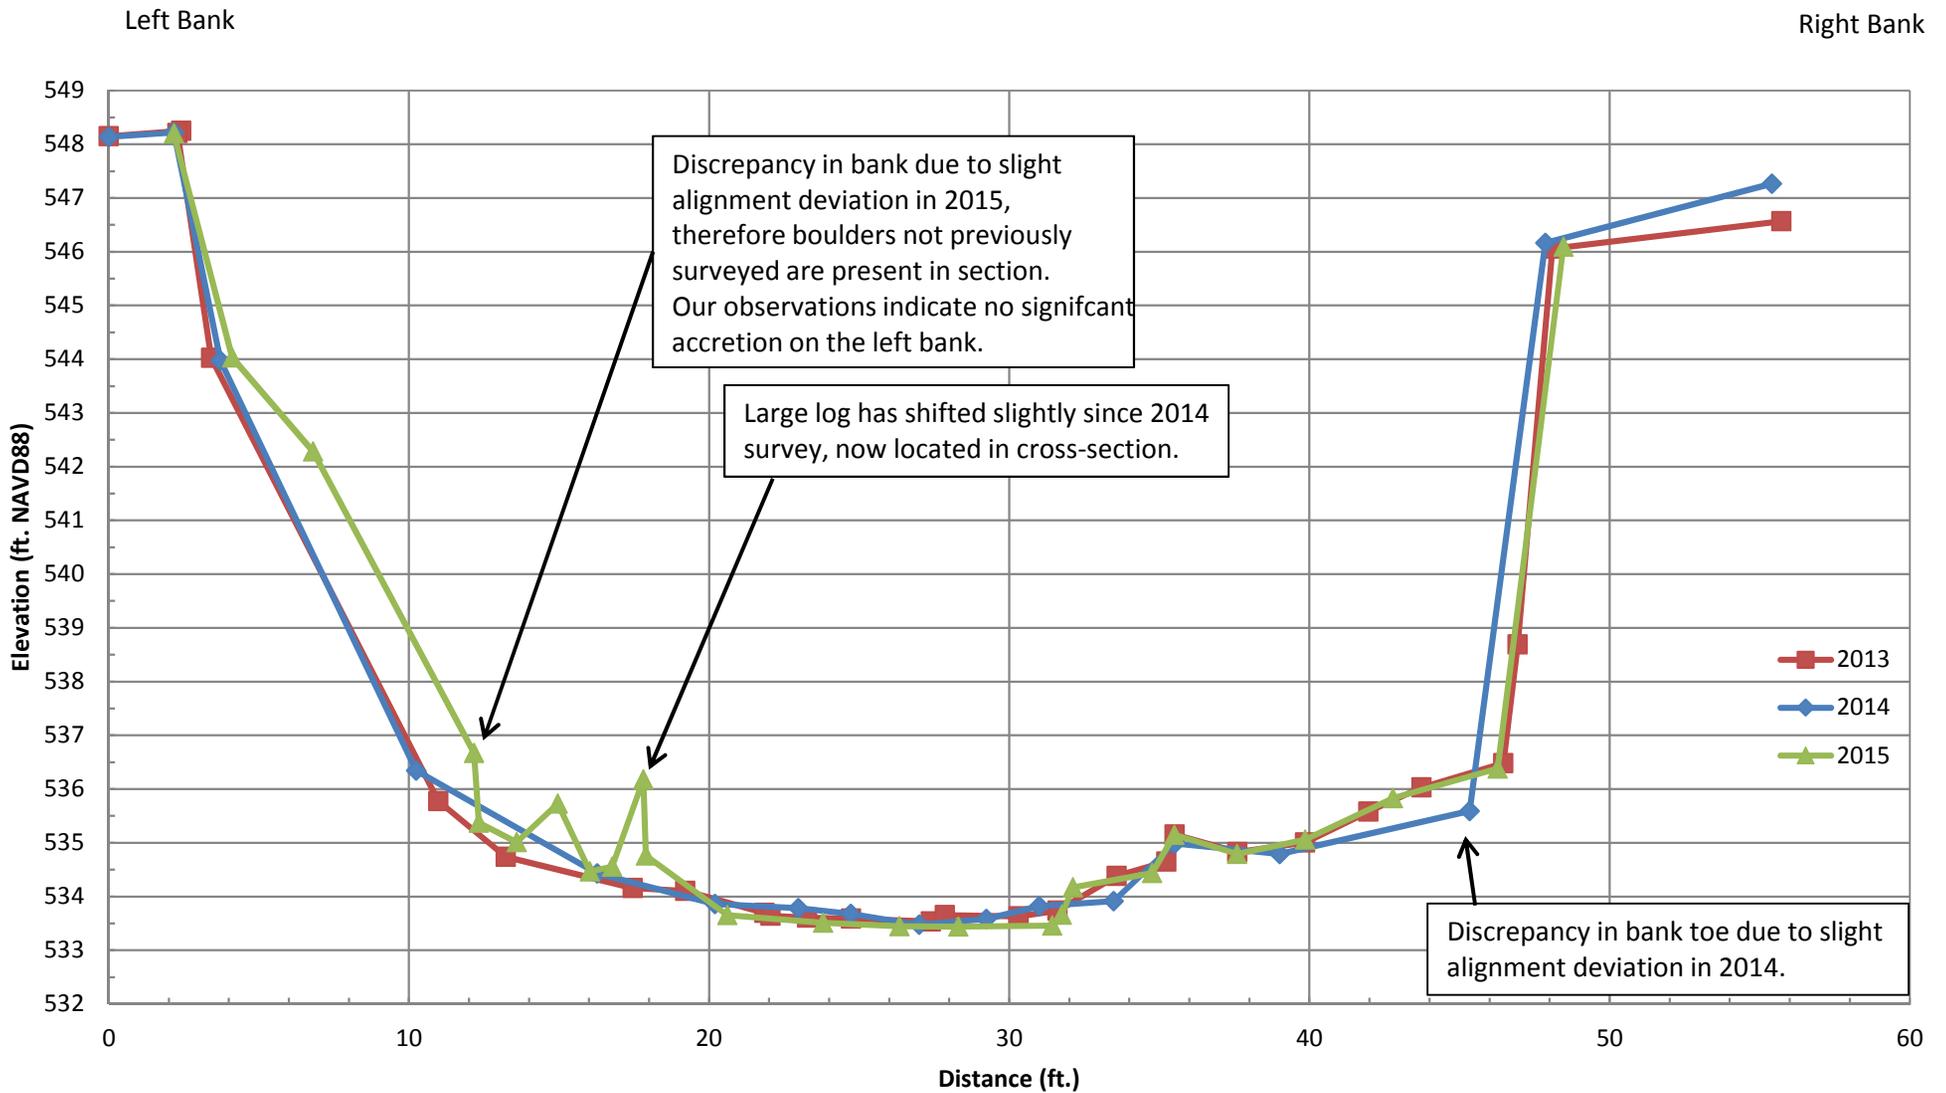
Figure 17 . Cross section 1, Alum Rock WY2015 monitoring, Santa Clara County, California.

Figures 17-23 show the results of the September 2014 cross sections surveys. Comparisons of October 2015 survey data to the previous years' data generally confirm visual observations –major geomorphic change, such as significant bank widening, downcutting or aggradation, did not take place in the fish passage over WY2015, but small and localized variations in bed elevations are present. XS 1 (**Figure 17**) shows that while the channel profile is stable, the large log that shifted during high flows (**Figure 7**) is now located within the cross section. XS 2 (**Figure 18**) shows that aggradation of organic debris and sediment is present on the heavily vegetated left bank of the channel, as well as on the channel bed. Slight changes in the channel bed due to the reworking of fine sediments, as observed in the visual observations and photo points, can be seen in XS 3 and XS 4 (**Figure 19, Figure 20**). The most appreciable changes of this type occurred between XS 1 and XS 2, and while they are not captured in cross section surveys, they are readily visible in the longitudinal profile (discussed below).

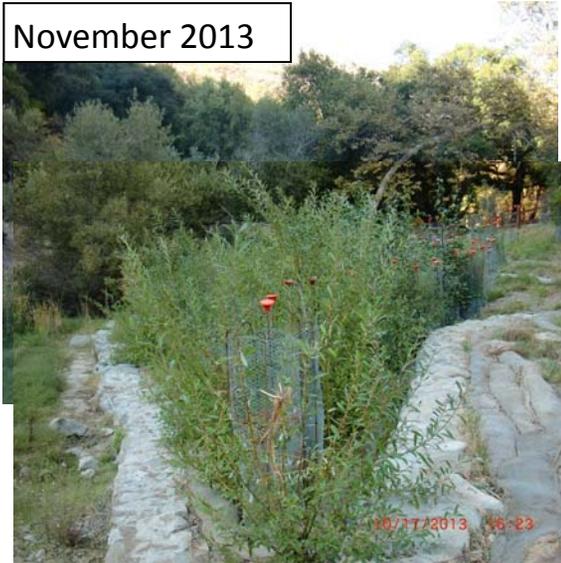
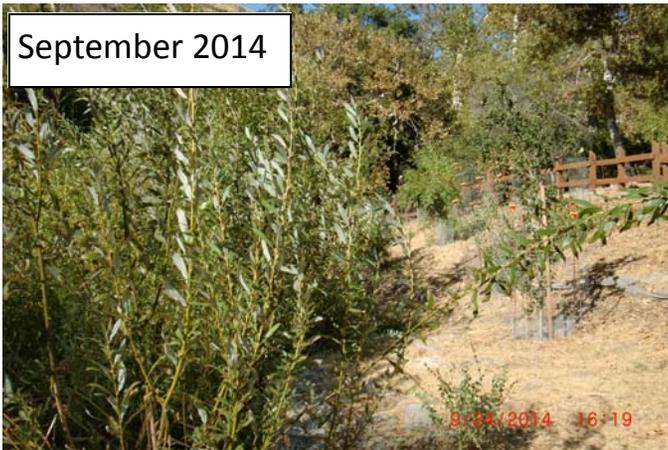
Visual assessment of geomorphic change on the floodplain was marked by vigorous growth of alders and willows, as is evident in the photo points (**Figures 25-30**). Aggradation was observed on top of the floodplain; evidence included organic debris wrack lines from high water and fresh sediment deposits. This is consistent with the stage record of inundation, as well as with the aggradation around the gage that was observed during the May 2015 site visit. The connections from the main channel to the constructed floodplain have not changed significantly, other than a continued increase in the vegetation growing around them. The thickness of this vegetation may have the capacity to divert most of the high flows away from the floodplain, protecting it from erosion and encouraging sedimentation, but may strongly divert flows into the opposite bank, increasing the potential for erosion. Such flow patterns and bank changes will be assessed visually during and/or following high flows in the upcoming water years.

Figure 25. Photo point 11, Site 10, Years 0-2. Alum Rock Monitoring, Upper Penitencia Creek, Santa Clara County, California . Photo point 11 looking upstream at Site 10 floodplain toward foot bridge. Refer to Figure 2 of this report for photo point locations.

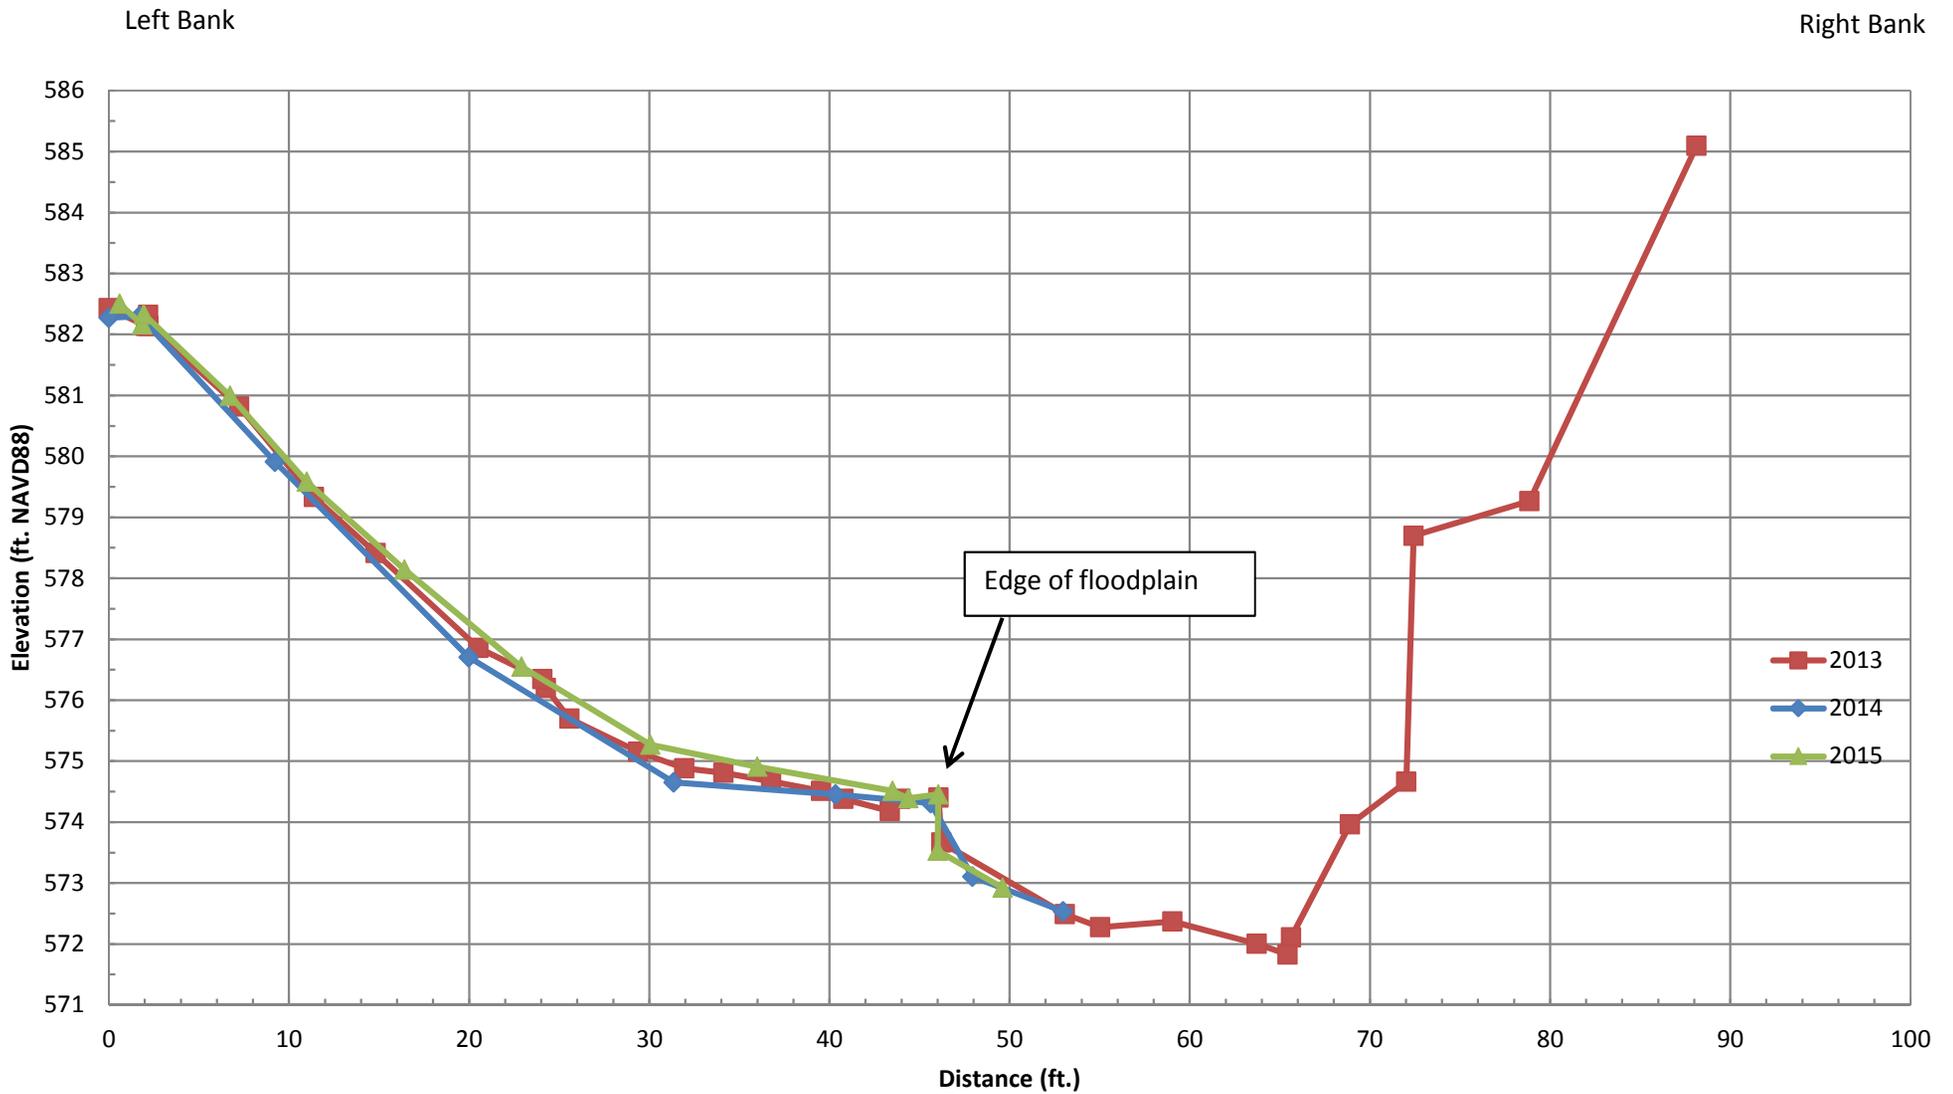
Figure 31 . Cross section 101, Alum Rock WY2015 monitoring, Santa Clara County, California.

Figures 31-32 show the results of the September 2014 cross sections surveys. Comparisons of the October 2015 survey to the previous surveys generally confirm the results of the visual observations: other than some aggradation, little geomorphic change took place in the floodplain over WY2015. This result was expected, as it was a relatively dry year, and high flows were infrequent. The comparison of the surveyed cross sections shows some reworking of the channel bed sediments, but no evidence of channel widening or downcutting. The floodplain is included in the survey of XS 101; however, we did not survey the right channel bank or channel thalweg during the September 2014 or October 2015 surveys. In Figure 32, we observe a significant change in topography between the stream channel and the floodplain wall. We attribute the change to deposition of sediment during the storms of December, 2014. In addition, we noted dense vegetation at this location, which likely enhanced deposition, locally.

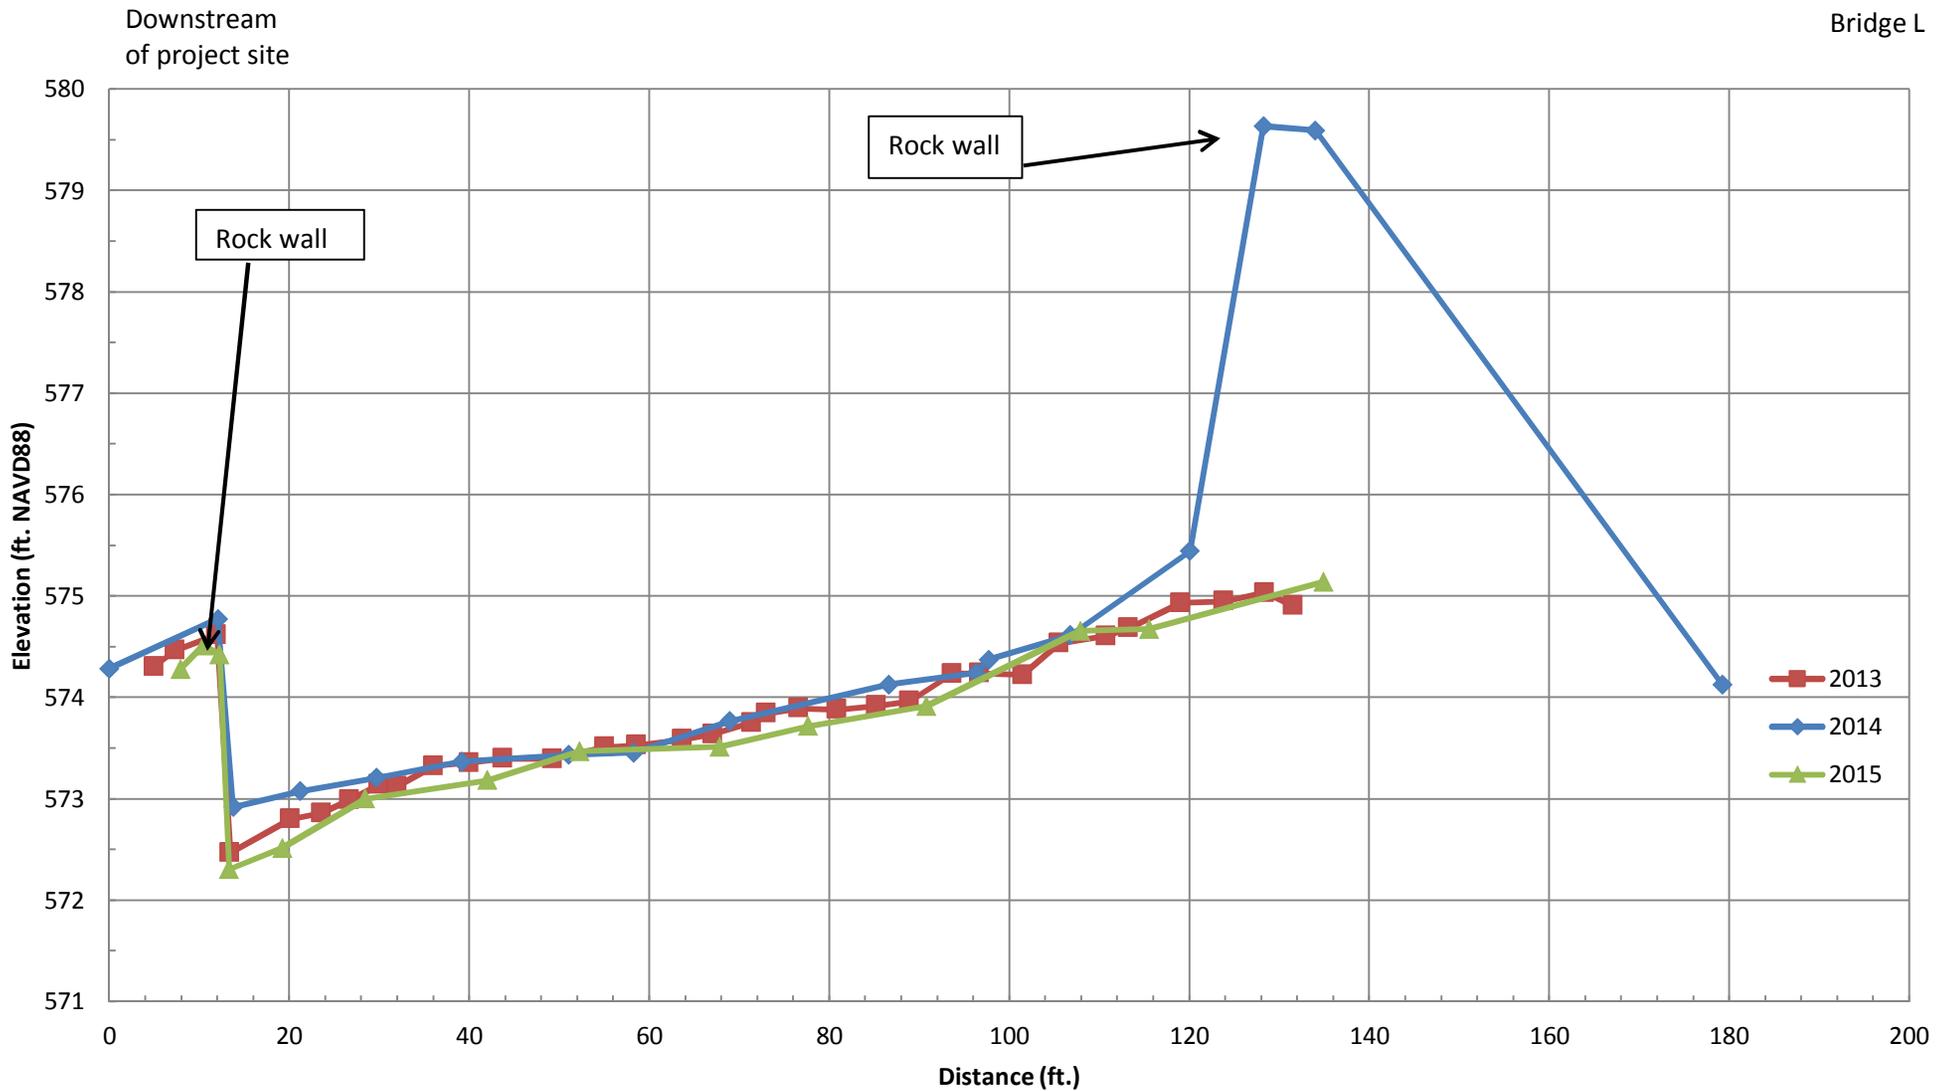
Figure 33 shows the results of the 2014 floodplain elevational survey. The elevation of the floodplain generally appears to be consistent from the baseline survey to the present, suggesting that the aggradation observed in visual observations is localized, and does not hinder the habitat function of the floodplain. The surveyed profile suggests geomorphic stability within Project Site 10. Note that the vigorous growth of vegetation on the floodplain is starting to hinder our ability to stay on this profile line; this will likely be an ongoing issue in future surveys.

Figure 33. Site 10 (Floodplain) elevational profile, Alum Rock WY2015 monitoring, Santa Clara County, California. Note that due to thick planted vegetation, line-of-sight is difficult. In order prevent damage to plantings, long profile may vary slightly year to year.
