# **Appendix K**

**EVALUATION OF TIRE DERIVED AGGREGATE  
AS INSTALLED BENEATH BALLAST AND TIE LIGHT RAIL TRACK**

**-- Results of 2009 Field Tests --**

**June 2009**

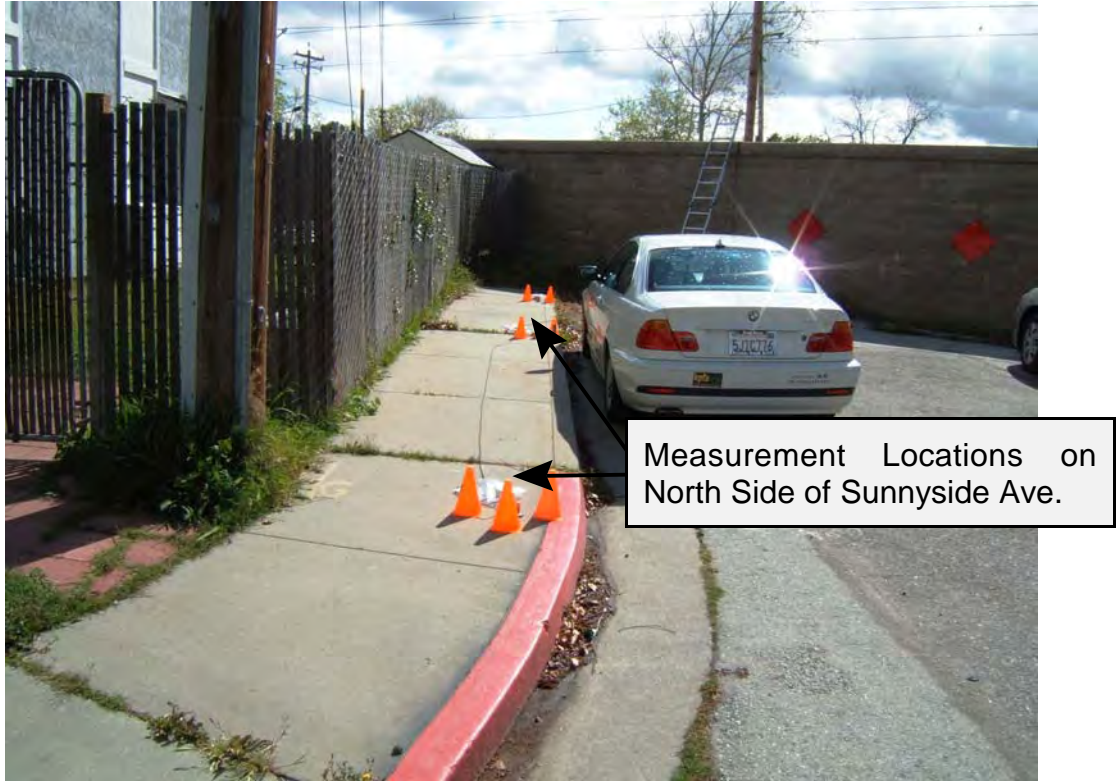
Measurement Locations on North Side of Sunnyside Ave.

FIGURE 2 - SITE 1 MEASUREMENT LOCATIONS 2-4

Figures 2 through 6 present photographs of the measurement locations and the configuration of the alignment, including rail condition after approximately one year of revenue operations.

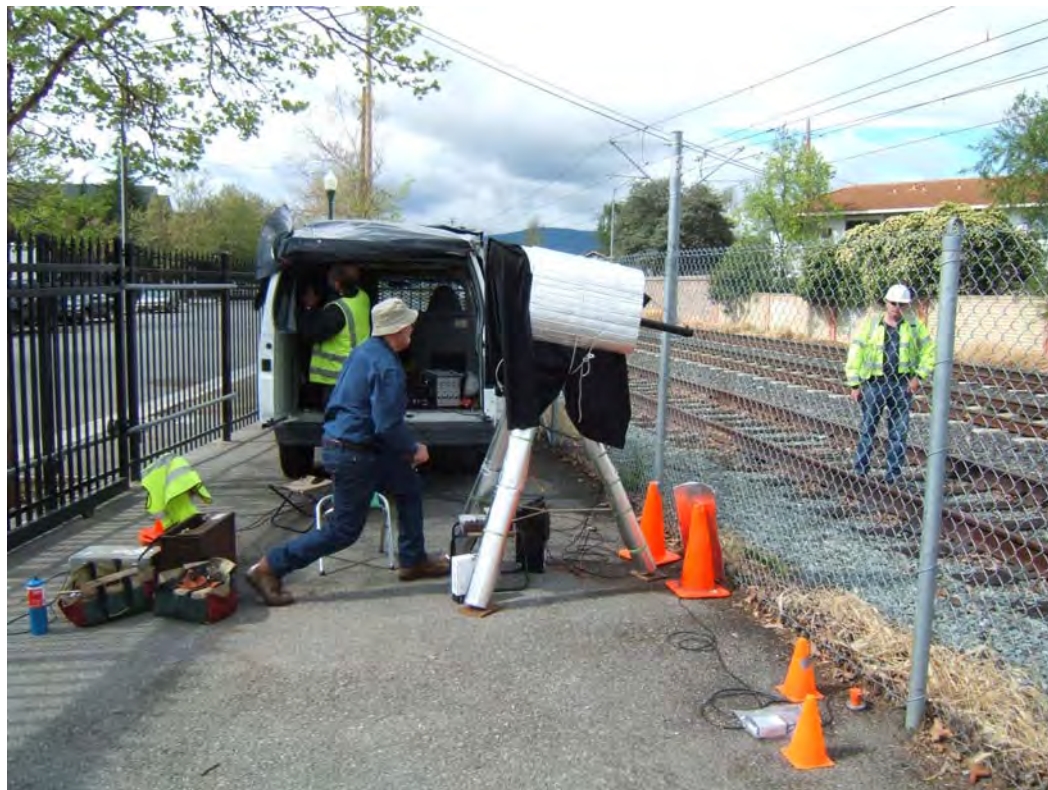
FIGURE 5 - OPTICAL RAIL DEFLECTION MEASURE DEVICE AT SITE 1

The measurement technique uses a light source (the target) mounted on the rail and a telescope at the instrument location with a PSD (Position Sensing Detector) at the focal point of the telescope. The telescope and PSD set up at Site 1 is shown in Figure 5. The characteristic of a PSD is that it generates currents from each end of the sensitive region of the detector, and the ratio of these two currents is directly related to the position of the centroid of the light spot falling on the sensor. PSDs are available in many sizes of sensitive areas and in one or two-dimensional configurations. For this project, a two-dimensional PSD with a sensitive area of about 4 x 4 mm was used. The horizontal axis was not recorded, but was used with a local, digital readout for horizontal alignment of the telescope axis with the target on the rail.

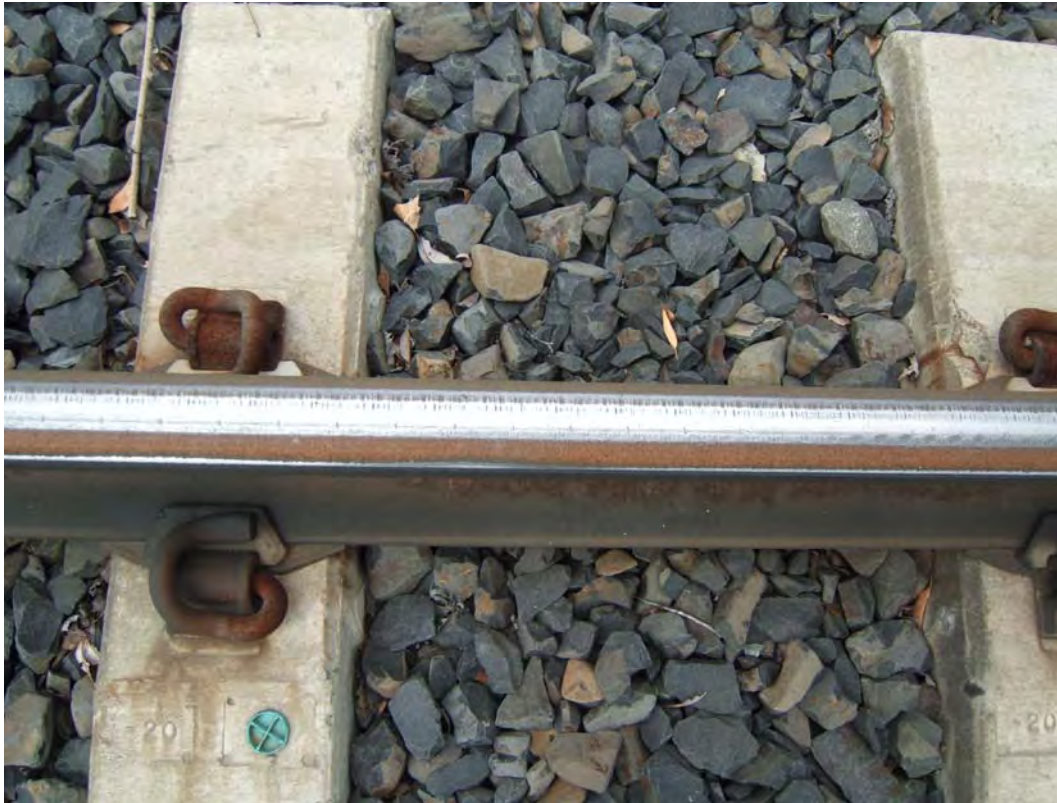
FIGURE 6 - RAIL CONDITION AT SITE 1

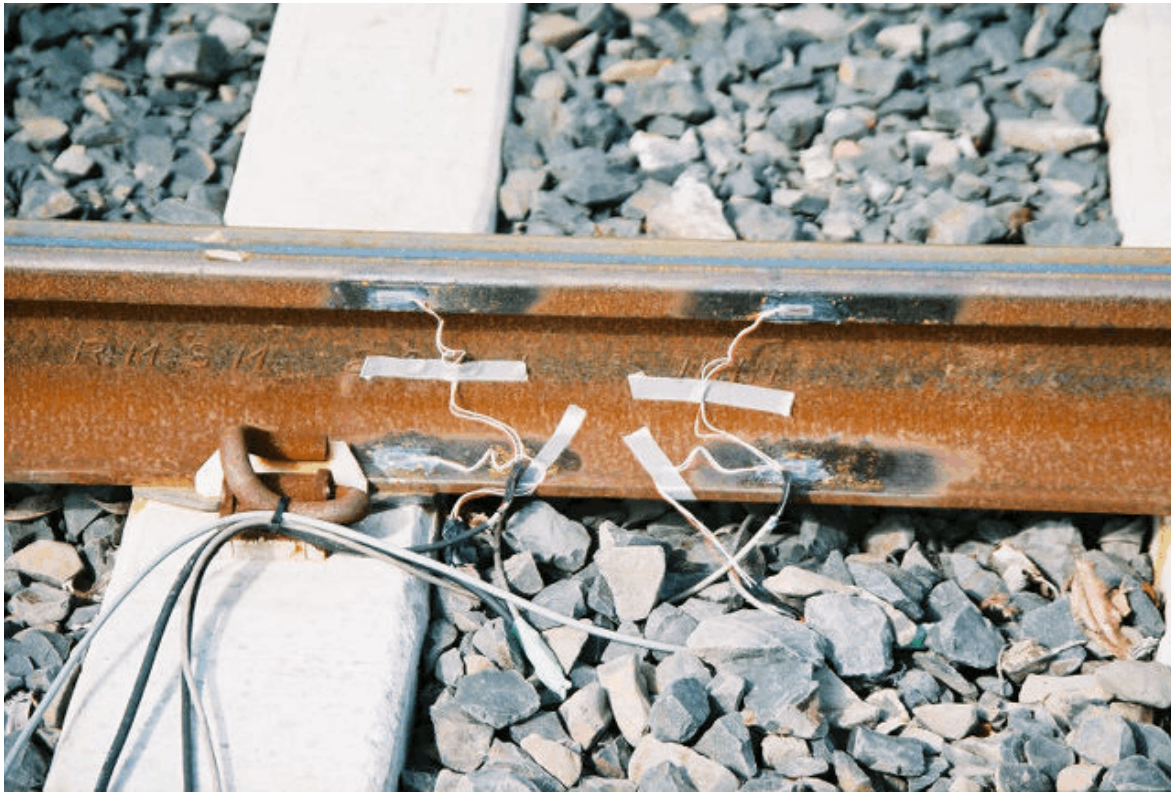
FIGURE 18 - STRAIN GAGE INSTALLATION AT SITE 1 (FROM 2005 TESTS)

As indicated, measurements of rail strain were obtained during train operations at three sections with TDA underlayment and at both control sections. At each location, a set of six strain gages were used to measure tension(elongation) and compression of the rail head and foot in the longitudinal direction, positioned both over a tie and at the mid point between two adjacent ties. At each position, one gage was mounted on the outside edge of the head, aligned laterally with two gages mounted on the inside and outside of the rail foot. Figure 18 shows a typical strain gage installation.

The selected gages were Vishay Micro-Measurements LWK-06-W250B-350 weldable strain gages, which were welded to each prepared section of rail with a Vishay Micro-Measurements Model 700 battery powered spot welder. After mounting the gages, a silicone compound was applied for protection, and shielded cables were attached to the gage leads and run under the tracks to a rack of Vishay Model 2311 strain gage signal conditioning amplifiers. Each pair of gages at the rail foot was combined into one channel, giving a total of four channels per location. The outputs of the amplifier were recorded on four channels of the Teac LX-10 16-channel data recorder, simultaneously with track deflection and ground vibration signals. Since these strain gages were originally applied to the rail prior for the 2005 tests, field testing and repair of the strain gages occurred prior to the 2009 tests to ensure that all strain gages functioned properly.

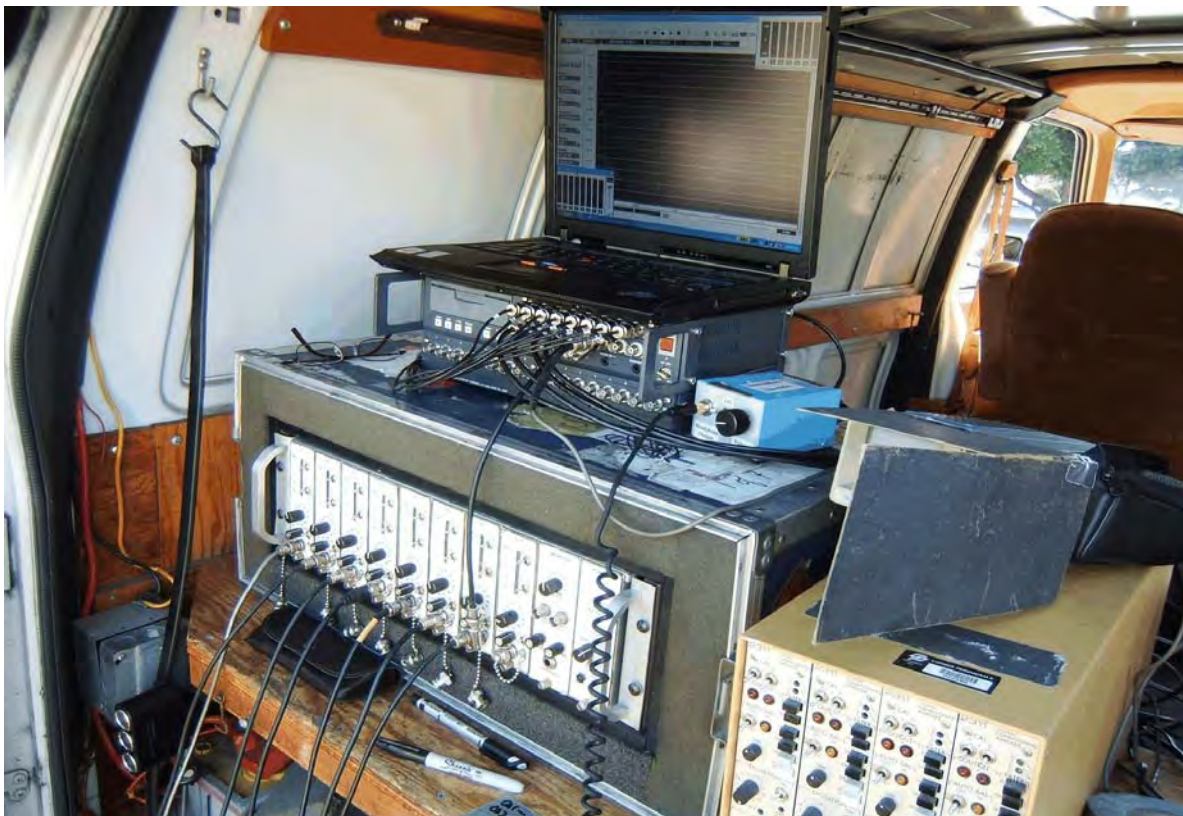
FIGURE 19 - MEASUREMENT MONITORING AND RECORDING INSTRUMENTATION (FROM 2006 TESTS)

A vibration velocity transducer (geophone) was located at each of the ground surface measurement locations. Each geophone (AMF Geospace Model GS 200X) was mounted with wax on a concrete or asphalt surface, or on a specially designed spike embedded in the ground. The output of the geophones was conditioned and amplified by WIA Type 116 geophone preamplifiers and a Type 228 8-channel decade amplifier. The output of the decade amplifier was recorded on a Teac Model LX-10 16-channel data recorder for subsequent data processing. The recording and monitoring instrumentation is shown in Figure 19.

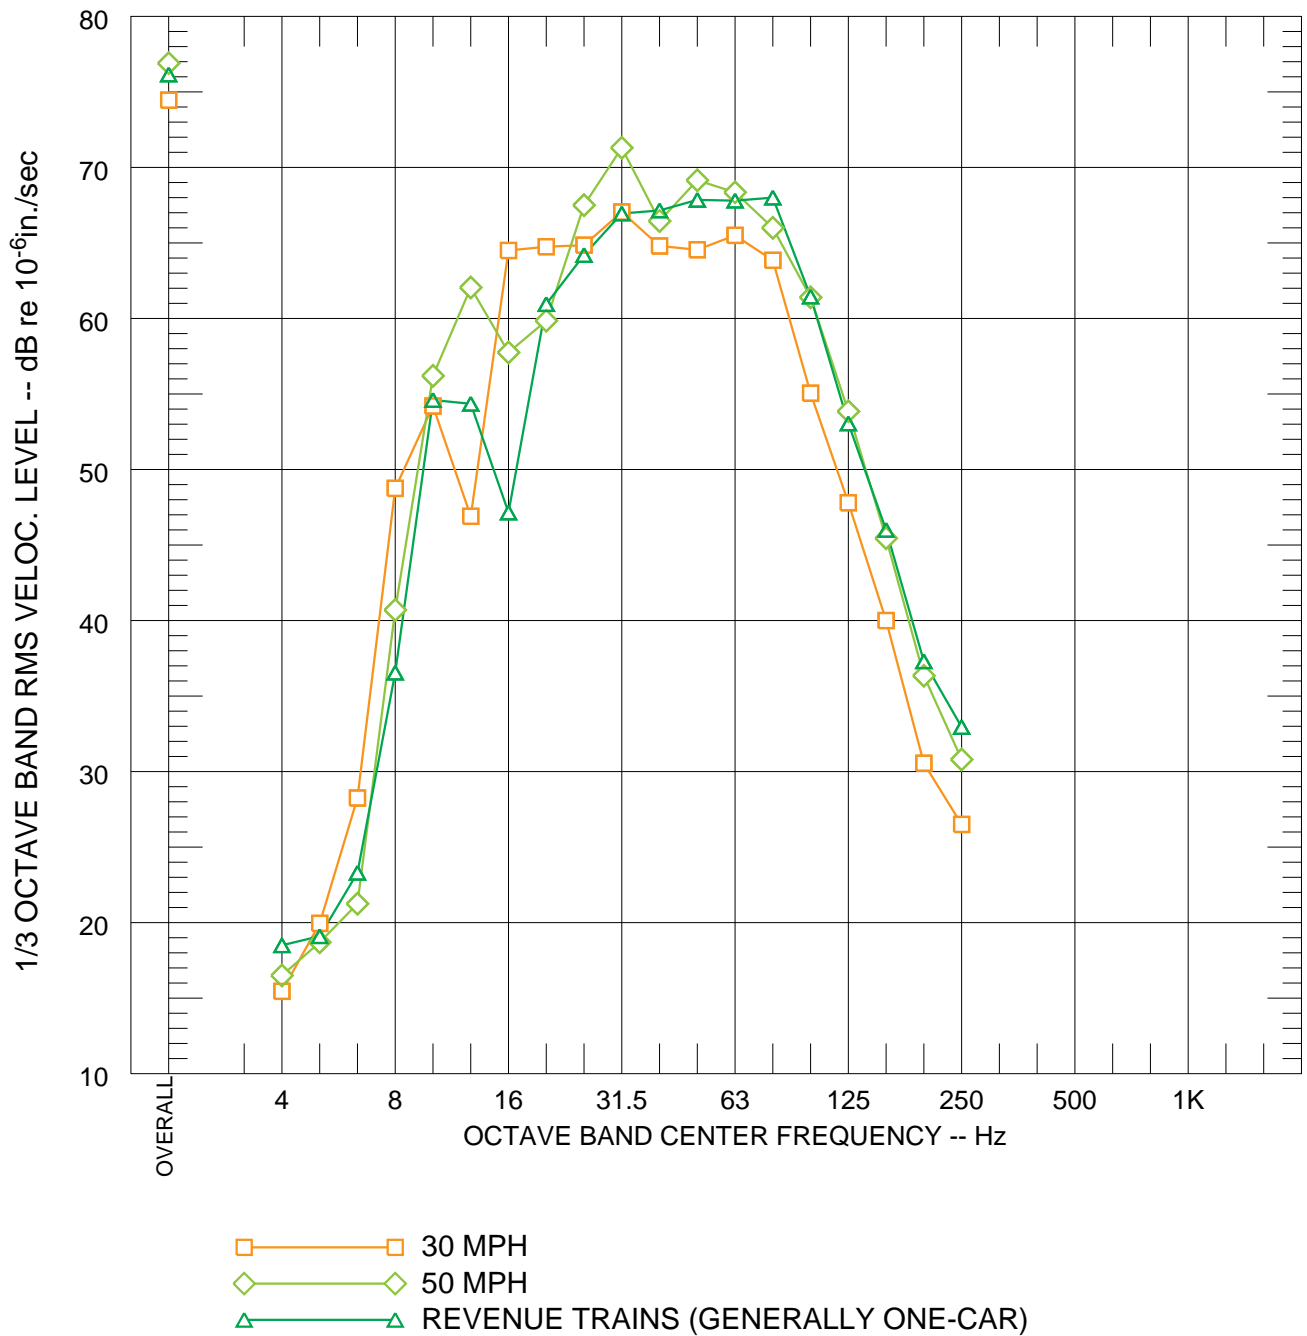
FIGURE 23 TWO-CAR TEST TRAIN PASSBYS AT TDA SITE #3 (NORTH OF LEIGH AVE.) - 25 FT FROM SB TRACK CENTERLINE

Figures 20 through 32 present the wayside groundborne vibration data for test train passbys in terms of 1/3 octave band vibration levels for the TDA and control sections that have been used to determine the insertion loss of the TDA underlayment. Revenue train passbys, usually single-car trains, were also recorded and are presented for general information on these figures. But as previously indicated, these data were not included in determining the insertion loss of the TDA underlayment. Figure 33 presents the insertion loss determined for each location using both the 25 ft and 50 ft data. These results are consistent with what was determined for the tests performed in 2005 and 2006. The insertion loss at TDA Site 1 shows low frequency reduction which is simply a factor of the comparison at control sections with higher levels of low-frequency vibration. The insertion loss at TDA Site 3 has been compromised to some degree by its short length that allows a certain amount of flanking vibration, and undoubtedly accounts for the TDA underlayment reduction in effectiveness at this location. Finally at TDA Site 4, a long single track section, the overall performance of the TDA underlayment is quite effective, with its relative amplification at the low frequencies, a factor of the comparison at the control sections which have lower levels of low frequency vibration. Figure 34 presents the average insertion loss for TDA Sites 1, 3 and 4 from the 2005, 2006 and 2009 tests along with a recommended design curve developed in 2006 for use on future designs. The 2009 tests show almost identical results to those from 2006. We believe that the design curve developed in 2006 is still valid, as it is expected that the average insertion loss for all locations would improve to what was determined from the 2005 tests when the insertion loss for TDA Site 2 had been included as part of the test program in 2006 and 2009.

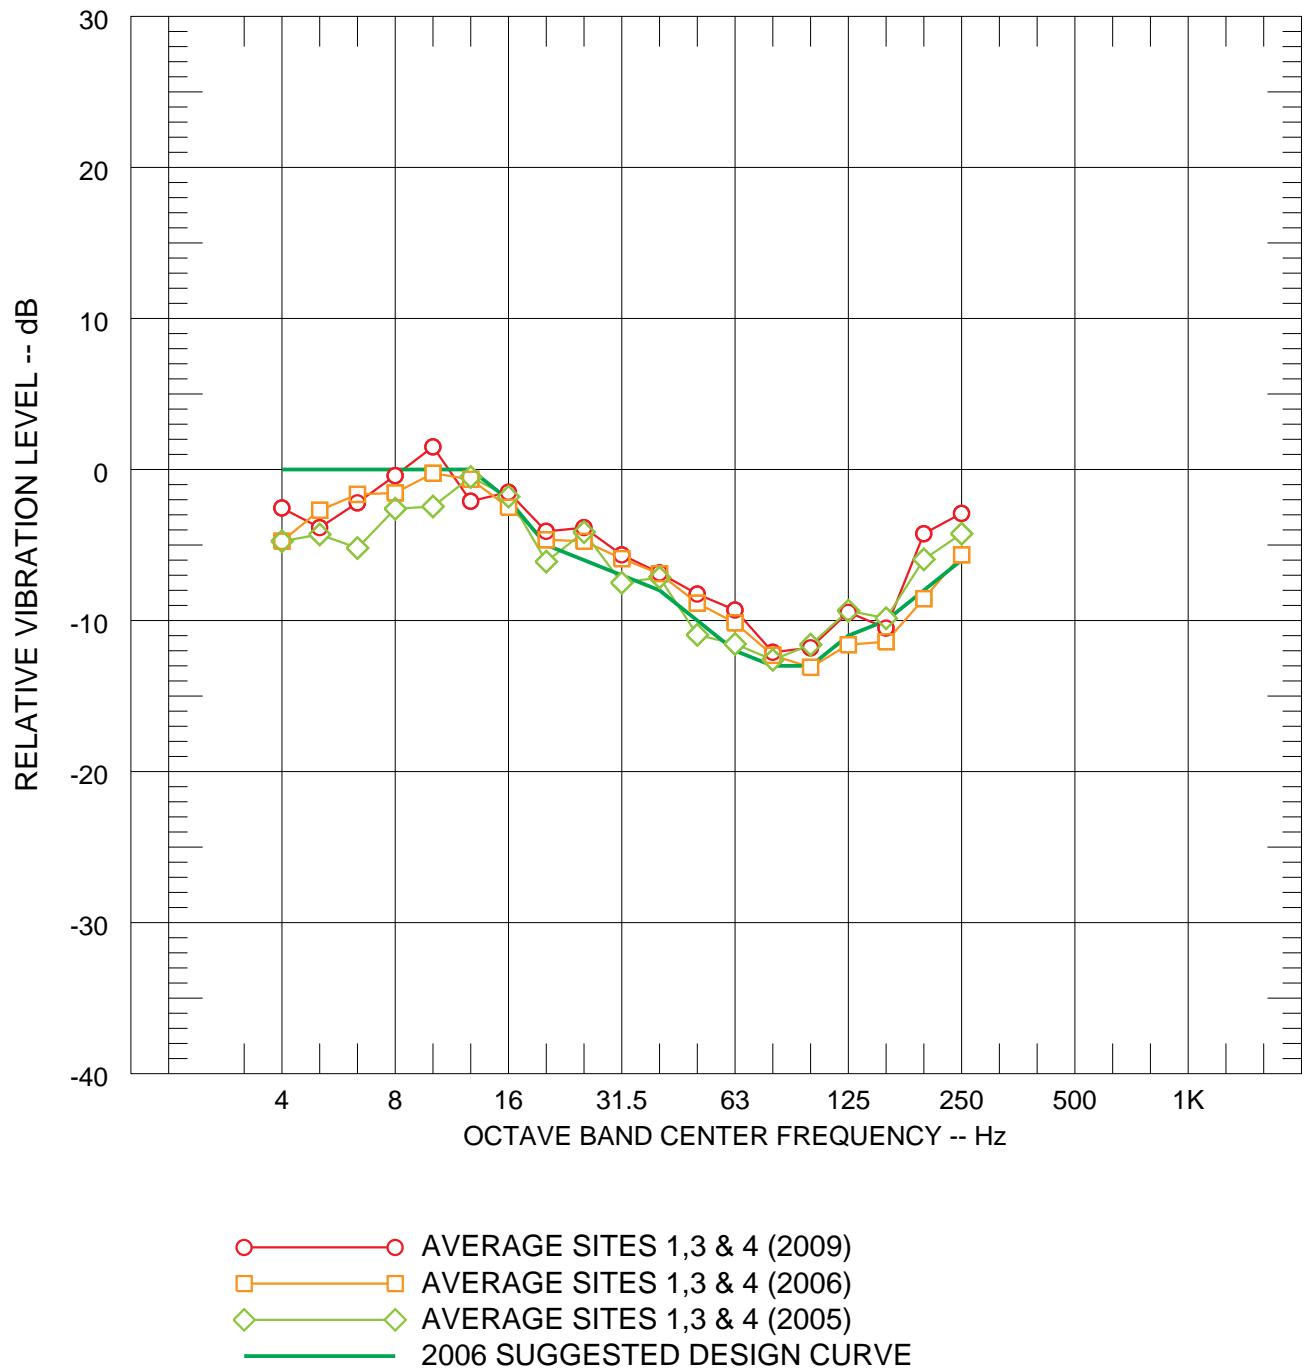
FIGURE 34 AVERAGE ATTENUATION OF TDA UNDERLAYMENT - TWO-CAR TEST TRAIN OPERATIONS FOR 3 TRAIN SPEEDS AND 2 MEASUREMENT DISTANCES

Review of Figure 34 indicates that the average insertion loss is similar for all three tests with some slight variations in the range of 25 to 80 Hz. These slight variations may be due to the fact that, as previously indicated, the insertion loss is based on a comparison of the groundborne vibration obtained at the TDA Sites in comparison with the groundborne vibration obtained at the control sites. Surface impact tests to determine vibration propagation characteristics were used to minimize differences between sites. However, since these sites are not in the same physical locations, there will still be some differences that are site specific and not related to the performance of the TDA underlayment. However, the overall attenuation curve is quite similar to that determined from all of the tests of TDA underlayment.

underlayment is somewhat more effective at lower frequencies. It is not expected that a consistent reduction of the very low frequency groundborne vibration ( $< 12.5$  Hz  $1/3$  octave band) will be achieved, but rather that this very low frequency reduction shown by Figure 34 for the 2005, 2006 and 2009 tests is simply a function of the averaging process and the fact that the very low frequency data were consistently lower at Control Site #1 (north of Stokes St.) than at Control Site #2 (south of Race St.). It is also believed that the TDA underlayment is still quite effective above 80 or 100 Hz and that the decrease in attenuation at the higher frequencies is simply the result of a decrease in the signal to noise ratio at these higher frequencies, since the wayside groundborne vibration generated by the trains at these higher frequencies is relatively low and not always significantly above the background vibration.
